SPORTS HALL – WARRANTY DEFECT OF FLOOR

DOI: 10.31490/tces-2019-0007

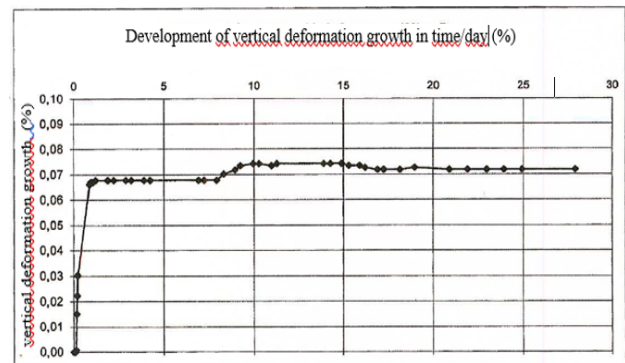
rating the sample and monitored until stabilization. The standard length of the test was 96 h. The largest change in volume was observed in the first few days for all selected samples, which were initially dried and then absorbed water until they reached a humidity value of 20% (Fig. 1).

Figure 1. Measurements of the progress of vertical deformation in the backfill sample[4]

It was concluded that the backfilling material specified in the project documentation, (i.e., natural aggregate) would not have demonstrated these changes in volume. The evaluation also measured temperature changes in the backfill and identified the binder type present in the recycled concrete. Just as in the previous test, a dried sample was mixed with water and the resulting heat of hydration values were compared to various binder types, such as cement and plaster. In order to precisely identify the material in the backfill, more tests were needed, including elemental analysis of the sample using x-ray fluorescence spectrometry on an XRF spectrometer and analysis of the powder using X-RAY diffraction. From these tests, several conclusions were made.

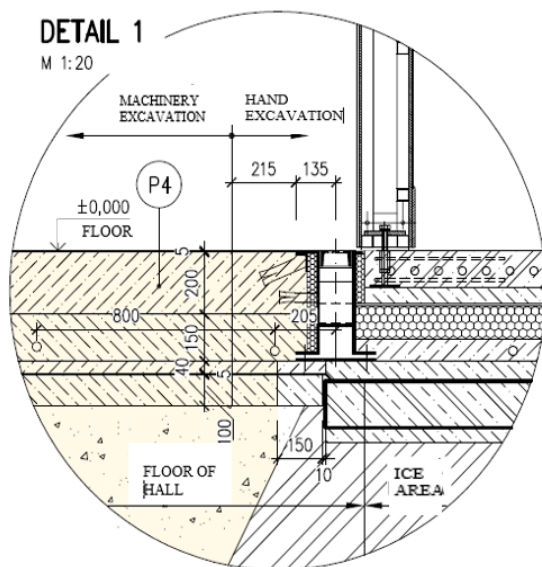
Figure 2. Detail of the contact between the concrete floor and the ammonia channel from reconstruction in 2012.[11]

The backfill material was probably activated by the penetration of water from the remaining old infrastructure or by a change in the level of ground water. The problem is illustrated in Figures 2 and 3. The redesigned project documentation already addressed the two problems, i.e. exchange of the backfill material, which did not comply with the project documentation in terms of its technical properties, but also a change in the floor heating system

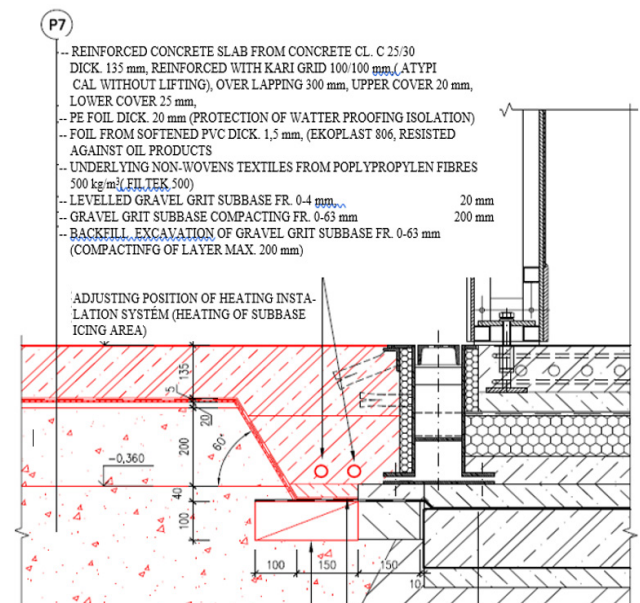
Figure 3. Detail of the contact between the concrete floor and the ammonia channel from reconstruction in 2016. [11]

Corrective actions in the form of replacing the backfill material, thinning the concrete floor to half its thickness and changes to the floor heating system by reducing the spacing between heating pipes led to a different temperature gradient and therefore tension in the concrete floor structure, which was the reason for the edges of the structure lifting initially. After these modifications were implemented in 2016, no further height irregularities caused by the floor lifting near the ammonia duct have been observed.
