**Filip ČMIEL<sup>1</sup>, Radek FABIAN<sup>2</sup>****ASSESSMENT OF ENVELOPE OF GOS PANEL SYSTEM  
MEASURED BY THERMOCAMERA****POSOUZENÍ OBVODOVÉHO PLÁŠTĚ PANELOVÉ SOUSTAVY GOS  
TERMORIZNÍM MĚŘENÍM****Abstract**

A thermocamera can be used for the assessment of building envelopes. Thermal bridges and their seriousness can be detected by a thermocamera. We used these measurements for the detection of thermal bridges and then for the assessment of improving steps on the building envelope. We used these measurements to compare envelopes of two objects of the same panel system which have been revitalized in different ways.

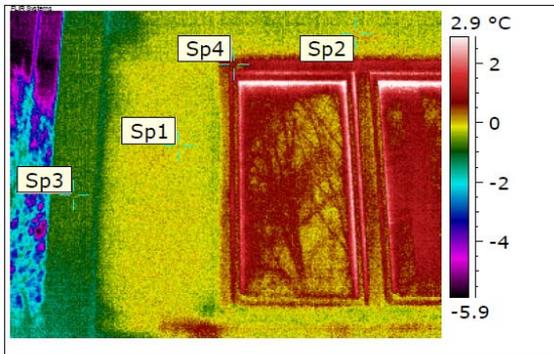
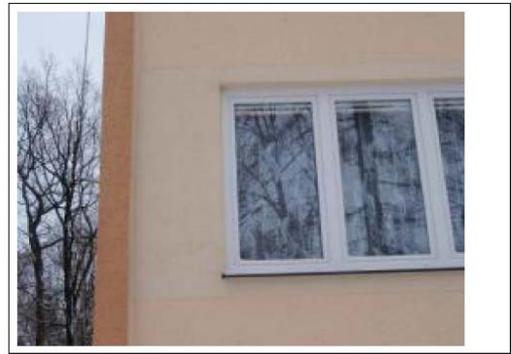
Pictures 5 and 6 demonstrate the surface temperature of the forward envelope of the gable wall from slag pumice concrete, thickness of 300 mm (Sp3), gas silicate spandrel stripe, thickness of 250 mm (Sp2) and window insets from YTONG, thickness of 250 mm (Sp1). The second object is jointly insulated. Picture 5 demonstrates higher surface temperatures and thus higher heating discharge.

Object Parameter	Value
Atmospheric Temperature	-2.0 °C
Label	Value
Sp1	0.1 °C
Sp2	0.2 °C
Sp3	-0.9 °C
Sp4	0.5 °C

Fig. 5 Picture by thermocamera – west view (uninsulated object GOS)

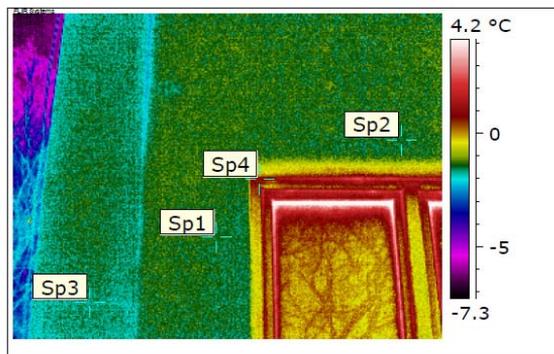
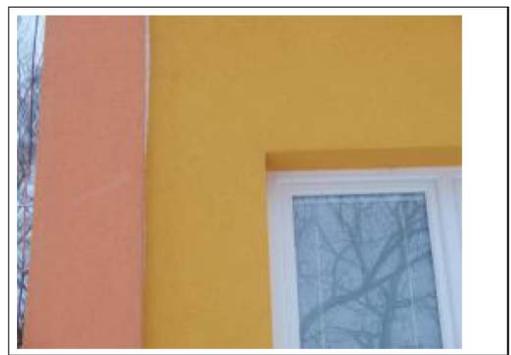
Object Parameter	Value
Atmospheric Temperature	-2.0 °C
Label	Value
Sp1	-1.5 °C
Sp2	-1.6 °C
Sp3	-1.9 °C
Sp4	0.6 °C

Fig. 6: Picture by thermocamera - west view (insulated object GOS)

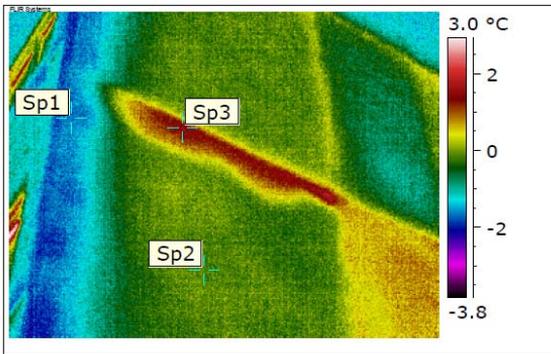
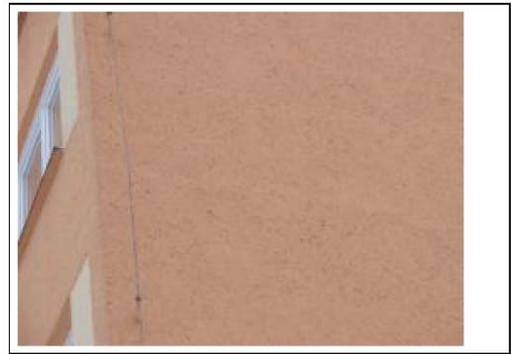
The building envelope of the block of flats (Fig. 7 and 8) forms in gables panels from slag pumice concrete (thickness of 300 mm). In an uninsulated object, there are not only higher surface temperatures, but also a thermal bridge at the joint of the panels in the gable (Sp3).

Object Parameter	Value
Atmospheric Temperature	-2.0 °C
Label	Value
Sp1	-1.6 °C
Sp2	-0.1 °C
Sp3	1.6 °C

Fig. 7: Picture by thermocamera – north view (uninsulated object GOS)

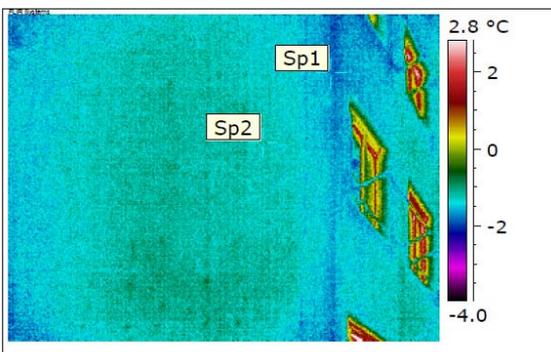
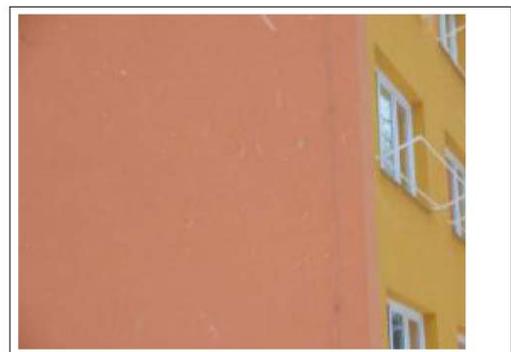
Object Parameter	Value
Atmospheric Temperature	-2.0 °C
Label	Value
Sp1	-1.9 °C
Sp2	-1.4 °C

Fig. 8: Picture by thermocamera – north view (insulated object GOS)

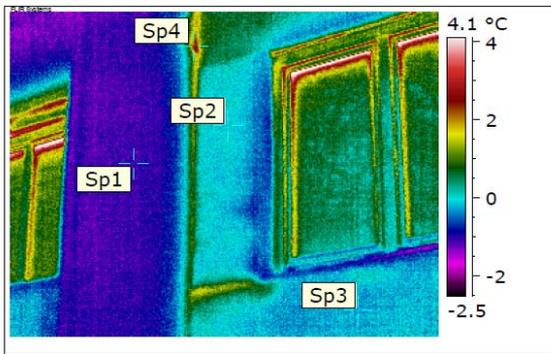
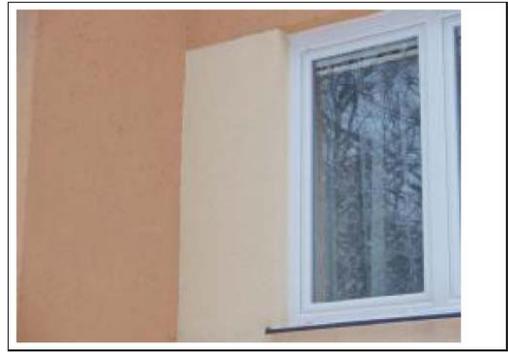
East face of building (Fig. 9 and 10) is divided by a vertical stripe of forward loggias. It is again possible to observe a thermal bridge in the corner of the loggia where the temperature of +2.5°C was measured (Sp4).

Object Parameter	Value
Atmospheric Temperature	-2.0 °C
Label	Value
Sp1	-1.2 °C
Sp2	0.0 °C
Sp3	-0.1 °C
Sp4	2.5 °C

Fig. 9: Picture by thermocamera – east view (uninsulated object GOS)

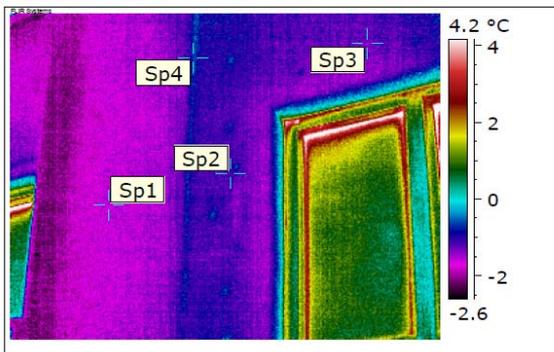
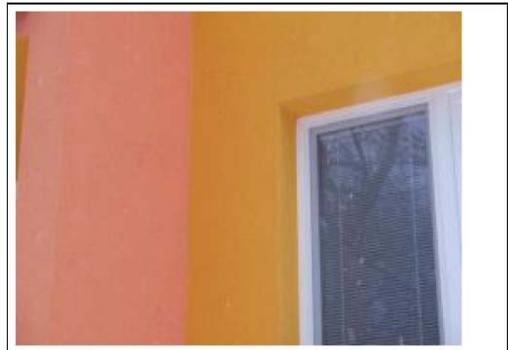
Object Parameter	Value
Atmospheric Temperature	-2.0 °C
Label	Value
Sp1	-1.8 °C
Sp2	-1.3 °C
Sp3	-1.5 °C
Sp4	-0.7 °C

Fig. 10: Picture by thermocamera – east view (insulated object GOS)

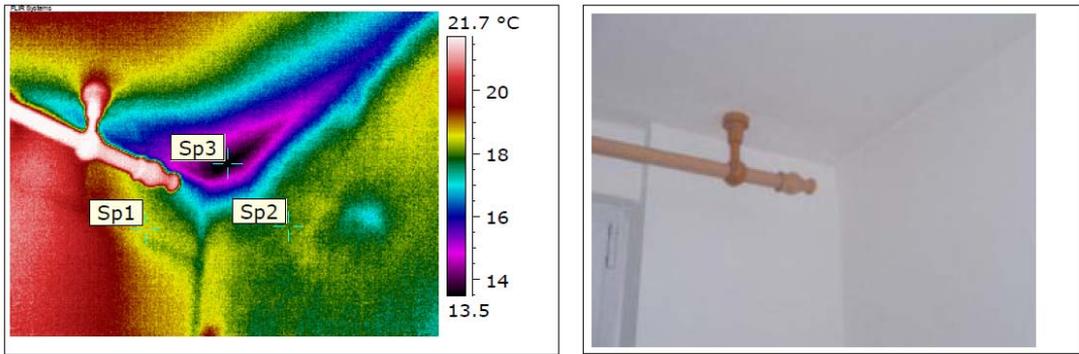
The last two thermographs from the interior (Fig. 11 and 12) show the south-east corner (a joint of a ceiling and enclosure walls). It is a joint of a peripheral panel from slag pumice concrete (Sp2) and window insets from YTONG (Sp1). The temperatures in the corner are distinctively lower which can result in the surface condensation of the water vapour in this part and mould occurrence.

Object Parameter	Value
Atmospheric Temperature	22.0 °C
Label	Value
Sp1	18.3 °C
Sp2	17.9 °C
Sp3	13.2 °C

Fig. 11: Picture by thermocamera – interior (uninsulated object GOS)

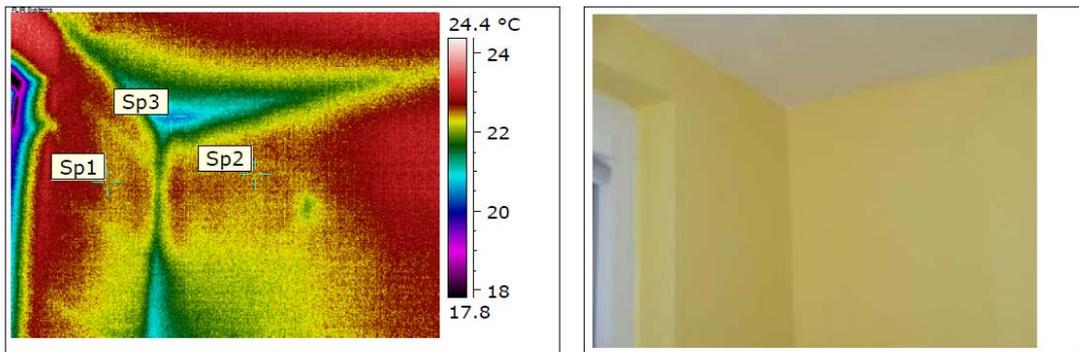
Object Parameter	Value
Atmospheric Temperature	23.0 °C
Label	Value
Sp1	22.4 °C
Sp2	22.2 °C
Sp3	20.6 °C

Fig. 12: Picture by thermocamera – interior (insulated object GOS)

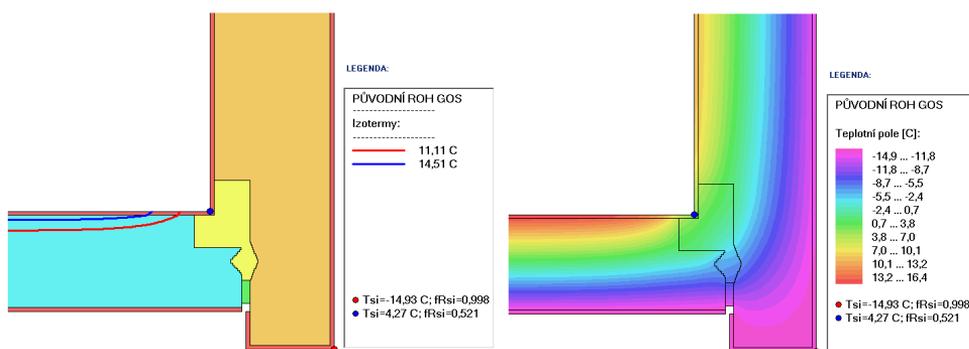
The modellings using software AREA 2009 (see Tab. 1) were carried out to enable a better comparability and to show an idea of seriousness of the faults of this detail. The modellings proved serious faults of this detail in the original type of construction (Fig. 13 and 14). In the inner corner, there was the lowest surface temperature of only +4.27 °C because of norm environmental conditions. Thus, the dew point temperature was exceeded which is under the given conditions +11.11 °C.

In pictures 13 and 15 (in the left part), the blue isotherm represents a critical inside surface temperature. In the immediate surroundings of the inside construction surface, the critical relative air humidity of 80 per cent is achieved. This value represents a criterion when the risk of mould occurrence appears. The red isotherm demonstrates the dew point temperature achieved in the construction where the relative humidity near the surface is 100 per cent. If it drops below this value, condensation occurs.

Pictures 13 and 15 show that the slag pumice concrete panel doesn't conform to the parameters required by heat engineering which results in lower temperatures near the inside surface of the panel.

Fig. 13: Isotherms and fields of temperature (uninsulated object GOS)

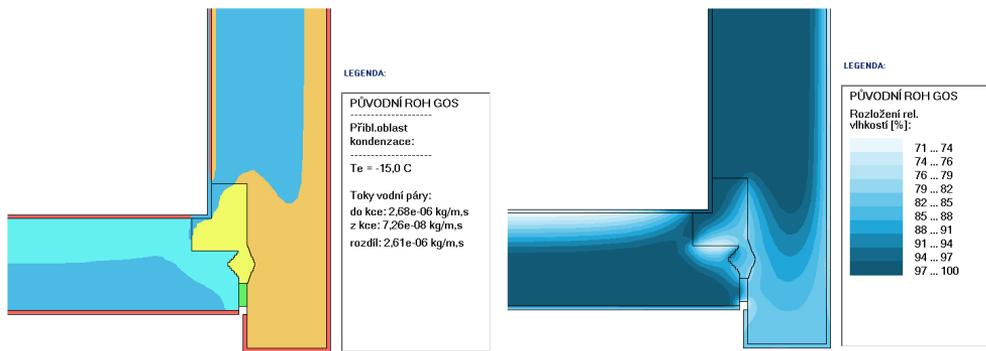
Fig. 14: The area of humidity condensation and distribution of relative humidity in the construction (uninsulated object GOS)

The last picture which refers to the original structural design (Fig. 14 – left part) shows a large condensation area in both constructions. Concerning the humidity balance in the construction, only the faced panel from gas silicate (see Tab.2) matches the requirements. On the other hand, the slag pumice concrete gable panel reaches a serious negative balance of the condensed and evaporated water vapour from the construction.

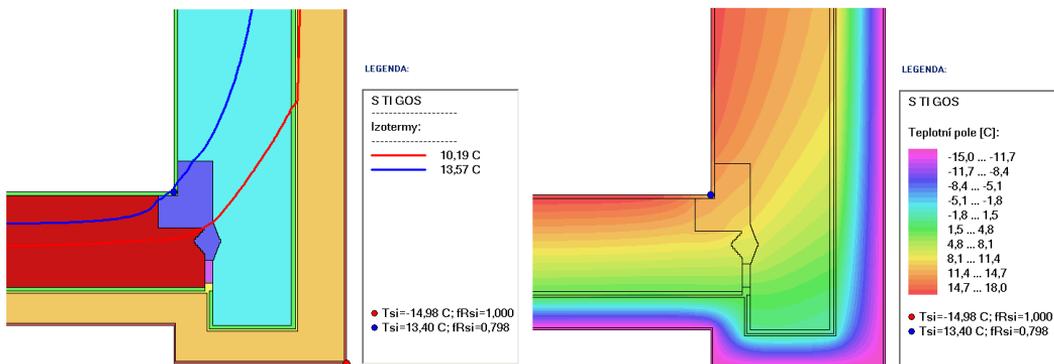
Fig. 15: Isotherms and fields of temperature (insulated object GOS)

It is obvious from picture 15 that there is no inside surface condensation. The risk of the mould occurrence on the surface is present only in a small area in the inner corner.

The lowest calculated surface temperature is 13.40 °C which represents the exceeding of the limit value by 0.17 °C. Picture 15 shows that the distribution of temperatures in both peripheral walling panels is approximately the same. Only with the face of building the field of temperatures is thicker, which is caused by a generally smaller thickness of the construction as compared to the gable of the object.

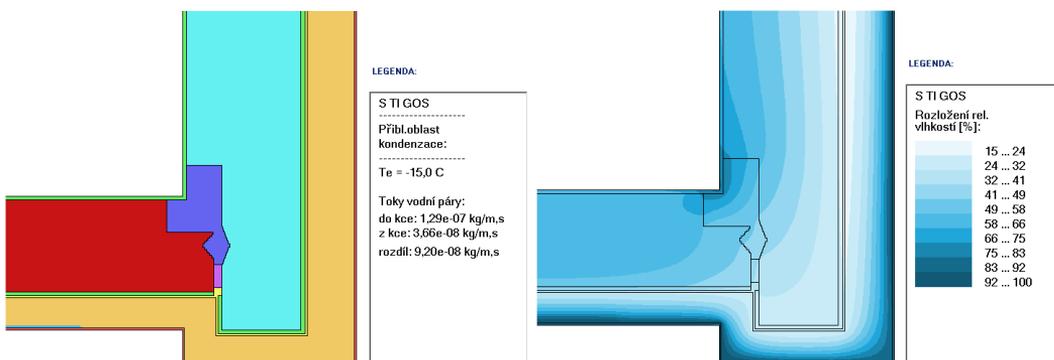
Fig. 16: The area of humidity condensation and distribution of relative humidity in the construction (insulated object GOS)

It is possible to see a striking improvement of the suggested and performed adjustments when comparing the size and locations of the condensation in the construction as shown in pictures 14 and 16. In the original design, surface condensation on the inside surface of the cladding occurred, while in the modified condition condensation occurs only near the outside surface of the contact insulation system.
