Martina PEŘINKOVÁ¹**THE RESEARCH OF LONG TERM EFFECT OF RECONSTRUCTION MONASTERY ON THE MOUNTAIN OF MOTHER OF GOD IN KRÁLÍKY****Abstract**

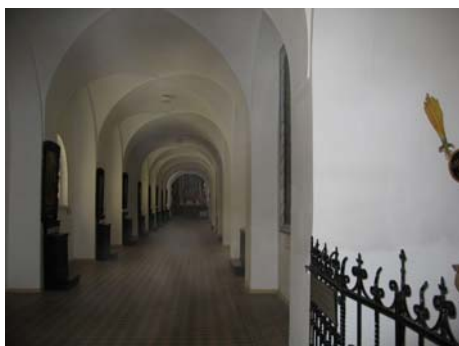
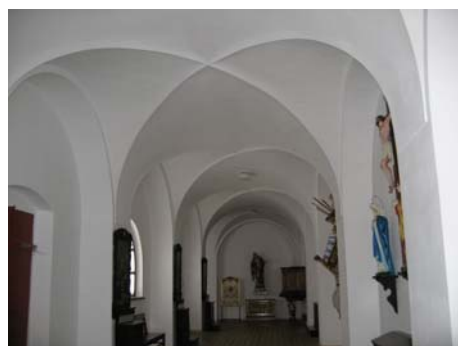
Photography No. 1 and 2: Interior of monastery corridors

The building is a brick structure in the area of plinth from the stoned masonry, above plinth from the brick masonry. The bases are traditionally stoned. Plasters inside the building were already before redevelopment partially removed up to a height where the masonry is disrupted by moisture and by the reaction of undesirable salts. There was visible local damage on the plaster mainly in the bottom part of the window and significantly darker border at the paint showing the changeover of wet and dry masonry which ranged between 1,5 to about 3 meters.

Increased resistance was on the inner wall in side hallway and gradually subsided. The outer wall showed equal height of moisture resistance and salinity about 1,0 to 1,8 meters. The biggest moisture did not likely get into the walls by capillary action of the bases but by the condensation in the warmer seasons when the temperature in the corridors is lower than outside.

In the summer months, when in corridors increases condensation of moisture, it's necessary to secure increased ventilation or an increase of temperature to prevent condensation of moisture on cold walls.

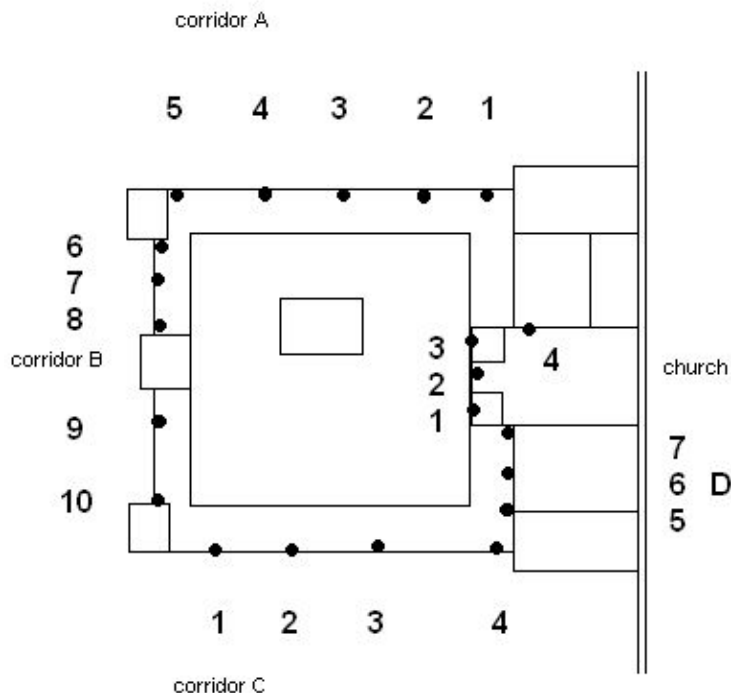
Picture No. 1: Designation of places of measurement and sampling, S ▲

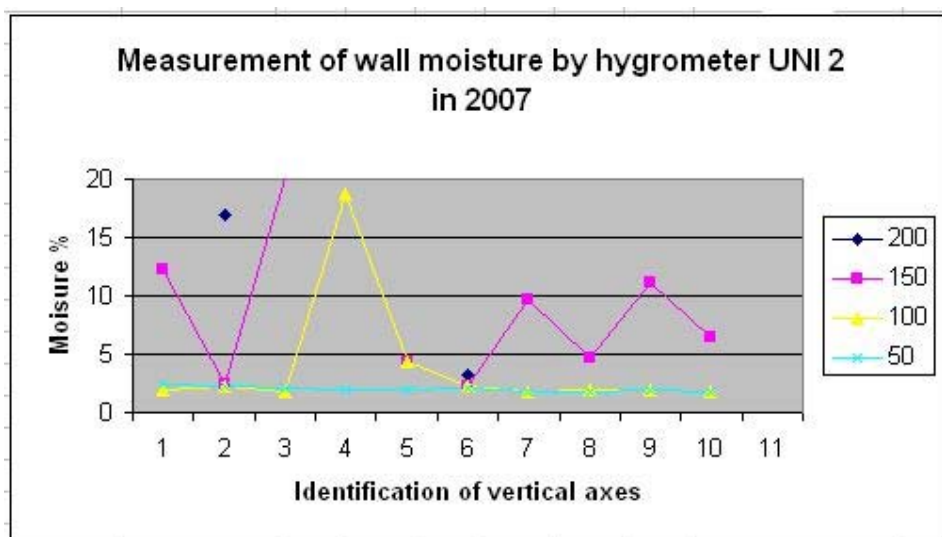
Because the height of redevelopment plasters was strictly regulated the measurement of moisture was done under the transitive of redevelopment plaster on regular plaster and above it. The measurement above redevelopment is marked by yellow color in the tables.

Picture No. 2: Measurement of wall moisture by hygrometer UNI 2 in 2007, corridor A+B

The results of this implementation show us important information. First of all there you can not fail to notice the differences of moistures under and above border of redevelopment. This demonstrates the failure of supplier's recommendation on sufficient height of redevelopment plaster which should be at least 50 centimeters above the critical moisture. An effort of heritage care to preserve identity of historic buildings is certainly understandable but here we see here possible consequences of half-hearted decisions. Wrong and inconsistent solutions can destroy the entire implementation and in the final result it's a waste of investment which can't be no longer expended.

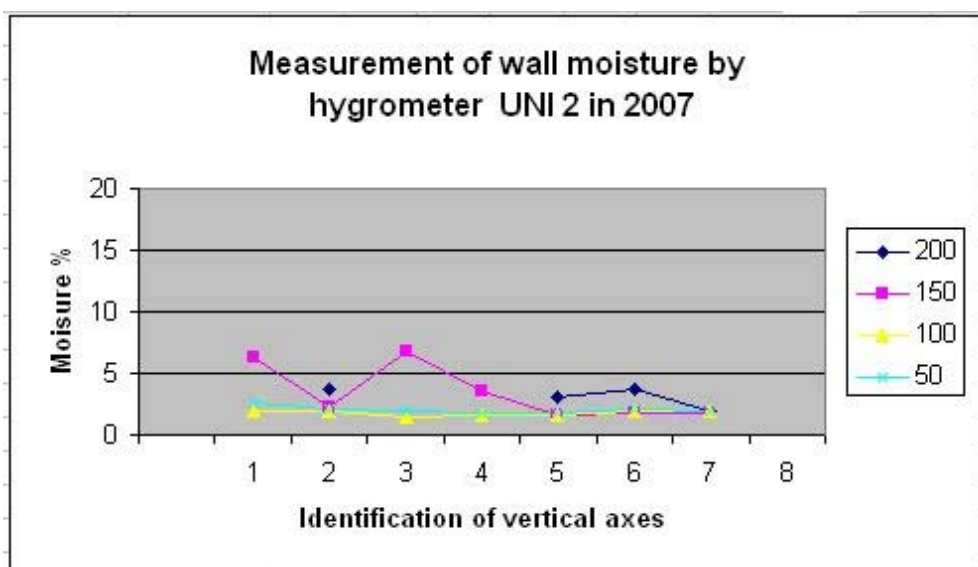
Picture No. 3: Measurement of wall moisture by hygrometer UNI 2 in 2007- corridor C+D

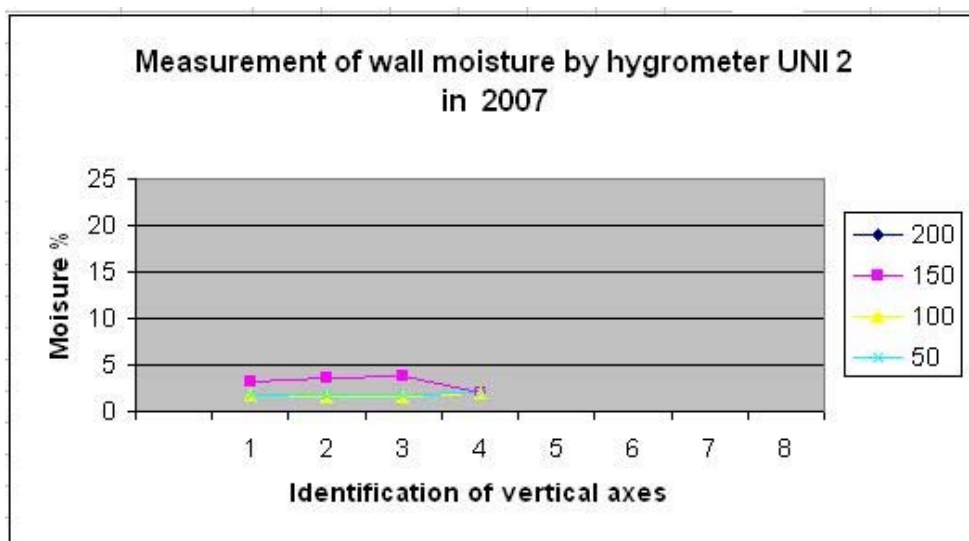
Picture No. 4: Measurement of wall moisture in the church by hygrometer UNI 2 in 2007
