**Filip ČMIEL<sup>1</sup>, Radek FABIAN<sup>2</sup>****THE IMPROVEMENT OF THERMAL PROPERTIES OF CLADDING OF THE EDUCATIONAL INSTITUTION IN FRYDEK MISTEK****VYLEPŠENÍ TEPELNĚ TECHNICKÝCH VLASTNOSTÍ OBVODOVÝCH KONSTRUKCÍ VÝCHOVNÉHO ÚSTAVU VE FRÝDKU - MÍSTKU****Abstract**

Thermocamera can be used for the assessment of building envelope. Thermal bridges and their seriousness can be detected by thermocamera. We used these measurements to compare the detail of contact building envelope with the column, which is made slag-pumice concrete in the original building and the same detail in the same building after thermal insulation.

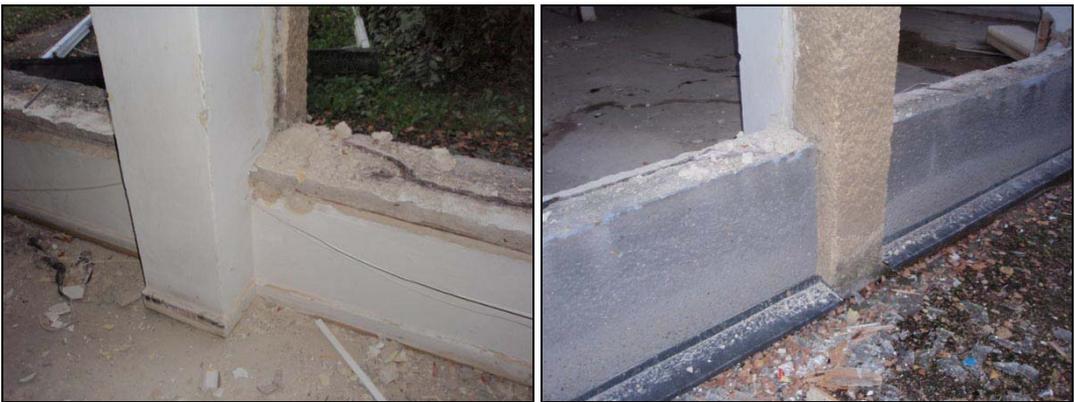
Figure No. 2: Detail of building under consideration from side of interior and exterior before thermal insulation

We focused on a detail of contact between the cladding and column during modelling and measurement. Vertical peripheral columns with dimensions 300 x 600 mm are made from slug-pumice concrete SPB135 and window sill ledgements with thickness of 300 mm are made from slug-pumice concrete SPB60. Because of the purpose of accommodation the surface of windows in the whole building has been reduced. Filling of the window sills and vertical parts of the cladding were made from building blocks IFT with thickness of 300 mm. The columns are ejected by 100 mm in front of the original window sill ledgements. The fillings are ejected by 100 mm as well, but according to the investor's requirement the cladding after the contact thermal insulation had to be without any protruding structures (Figure 3).

Contact insulation from expanded polystyrene with the thickness of 200 mm was used for the existing window sills and the new filling from the level of rough floor on the first floor. Polystyrene with the thickness of 100 mm was used on the columns and peripheral structures for alignment of the whole facade to one plane.

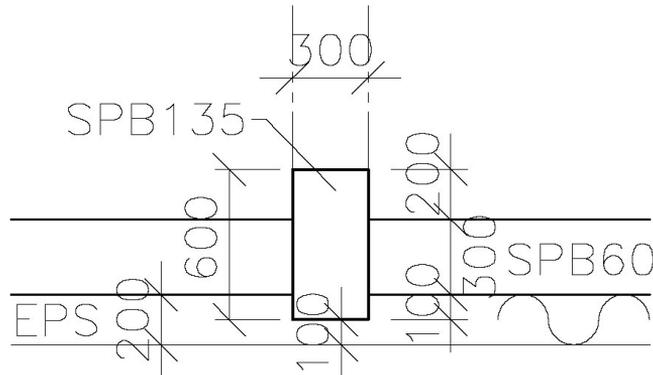
Figure No. 3: Solved detail of horizontal cross section of column with thermal insulation and window sill made from slag-pumice concrete

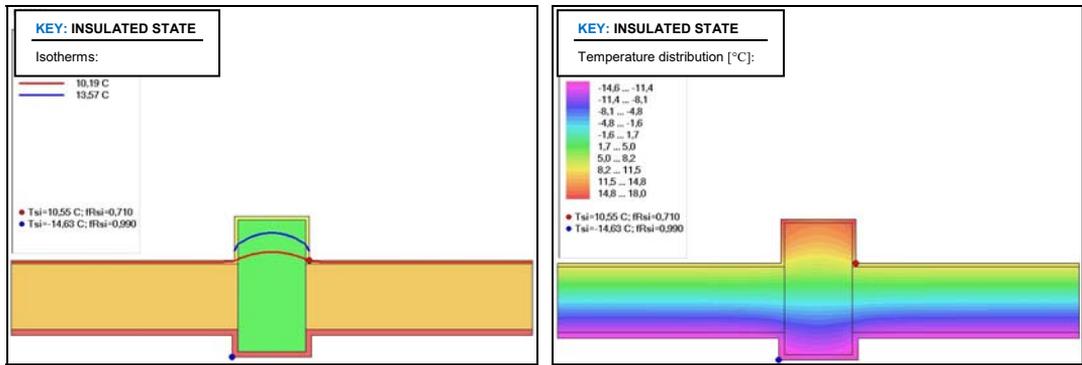
Blue isotherm in the Figures No. 4 and 6 (left part) represents critical interior surface temperature, when critical 80% relative air humidity is achieved at the vicinity of the structure inner surface. This is a criterion that signals a danger of mould growth. Red isotherm shows and achievement of dew point in the structure, when the relative humidity close to the surface is 100%. Condensation takes place in case of a drop below this value.

Figure No. 4: Isotherms and temperature fields (detail without thermal insulation)

It is evident from the previous figure (Figure No. 4) the slag-pumice concrete panel does not fulfil the required parameters from the standpoint of thermal technique. It takes effect by lower temperatures on the panel inner surface. Temperature field modelling in the Figures No. 4 and 6 (right part) shows marked differences.

Big condensation area in both structures is visible on the next figure that is related to the original structure design (Figure No. 4 – left part). The slag-pumice concrete window sill panel and column reach a serious negative balance of condensed and evaporated water vapour from the structure according to the humidity balance.

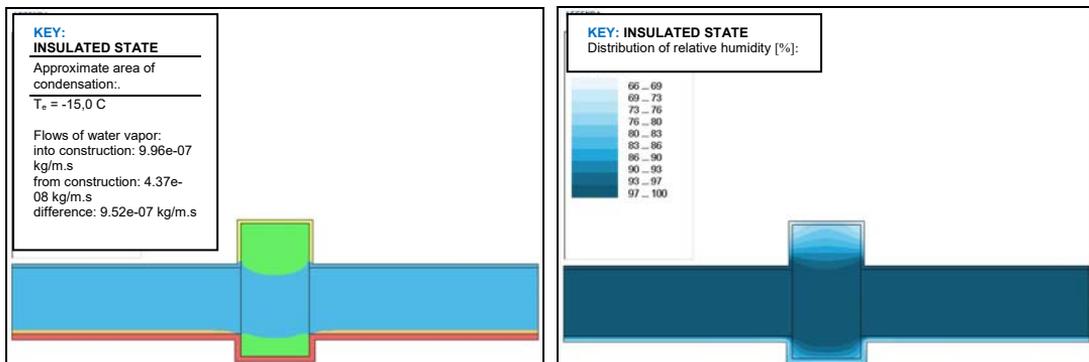
Figure No. 5: Area of humidity condensation and distribution of relative humidity in structure (detail without thermal insulation)

Improvement of proposed and implemented changes is visible from a comparison of size and place of condensation in the structure according to the Figures No. 5 and 7. Even surface condensation takes place on the inner surface of the cladding in the original version, while in case of the modified state the condensation takes place only close to the external surface of the contact thermal insulation system. Increasing of lifespan of the load-bearing structure as well as the whole building has been achieved owing to the shift of condensation area to the thermal insulating material of the façade.

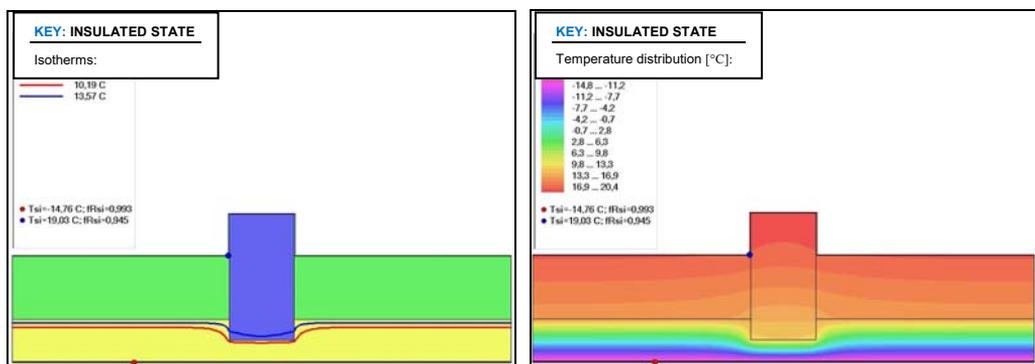
Figure No. 6: Isotherms and temperature fields (detail with thermal insulation)

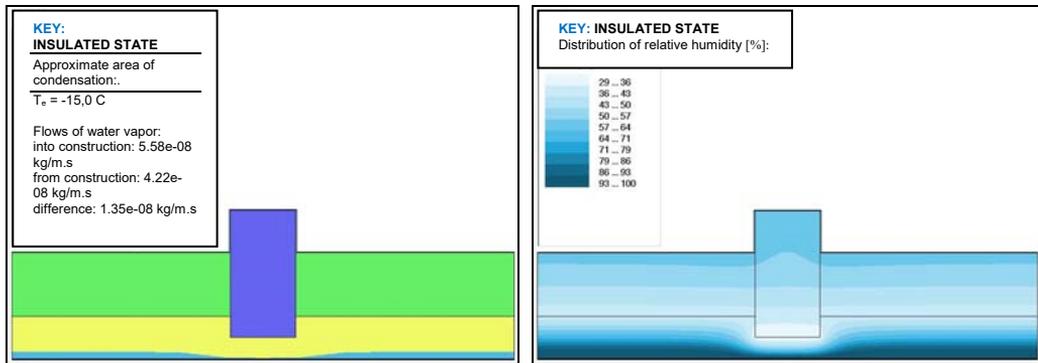
Figure No. 7: Area of humidity condensation and distribution of relative humidity in structure (detail with thermal insulation)

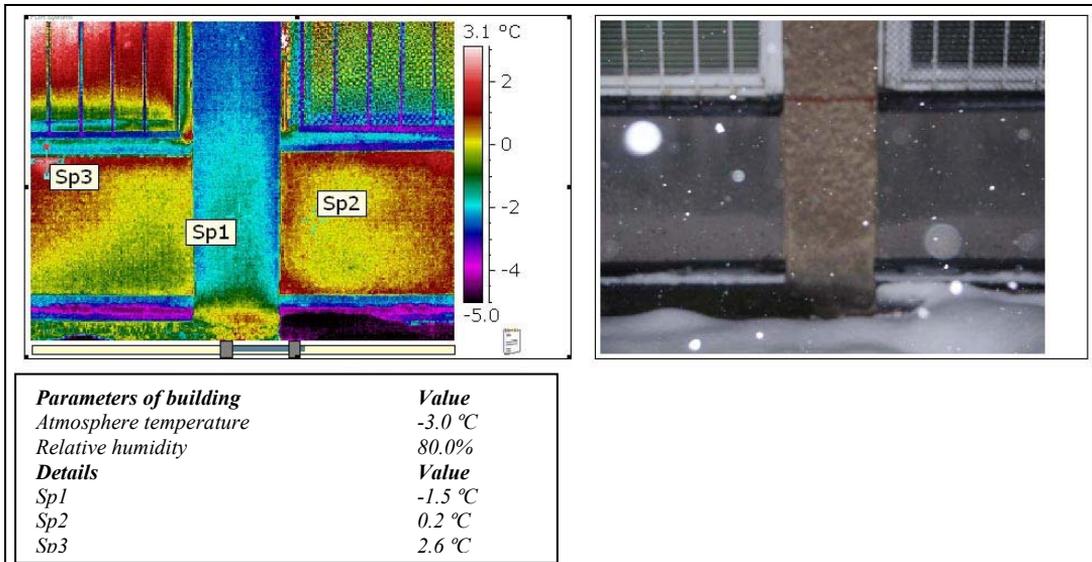
You can see surface temperatures of cladding made from slag-pumice concrete without thermal insulation from the exterior side in the Figure No. 8. Higher temperature was measured on the window sill panel made from SPB60 in comparison with column made from SPB135 (point Sp1) at the points Sp2 and Sp3 This is caused by a higher thickness of the column and its higher thermal resistance, but also by central heating behind the window sill panel. There is a substantially increased thermal flow under external flashing of the window sill that causes a higher heating discharge at the point Sp3.

Figure No. 8: Thermo-visual image of building without thermal insulation (exterior)

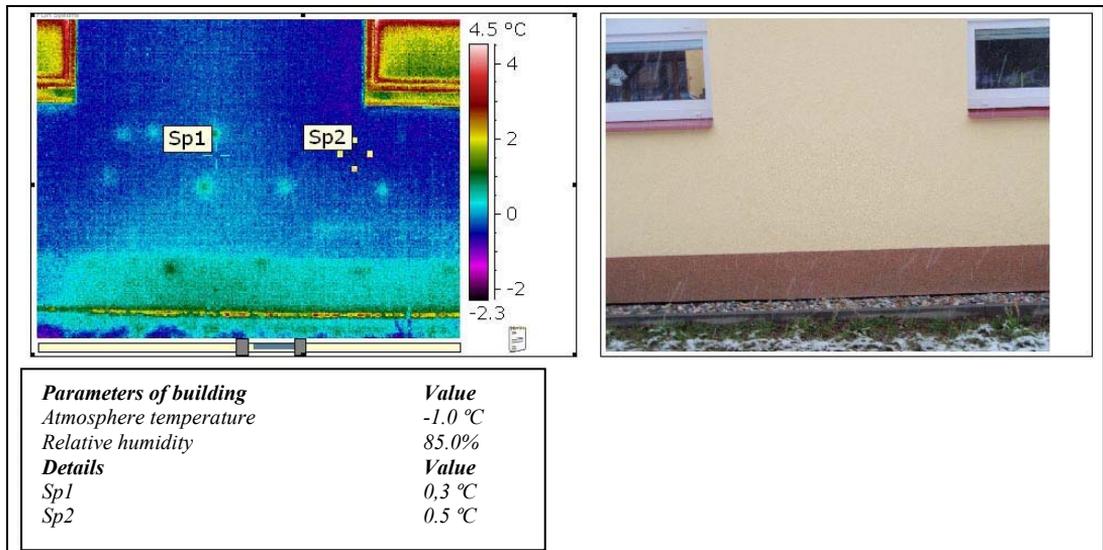
Identical measured detail after the contact thermal insulation installation is in the Figure No. 9. The surface temperature of the cladding insulated by means of expanded polystyrene is nearly the same both at the place of column (Sp1) and at the place of the window sill (Sp2).

Figure No. 9: Thermo-visual image of building with thermal insulation (exterior)

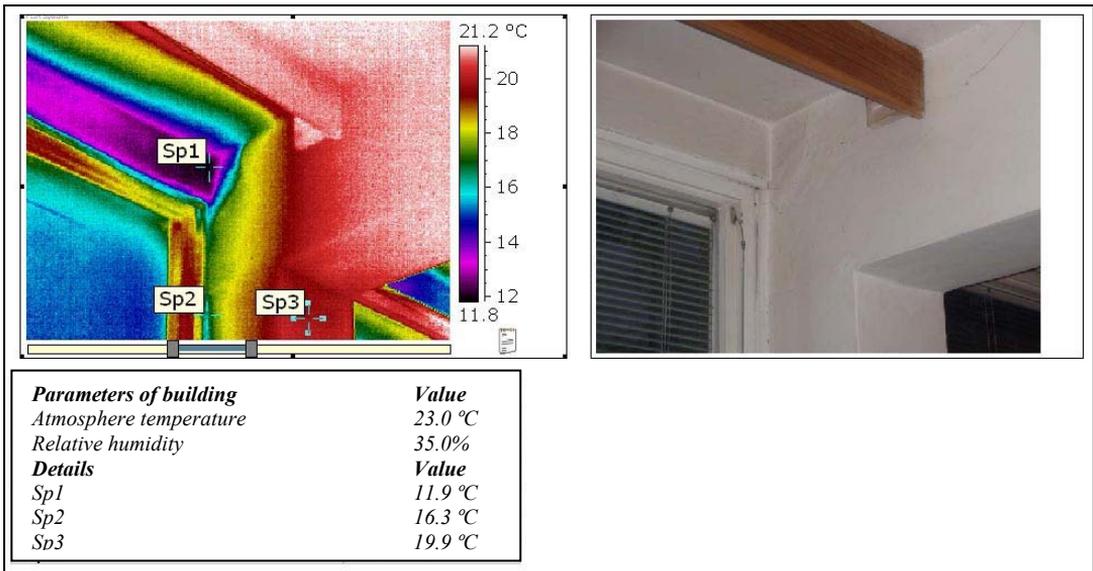
You can see a difference of surface temperatures from the side of interior in the corner next to the ceiling structure before thermal insulation installation on the following figures (Figure No. 10) and after the installation (Figure No. 11). Noticeably higher temperatures are visible above the window at the point Sp1 in the Figure No. 10. This could cause a surface condensation of water vapour at given place and attack of the inner surface of the structure by mould. The problem did not arise because of a natural infiltration of air through original wooden double windows. A noticeable

Figure No. 10: Thermo-visual image of building without thermal insulation (interior)

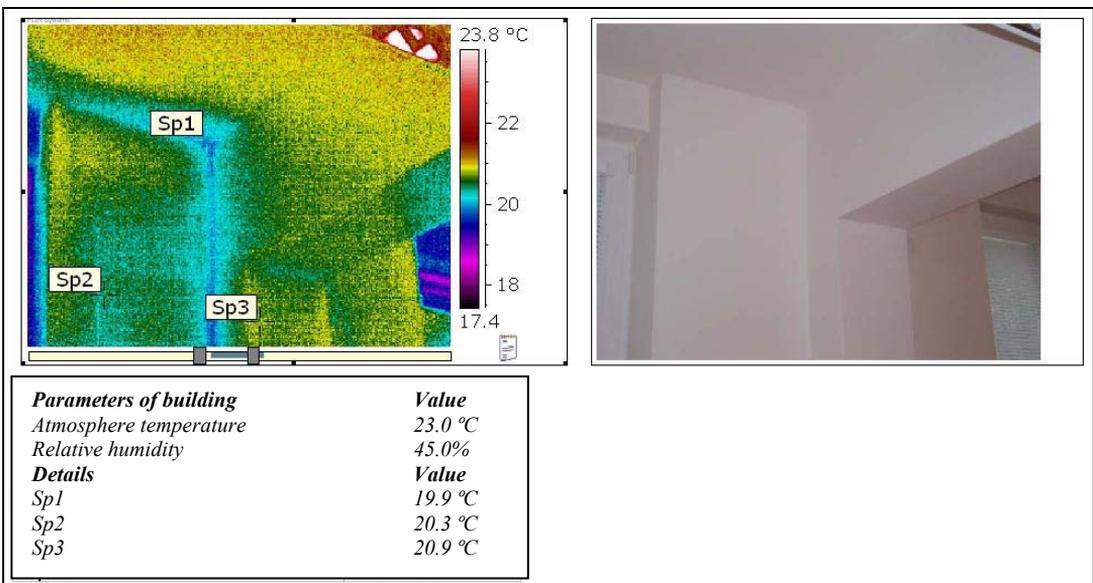
improvement of the studied detail is evident after the lining construction and after the finishing of other construction works (Figure No. 11).

Figure No. 11: Thermo-visual image of building with thermal insulation (interior)

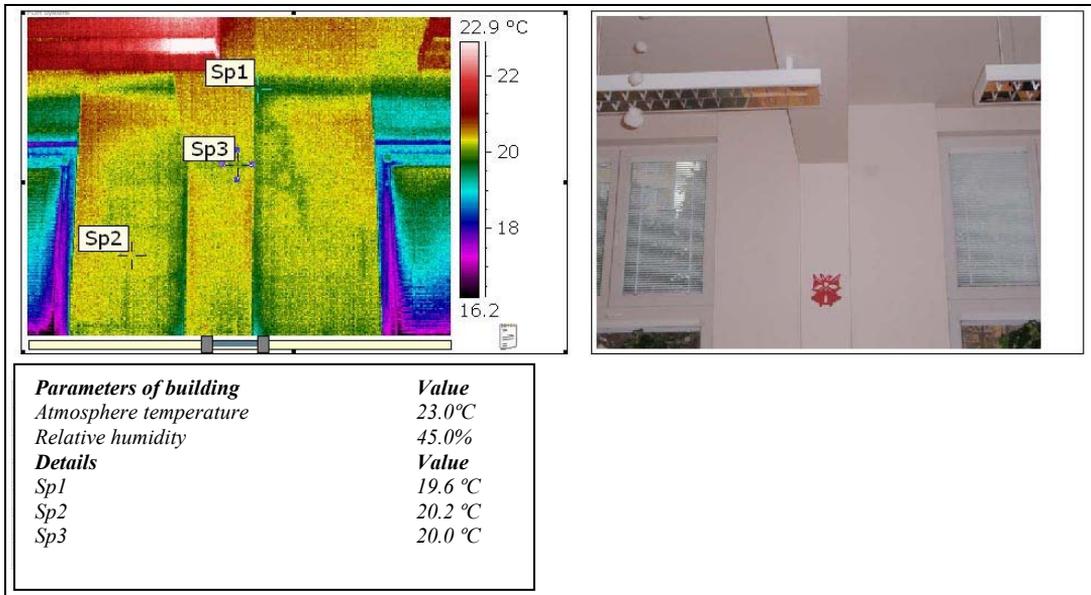
Influence of construction changes of the cladding structure from the interior side (Figure No 12 and from the exterior side (Figure No. 13) is visible in the Figures No. 12 and 13). The measured surface temperatures are nearly homogeneous in both following thermograms.

Figure No. 12: Thermo-visual image of facade with thermal insulation from side of interior

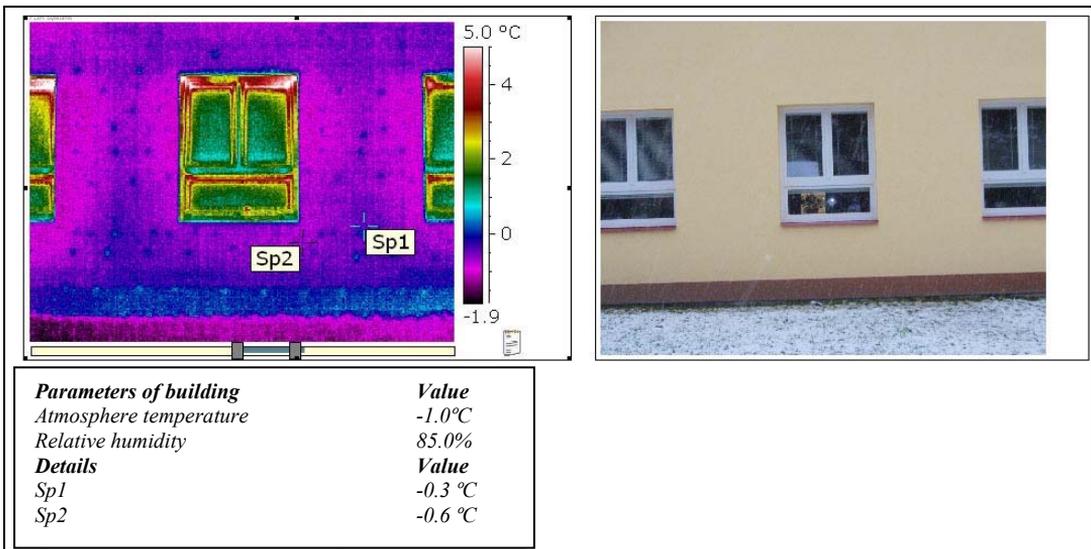
Figure No. 13: Thermo-visual image of facade with thermal insulation from side of exterior
