THE ANALYSIS OF SLOPE STABILITY OF THE STREAM VÝŠINA IN ORLOVÁ

This paper analyzes the stability of the slope near a stream in Orlova district. The instability of the slope has a negative impact on a hot water pipeline located in the crown of the slope. The assessment is based on a survey of the current state of the slope, and mathematical models in two cross sections. Mathematical models were developed in software Plaxis 2D based on finite element method (FEM). The results of mathematical models allow locating the critical slip surface in the slope, to predict the unstable areas and possible negative effects of a potential landslide in the hot water pipeline.

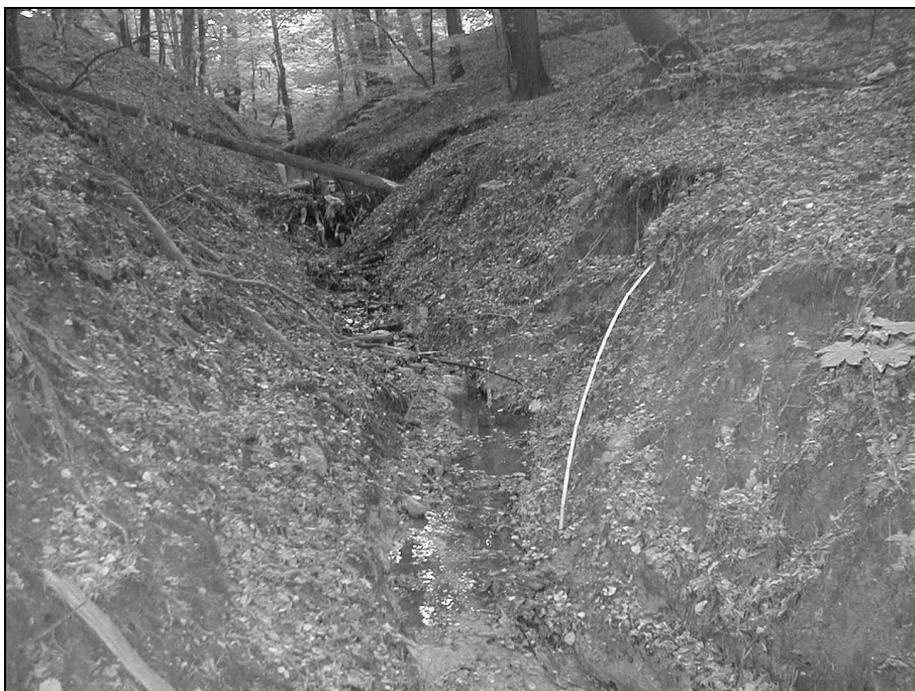
Fig. 1: Photo of the Výchina stream slope and its current condition.

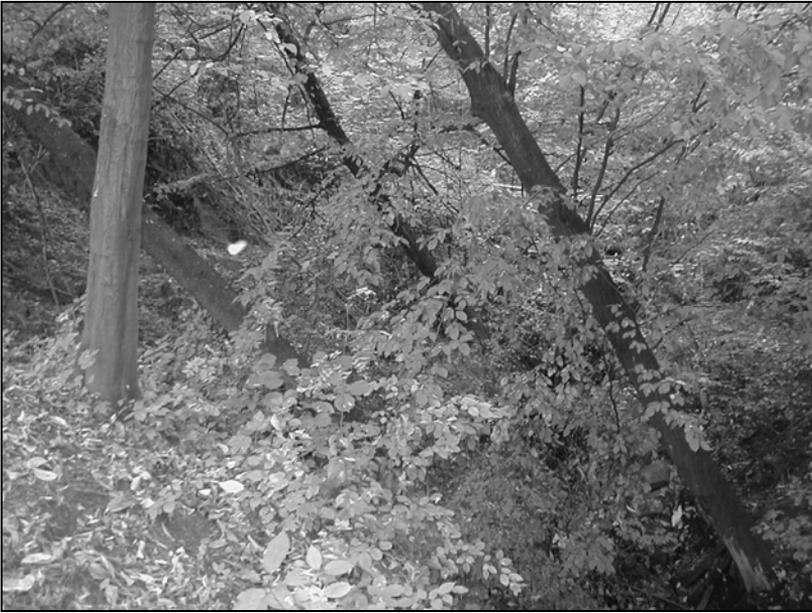
The photo-documentation shows enormous erosion on the both stream-banks of Výchina and there is an apparent instability of the surrounding slopes. (so called “drunken trees”, local landslides, erosive influences)- see below photo 2 and 3.

Fig. 2: So Called “Drunken trees”

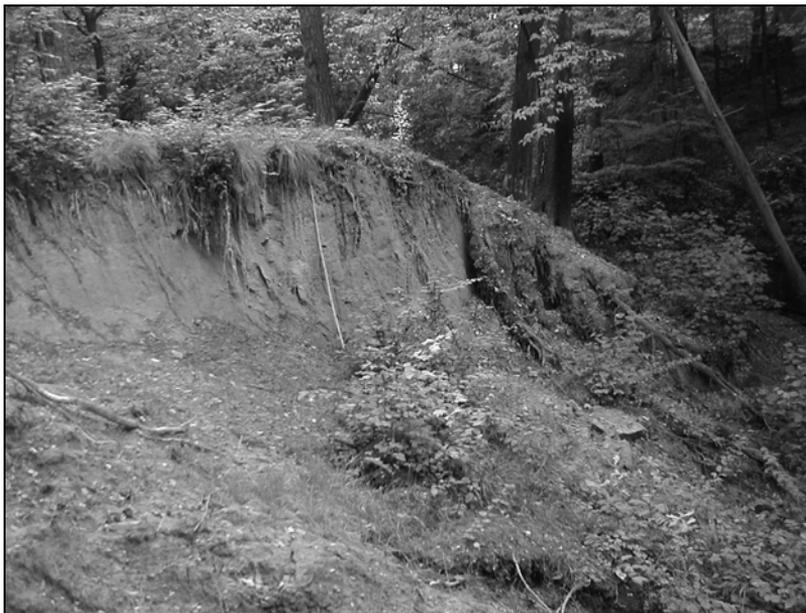
Fig. 3: The local partial landslide

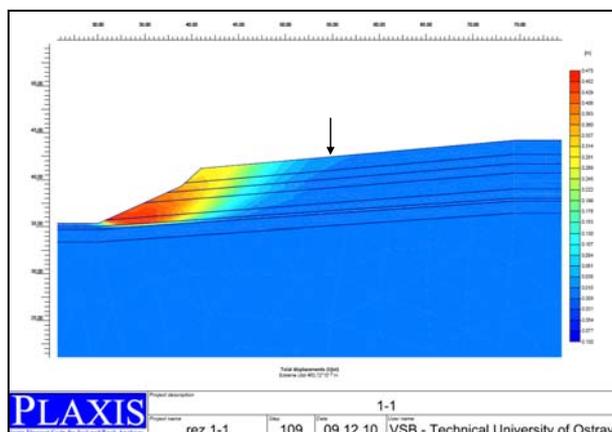
Maximum calculated displacements reached 460 mm. The peak values appeared at the bottom of the slope (see the figure 6). Figure 7 shows total displacements in the water pipeline area. According to the model they are expected to be up to 20 mm. Figure 8 illustrates increasing porous pressures development. The red spectrum marks pressure, the blue one indicates a tension.

The total degree of stability of the model calculation was 1,04. This value is on a boundary line of maximum limit of the shear strength. Therefore, the degree of stability does not reach required rate 1,5 for permanent slopes and indicates the instability of analysed slope structure despite the fact that the model did not take into account any other negative effects. Moreover, groundwater level was quite deep below the surface in the model (resulting from borehole survey and is supposed to vary depending on the climate conditions). For those reasons, we can consider the profiled slope as very unstable and it is likely to have other landslides in this area.

Fig. 6: Maximum total displacements- Model 1

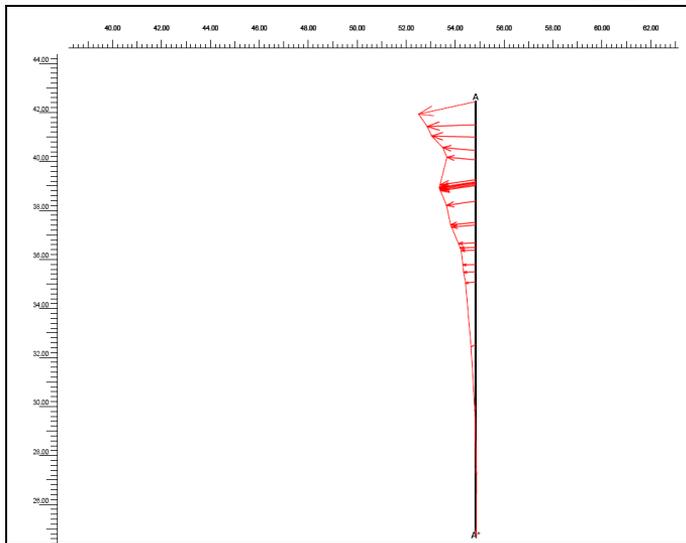
Fig.7: Total displacements at the pipeline area (max. 20 mm) –Model 1

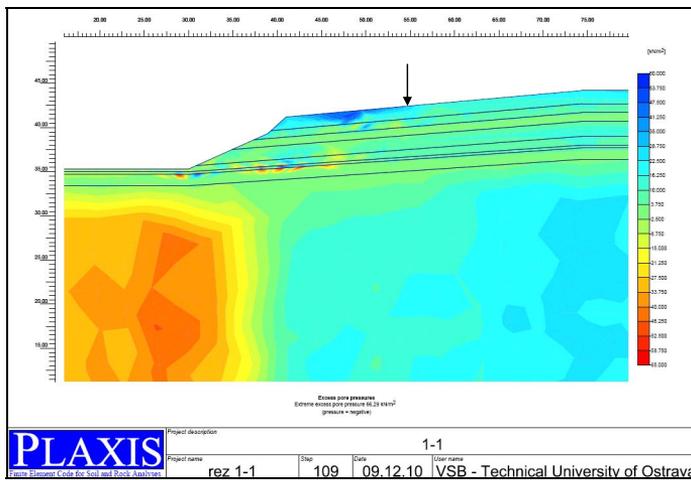
Fig. 8: Porous pressures development

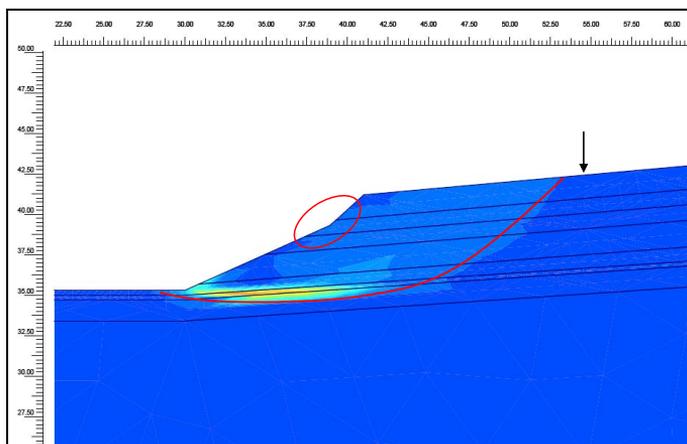
Fig. 9: Localization of slip surface in the slope

The figure 9 depicts the slip surface marking the most critical parts. The fundamental slip surface spreads on the boundary of sandy and clay layer and goes through the bottom of the slope, the partial slip surface is located at the top of it. The figure 9 also shows presumed outreach of the fundamental slip surface in relation to the hot water pipeline. In case another landslide occurred along this critical slip surface, the hot water pipeline would stand on the edge of it and there is no certainty what could have caused some other subsequent deformations.

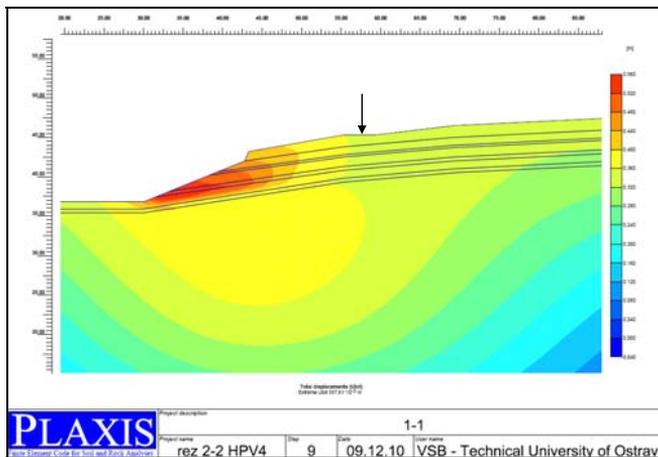
The second version took into account the reduced groundwater level of 4,5 meters below the surface. In this model version 2, the maximum calculated displacement moves reached 557 mm. The peaks values were reached again at the bottom of the slope (see the figure 10), but the deformation radius is bigger. The figure 11 indicates total displacement moves at the place of hot water pipeline. According to the model we can expect them to be 300 mm. Degree of stability corresponding to the situation in the model 2 equals the value of 1, which means again the instability of the analysed slope profile.

Fig. 10: Maximum total displacements – Model 2

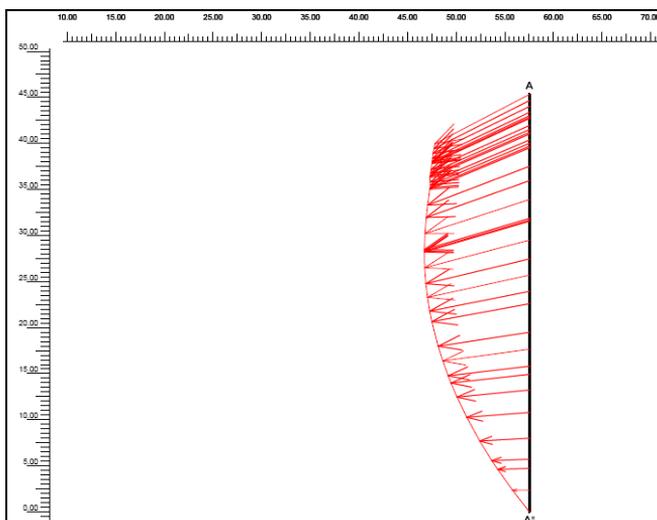
Fig. 11: Total displacements in the hot water pipeline area (max. 300 mm) – Model 2

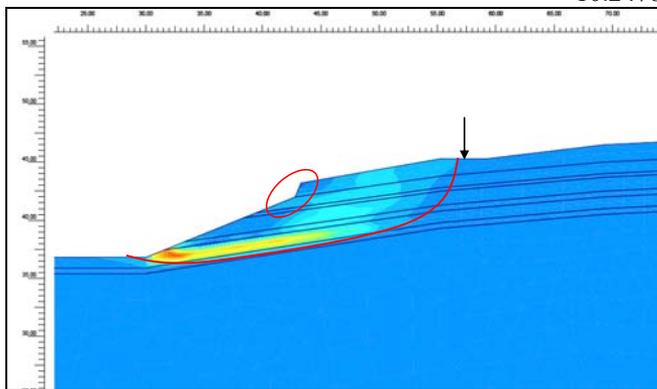
Fig. 12: Localization of slip surface – Model 2

The figure 12 illustrates slip surface of the model No.2 marking the most critical parts. The fundamental slip surface spreads in the clay layer and reaches the line of hot water pipeline. In case there was a landslide along this critical slip surface, the hot water pipeline feet would be in imminent danger.

Based on an available photo-documentation, expert terrain reconnaissance and results of mathematical models, it can be stated that the slope area in question is unstable and the signs of instability endanger the hot water pipeline situated in this place. The situation needs an acceptance and early execution of redevelopment precautions. The scheme of redevelopment precautions and their model analysis were not the subject of an expertise which was realised by Expertise Department at FAST VŠB-TU Ostrava
