Vladislav KŘIVDA¹, Ivana MAHDALOVÁ²**USE OF VIDEO ANALYSIS OF CONFLICT SITUATIONS BY THE EVALUATION
OF INAPPROPRIATELY DESIGNED BUILDING ELEMENTS ON ROUNDABOUTS****VYUŽITÍ VIDEOANALÝZY KONFLIKTNÍCH SITUACÍ PŘI HODNOCENÍ NEVHODNĚ
NAVRŽENÝCH STAVEBNÍCH PRVKŮ NA OKRUŽNÍCH KŘÍŽOVATKÁCH****Abstract**

The article deals with possibility of use of video analysis of conflict situations during observation of damaged inappropriately designed building elements and the other problems on roundabouts. This article analysis selected situations for example wrong way of drive vey near curb, problems during exiting the double-lane roundabout and influence of near intersection with traffic lights.

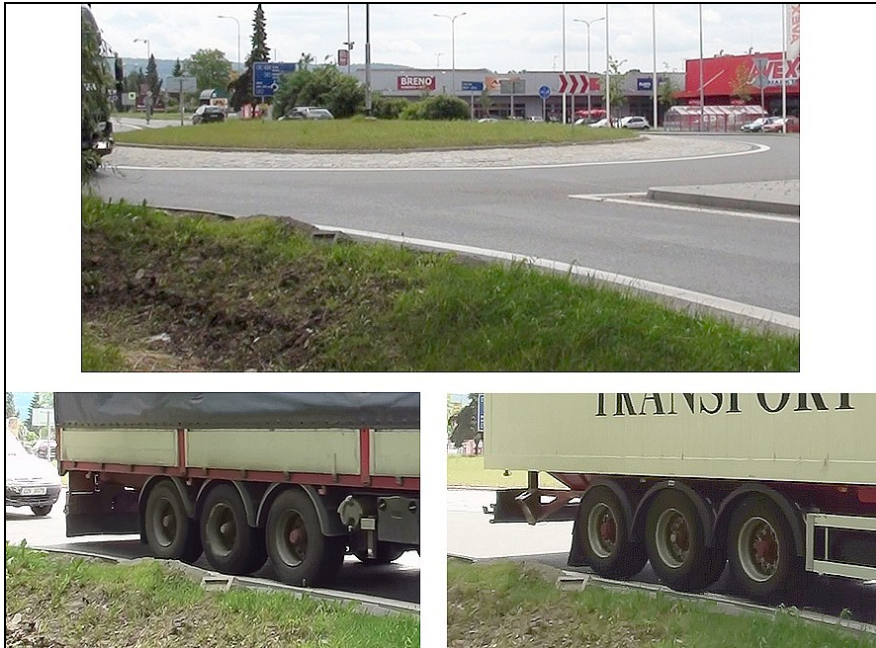
The analysis outlined fact that the most important conflict situations occur, when vehicle exiting the roundabout, goes the right guide strip very close to curb (see Figure 1). The curb of this exit is damaged on two places (see Figure 2) and obviously, there has been a traffic accident. According to § 47 of Law No. 361/2000 (Czech Highway Code) the traffic accident is also an incident in which there is a damage to the property in direct connection to the operation of a vehicle in motion. The question whether it was a unique event, or such dangerous situation occurs regularly, was answered by here accomplished exactly video analysis.

During one hour observation this situation occurred 23 times, in most cases trailer sets (61 %), following by lorries (26 %), road trains (9 %) and buses (4 %) – with the traffic flow 1290 vehicles per hour on the whole roundabout and 512 vehicles per hour on the monitored exit (from that 83 vehicles of aforementioned types, i.e. lorries, road trains, trailer sets and buses).

This situation can generally occur either due to wrongly designed exit (can be verified by the rupture curves) or due to wrongly turn maneuver. In the case of the monitored intersection (Masarykova – parking Tesco in Valašské Meziříčí) which is the first roundabout in direction from Hranice na Moravě, the drivers exiting the roundabout in direction to Hranice (e.g. from the city) are, by the view of large roadway next to them, incited to speed up. This behavior is evidently unacceptable; nevertheless the hard shoulder of sickle shape would be of great use here.

Figure 1: Roundabout Masarykova – parking Tesco in Valašské Meziříčí (up) and detailed views of exit guide strip (down)

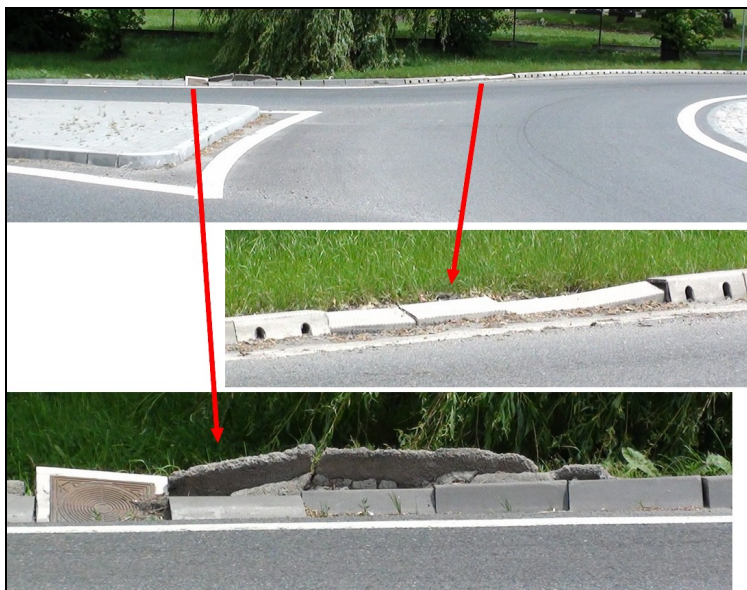
Figure 2: Detailed views of damaged curb on the exit from the roundabout Masarykova – parking Tesco in Valašské Meziříčí

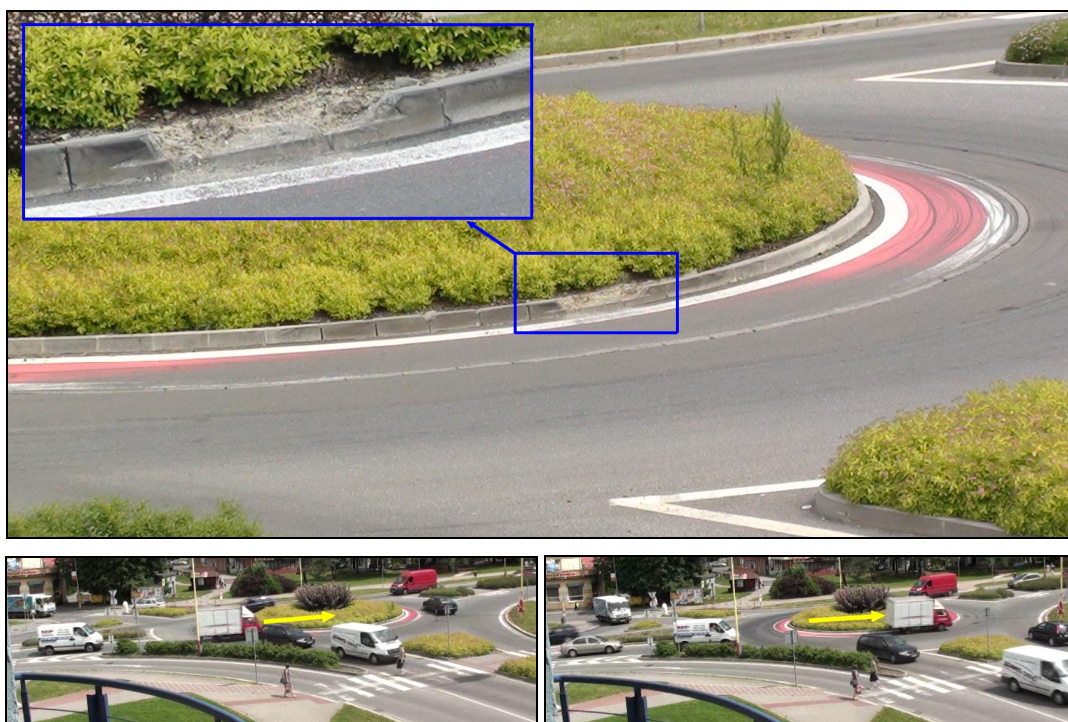
Other problems are related to the curbs of central islands. As shown in Figure 3 (upper picture), drivers are going over optical truck apron near of the curb. The cause of such a behavior can be either a wrong circulating roadway passage (intentionally) or a by-passing the queue of vehicles which was caused in front of the pedestrian crossing, as shown on the lower pictures of Figure 3.

Figure 3: Formation of vehicles queue in front of the pedestrian crossing on the roundabout Vsetínská – Sokolská – Žerotínova in Valašské Meziříčí

Although this problem can be solved by a move of the pedestrian crossing further from the circulating roadway, it would generate other problems, such as pedestrian path extension, higher vehicles speed (drivers are, at the crossing, further from roundabout – it can cause other dangerous situations). The cancellation of this pedestrian crossing is not always convenient because of the intensity of pedestrians (this applies to a roundabout presented on Figure 3 also).

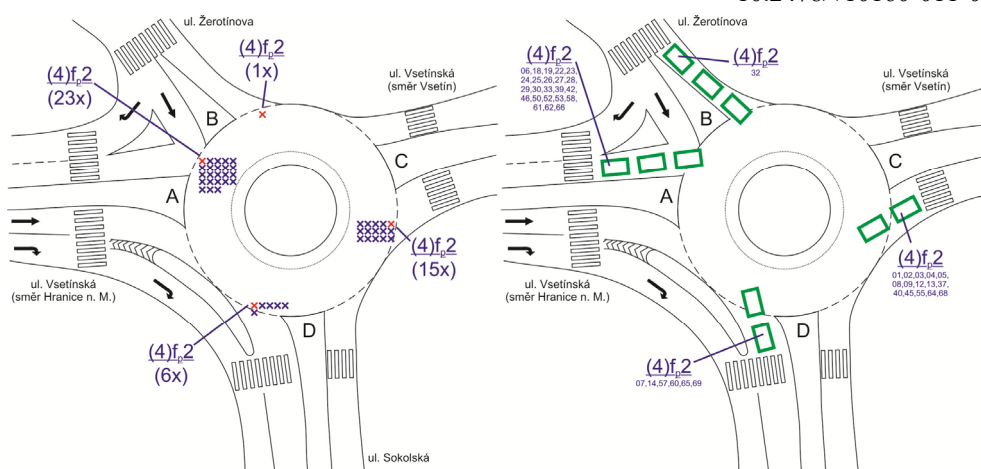
Figure 4 exhibits the conflict situations and their numbers monitored during one hour on the roundabout Vsetínská - Sokolská - Žerotínova in Valašské Meziříčí (with the total traffic volume of 2115 vehicles per/hour).

Figure 4: Schematic representation of conflict situations arising from stopped traffic flow in front of pedestrian crossing on roundabout Vsetínská – Sokolská – Žerotínova in Valašském Meziříčí

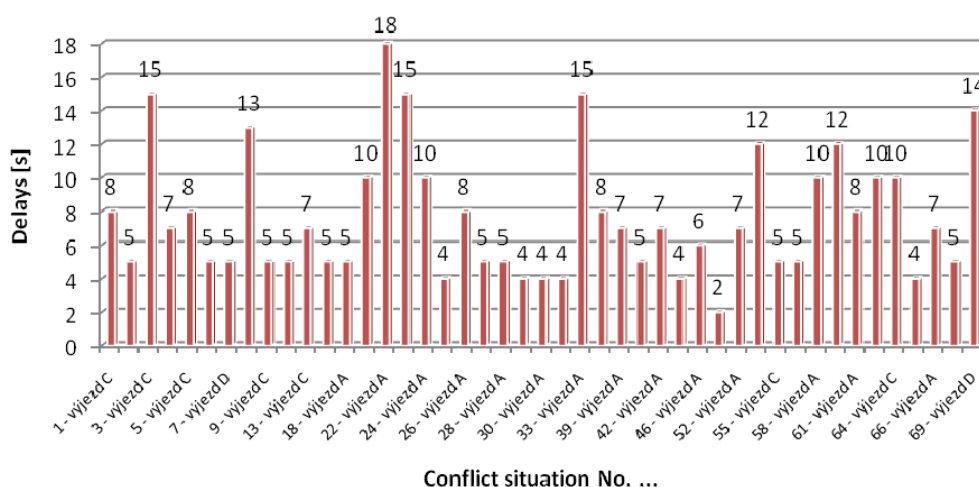
The graph on figure 5 presents, for curiosity, the delays caused by stopped traffic flow in front of pedestrian crossing.

Figure 5: Vehicles delays caused by stopped traffic flow in front of pedestrian crossing on the roundabout Vsetínská – Sokolská – Žerotínova in Valašském Meziříčí (“výjezd” = exit)

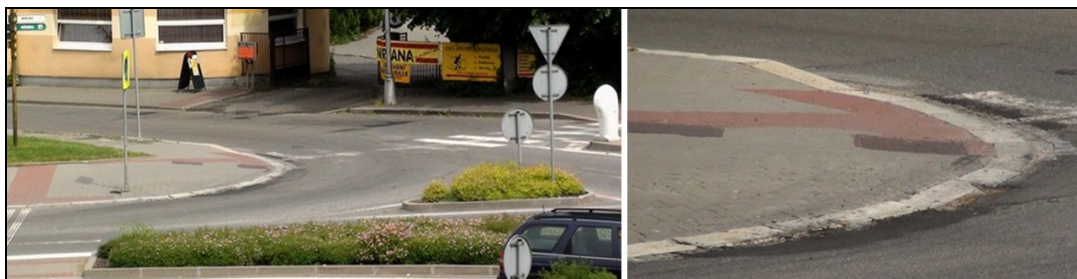
On the same roundabout (see previous sub-chapter 2.2) is also evident damage on outer curb of the by-pass (Figure 6). As can be seen on the figure 4 (this is a direction from Žerotínova street to the right to Vsetínská street), the outer curb radius is rather small, and is the cause of the drive of the lowered curb on this place. It would be convenient to use the hard shoulder of sickle shape, with the respect to the pedestrian security on the sidewalk in proximity of this place.

Figure 6: Damage of the curb of the by-pass on the roundabout
Vsetínská – Sokolská – Žerotínova in Valašské Meziříčí

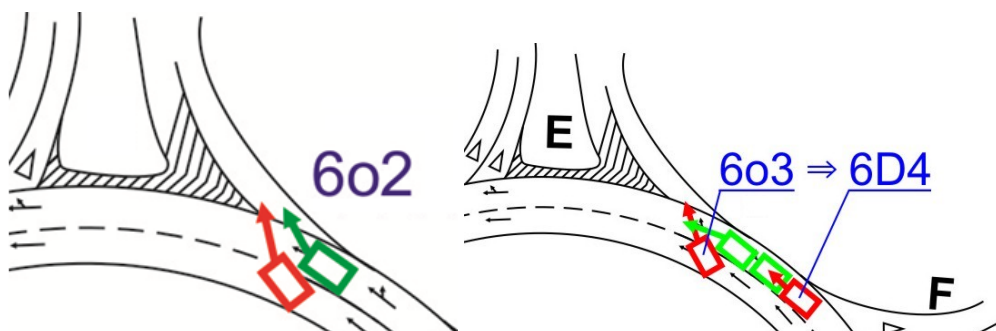
The exiting double-line circulating roadway is always problem and is an origin of many conflict situations. Figure 7 presents schematically the situations on single-line exit, while Figure 8 shows the situations on double-line exit. Three characters symbol determines the conflict situation [5]: the first character (here “6”) denotes a situation between cars, second character (here “o”) means a restriction or danger in driving; respectively “D” - possible danger of rear-end collision; and third character represents seriousness of the conflict (here, simply speaking, “2” – weak reaction, “3” – strong reaction, “4” – traffic accident). These conflict situations were observed on all monitored roundabouts of this type.

Figure 7: Possible conflict situations during exiting double-line circulating roadway to single-line exit

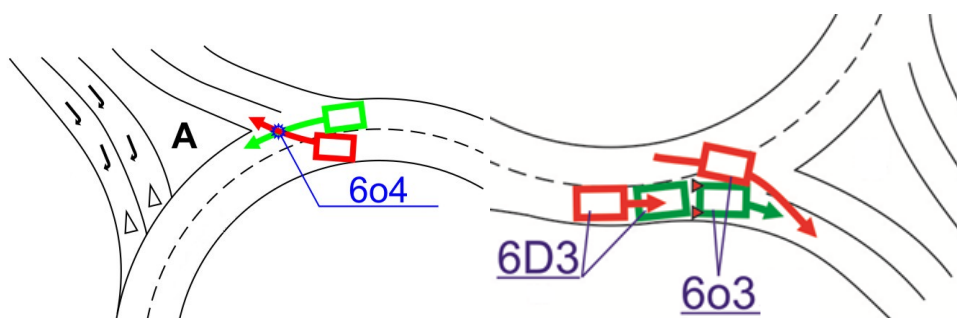
Figure 8: Possible conflict situations during exiting double-line circulating roadway to double-line exit

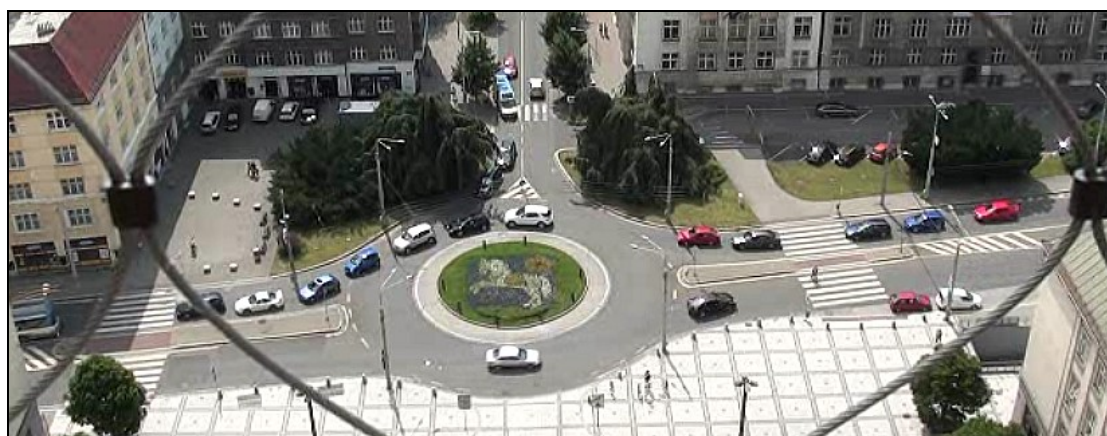
The last situation we are presenting here, although not directly related to building elements of intersection, is rather related to the selection of suitable type of intersection. Roundabout in Figure 9 is at a distance of about 140 meters from the control junction (on the picture to the left of the roundabout in question). At higher volumes on the control junction cause formation a queue of vehicles which extend the roundabout where the traffic is either limited or completely stopped.

Figure 9: Stopped traffic on the roundabout Sokolská – 30. dubna
influence of the queue on near control junction Sokolská - Českobratrská

This example clearly shows the inappropriately combination of two different types of intersections, situated short distance apart. The control junction would be better type of intersection instead of roundabout. However, it is evident that the use of exactly roundabout at this place (in front of the City Hall's lookout tower) has rather an esthetic reason.
