Radim ČAJKA¹, Petr MARTINEC²STRUCTURAL FAILURES OF BUILDINGS CAUSED BY VOLUME CHANGES
OF STEEL SLAGPORUCHY STAVEBNÍCH OBJEKTŮ VLIVEM OBJEMOVÝCH ZMĚN
OCELÁRENSKÉ STRUSKY**Abstract**

The paper deals with structural failures of buildings caused by volume changes of steel slag in subsoil of hospital in Ostrava-Poruba. The building consists of a monolithic reinforced concrete frame structure with floor slabs on slag sub-base. Latest measured increases in deformations show that the slag swelling in the sub-soil continues, and as the measured dependences show, there is no stabilization of the movement.

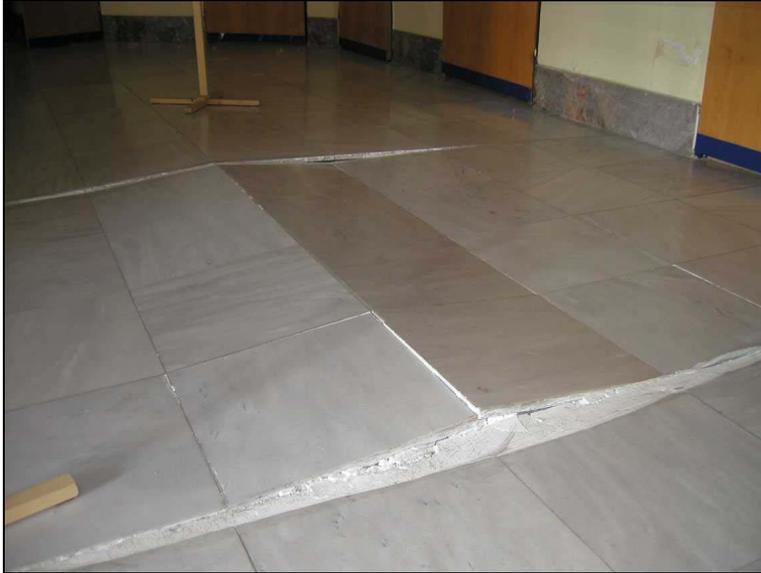
When examining the building in 10/2006, inclined shear cracks in external walls and connecting non-load bearing walls were recorded in the entrance area, public areas, grocery shop, storage rooms, and connecting corridors. The door openings and doorframes are distorted and skewed; the floor surface is bulged upward and penetrated by cracks. See Figure 1 for the bulges and the peeled tiles at the entrance area outside the public area facilities (men's and women's restroom, cleaning room).

Figure 1: Deformation of the floor and tiles

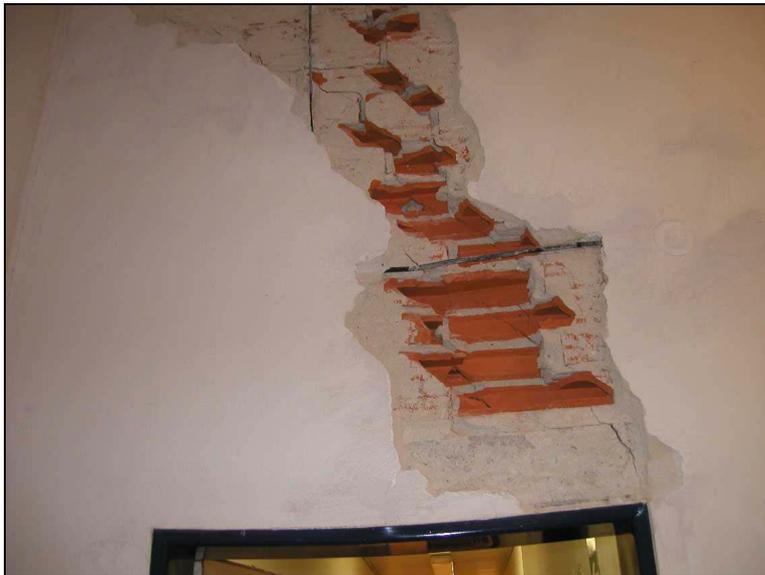
In some places deformations already reach values such that it resulted in the destruction of the brickwork and crumbled parts of perforated bricks, see Figure 2 [1].

Figure 2: View of damaged brickwork of the non-load bearing wall

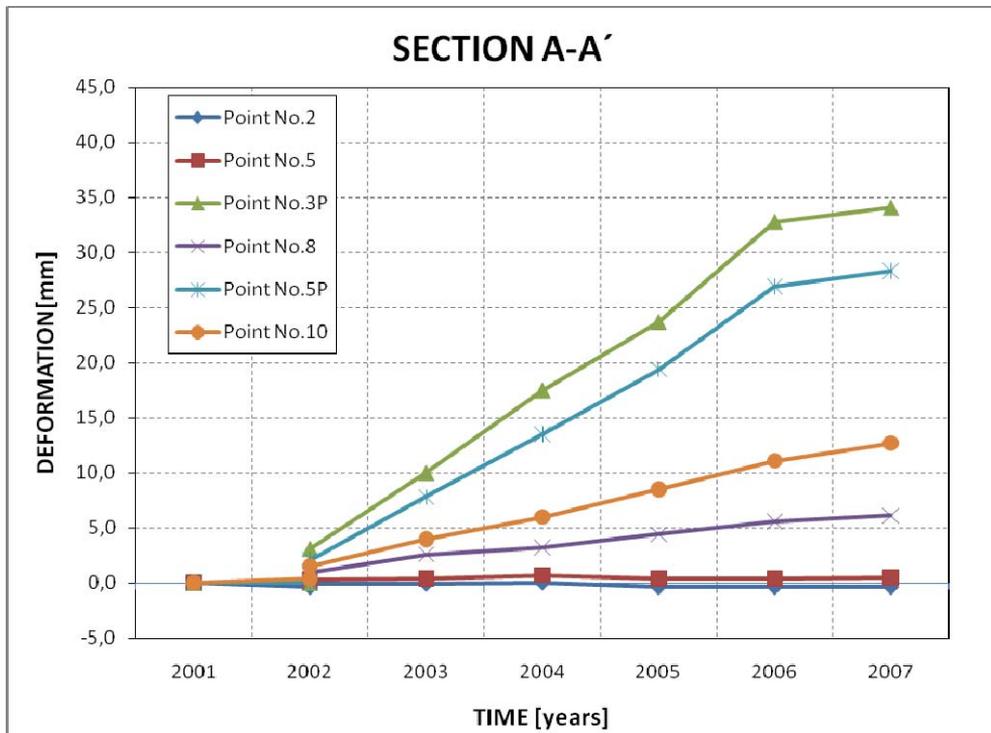
Figure 3: Vertical deformations of measured points A-A in time

Time course of deformations in individual cross section profiles and points is shown in Figure 3 to 6. The maximum bulge of the floor reached the value of 39.6 mm within the period of January 23, 2002 to January 24, 2007, and then the value of even 46.1 mm within next 15 months to April 24, 2008 (maximum increase of 6.5 mm in 15 months). However, the initial deformations of approximately 110 mm need to be added to this value, so the last height unevenness of the floor reached over 150 mm as of the date of the last measurement, and the deformations are still continuing.

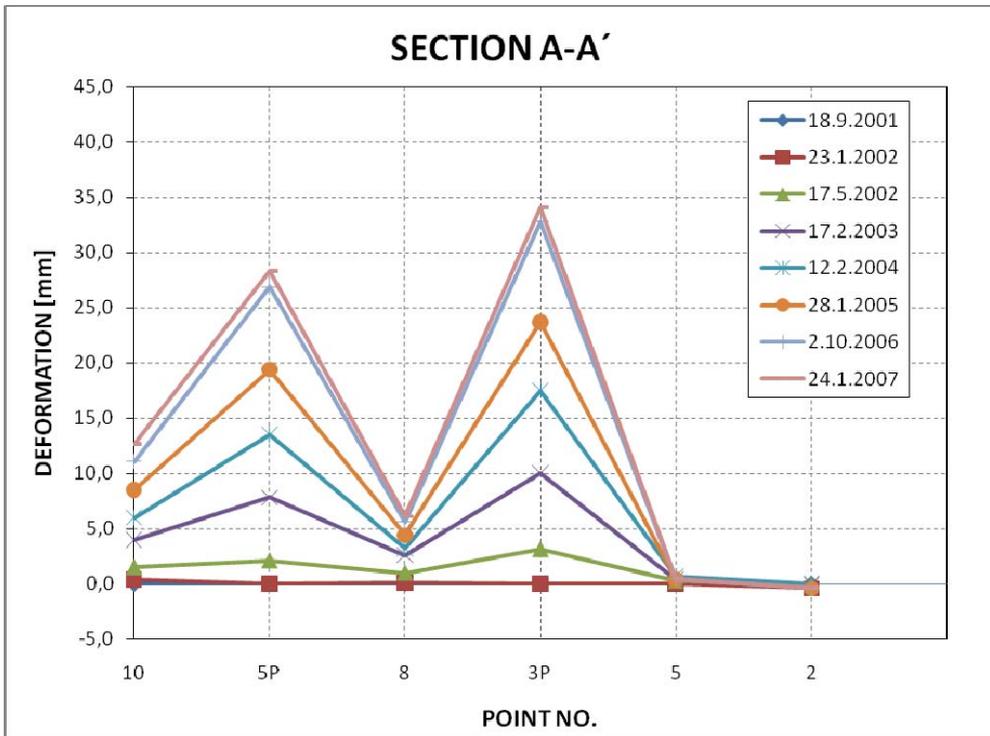
Figure 4: Vertical deformations of measured points in section A-A

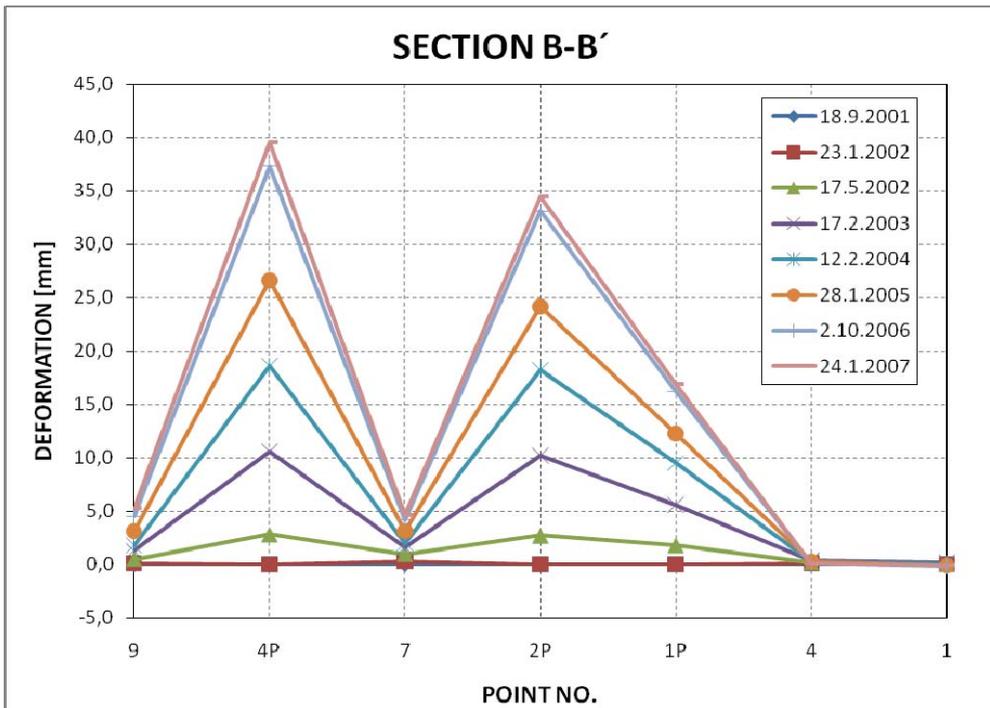
Figure 5: Vertical deformations of measured points B-B in time

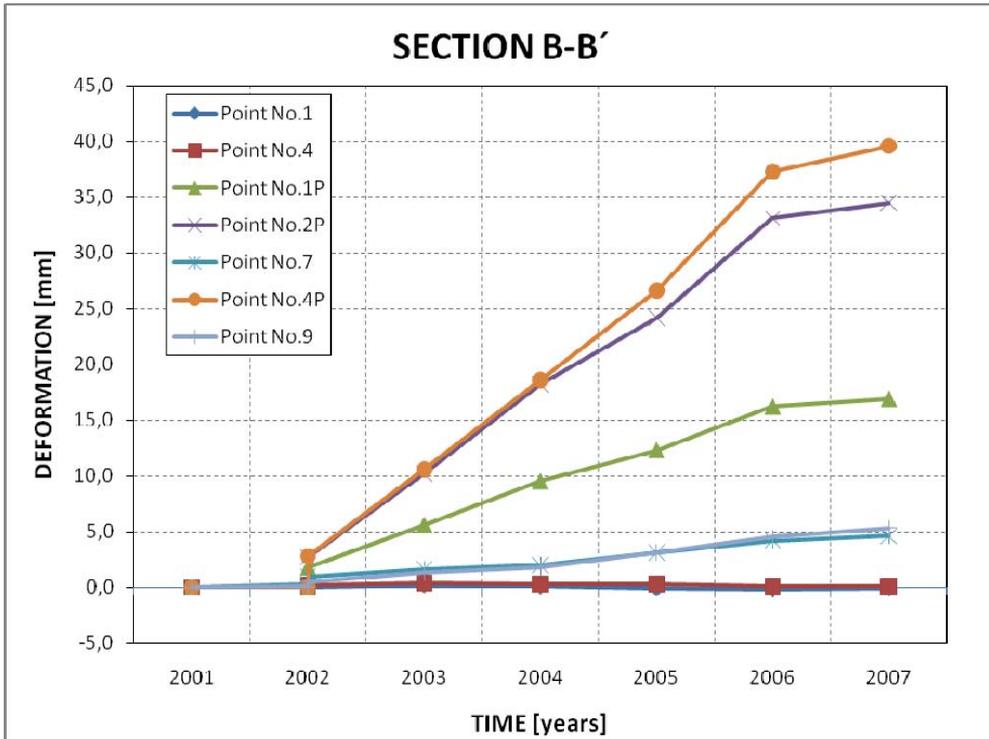
Figure 6: Vertical deformations of measured points in section B-B

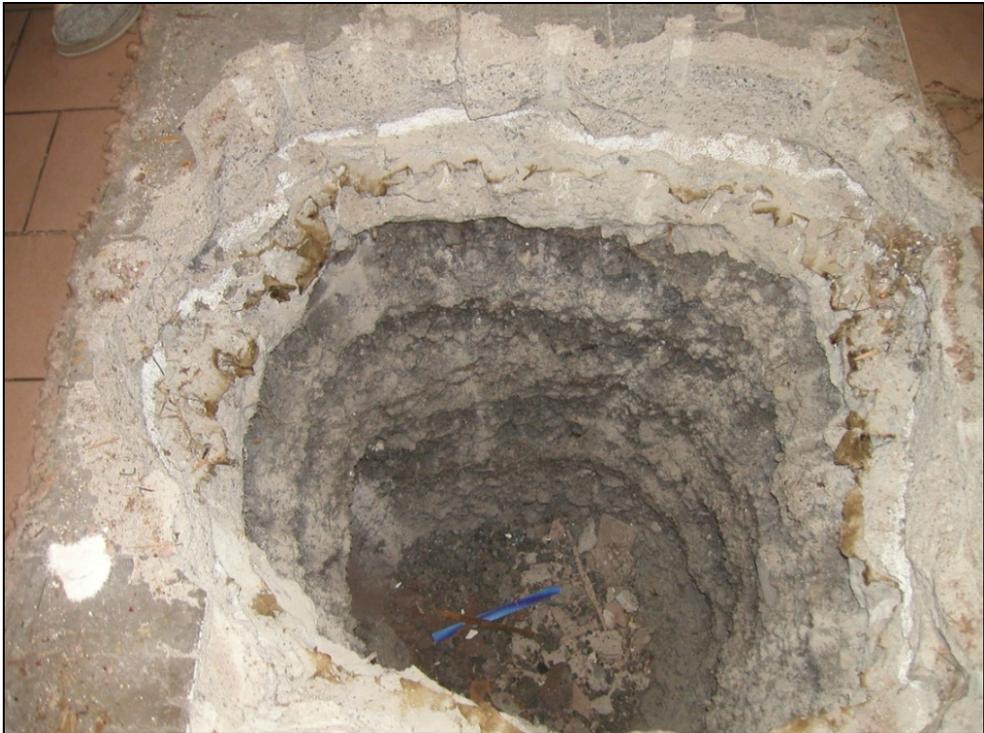
Figure 7: Sampling probe dug inside of the building

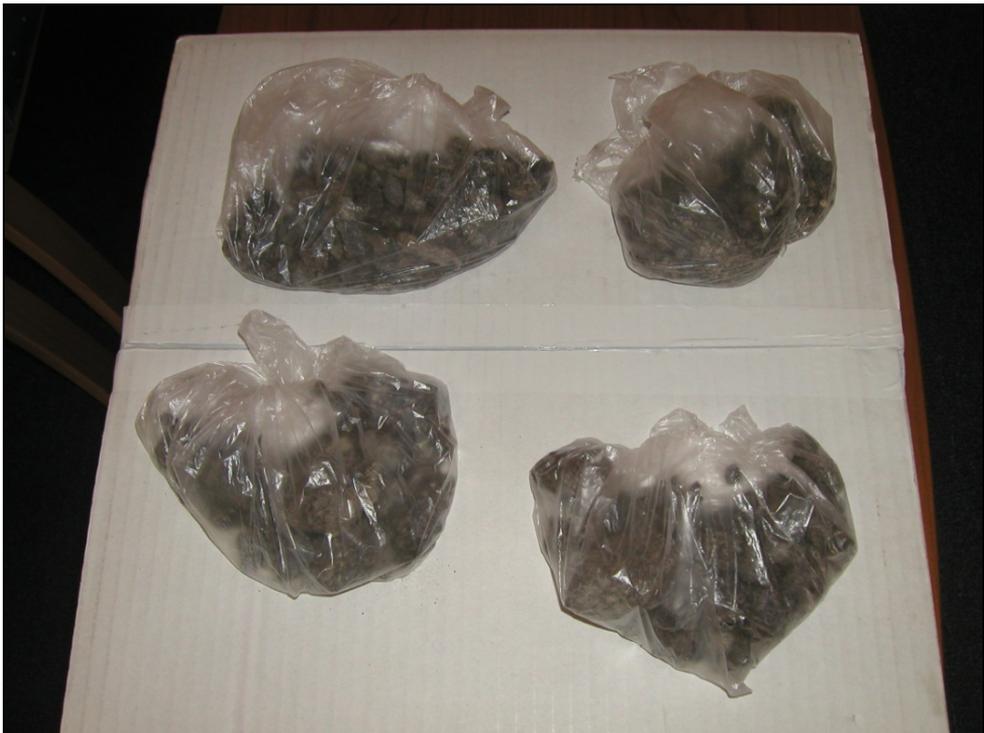
Figure 8: The analyzed slag samples taken from the probe dug in sub-soil of the building
