Vladislav KŘIVDA¹, Ivana MAHDALOVÁ²**PROBLEMATIC TURNING OF BUSES ON WRONGLY DESIGNED INTERSECTION****PROBLEMATICKÉ ODBOČOVÁNÍ AUTOBUSŮ NA CHYBNĚ NAVRŽENÉ KŘÍŽOVATCE****Abstract**

The paper deals with problematic turning of buses on selected intersection with use of video analysis of conflict situations. This paper also describes a new attitude to division and marking of conflict situations and also one of the methods during video analysis of conflict situations by the evaluation of inappropriately designed building elements on intersections.

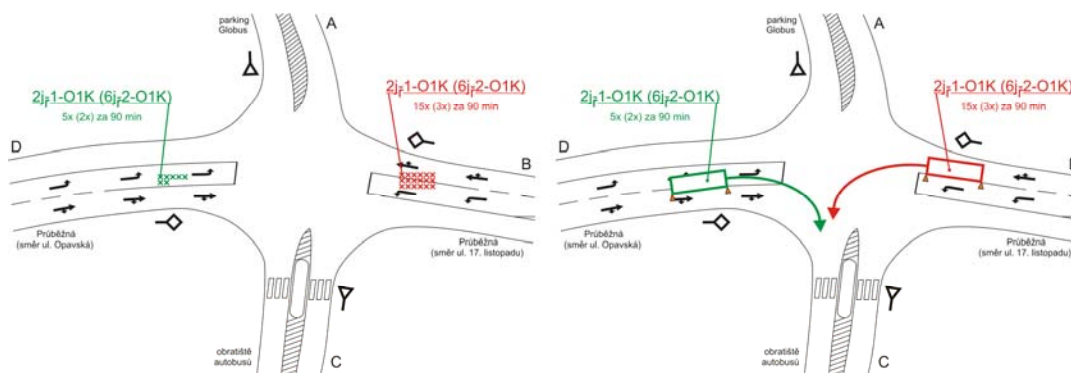
During conflict situation $2j_{\text{f}}1\text{-O1K}$ (or $6j_{\text{f}}2\text{-O1K}$, when the other participant is restricted or endangered) the driver have to drive by next turning lane (see Fig. 5).

Fig. 5: Scheme of origin and localization of conflict situation $2j_{\text{f}}1\text{-O1K}$ (or $6j_{\text{f}}2\text{-O1K}$)

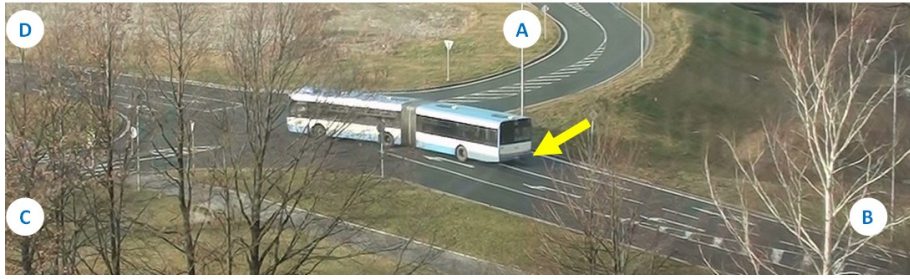
- either to the left from leg B to C (see Fig. 6 or 8), when the driver drive by running lane,
- or to the right from leg D to C (see Fig. 7 or 9), when the driver drive by left turning lane.

Fig. 6: The bus driving by running lane during turning to the left (conflict situation 2j_f1-O1K)

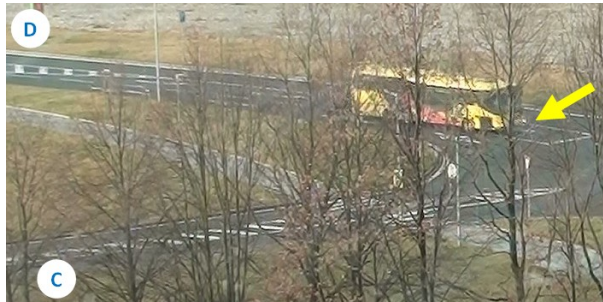
Fig. 7: The bus driving by left turning lane during turning to the right (conflict situation 2j_f1-O1K)

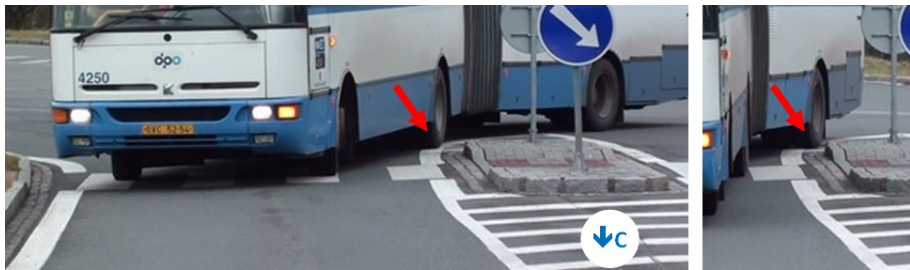
The reason of this behavior is following: the bus drivers have problem to go into space between refuge island and right curb (see exit C on Fig. 2). In case of drive from leg B to C (the left turning) the buses usually drive over visual island (i.e. conflict situation 2j_{so}1-O1K) and then near the curb (i.e. conflict situation 2j_o1-O1K) – see Fig. 8. The vehicles going from leg D to C (the right turning) then drive near the curb (i.e. conflict situation 2j_o1-O1K) – see Fig. 9. This way of drive can moreover endanger pedestrians which are near pedestrian crossing.

Fig. 8: The bus driving over visual island (conflict situation 2j_{so}1-O1K), or near the curb of refuge island (conflict situation 2j_o1-O1K); the left picture shows driving over guide lane by left wheel of the second axle, the right picture shows the third axle the same bus

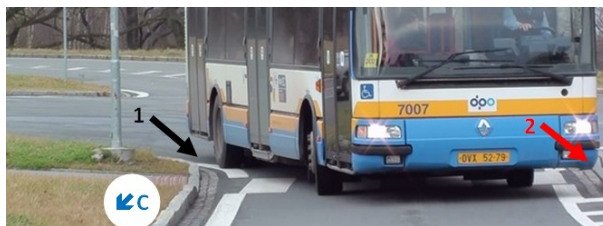
Fig. 9: The bus driving near the curb of refuge island (No. 1; conflict situation 2j_o1-O1K); 2 ... driving by left profile of the bus over guide strip

We can also say, that the driver of bus turning to the right (from D to C) in quest to prevent drive onto curb by right wheels can contrariwise drive onto curb of refuge island by the left wheels (or they drive by bus profile over guide strip – see Fig. 9, arrow 2) – analogically for bus driver turning to the left (from B to C).

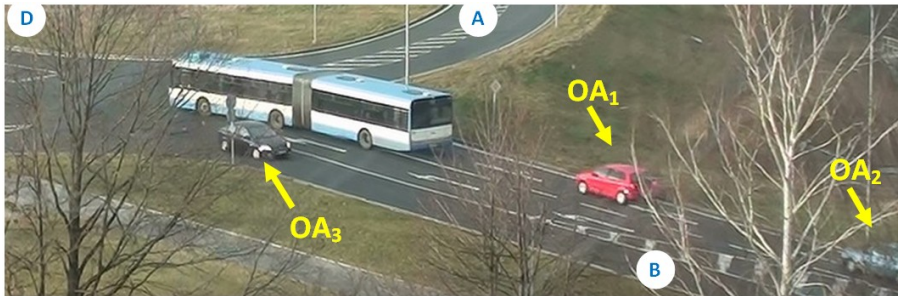
We can state, that the drivers to prevent situation $2j_o1-O1K$ and $2j_{so}1-O1K$ have to cause the situation $2j_f1-O1K$ or $6j_f2-O1K$ – and contrariwise. By driving by wrong lane the other participants of road traffic can be restricted or endangered (i.e. conflict situation $6j_f2-O1K$ – see Fig. 10).

Fig. 10: The restriction of the other vehicles (OA_1 and OA_2) by bus turning to the left (giving way to vehicle OA_3) and driving over running lane (conflict situation $6j_f2-O1K$)

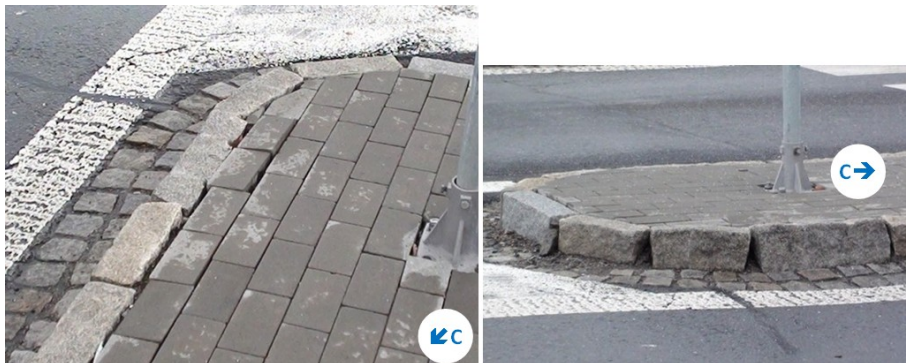
The curb between entry D and exit C isn't damaged, however the curb of refuge island on leg C is damaged – see Fig. 11.

Fig. 11: The damage curb of refuge island on leg C

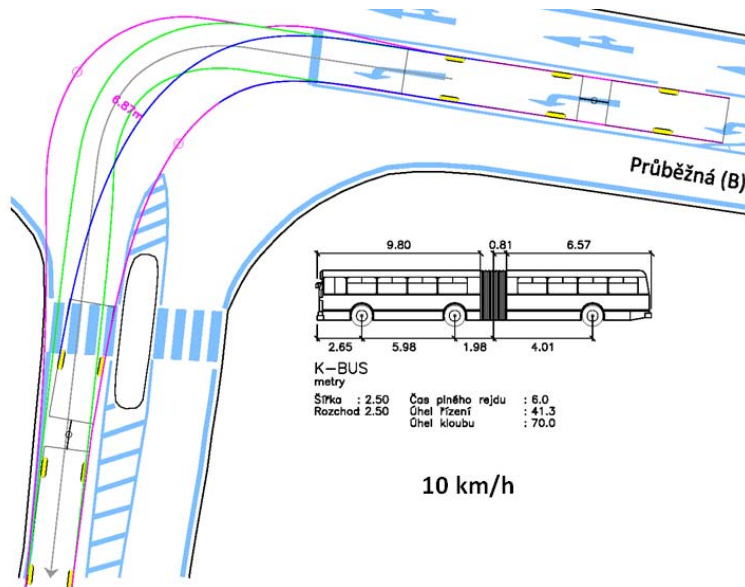
As the first problem will be describe the *left* turning from Průběžná street (*leg B*) in the direction to bus stop on leg C, when the articulated bus used the left turning lane. On Fig. 12 we can see, that this type of bus has already in low speed (10 km/h) relatively problem with exit to leg C (where the refuge island is). However, the bus don't go neither by front nor by rear wheels onto curb,

Fig. 12: The rupture curves (AutoTURN) for turning from leg B to leg C with use of the left turning lane (speed 10 km/h)

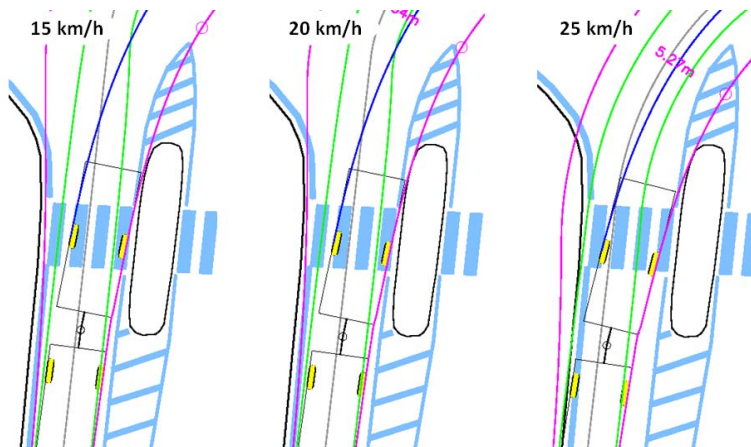
but only onto visual island. The details on Fig. 13 show the same situation, but for greater speeds (15, 20 and 25 km/h). During speed 20 km/h the vehicle already drives near the curb of refuge island, during speed 25 km/h the bus even drive onto the curb by the right wheel.

Fig. 13: The rupture curves (AutoTURN) for turning from leg B to leg C with use of the left turning lane (speeds 15, 20 and 25 km/h)

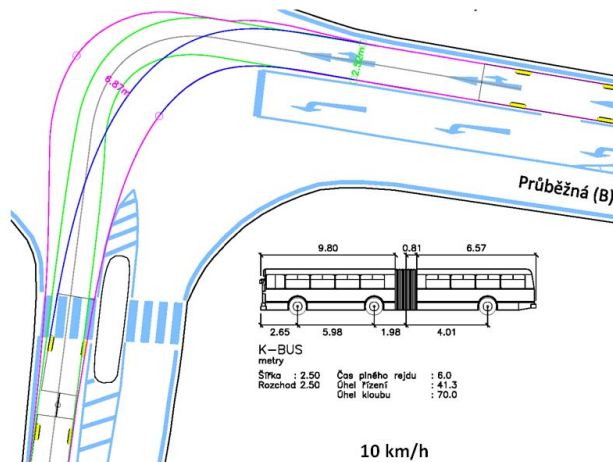
On Fig. 14 is showed the situation, when the articulated bus don't use the left turning lane, but the next lane (for drive strait and on the right) – there is situation for speed 10 km/h. This bus don't drive neither onto guide strip nor visual island (even if with minimal or zero reserve). The details on Fig. 15 show the same situation, but for greater speeds (the situation is logically more problematic).

Fig. 14: The rupture curves (AutoTURN) for turning from leg B to leg C without use of the left turning lane (speed 10 km/h)

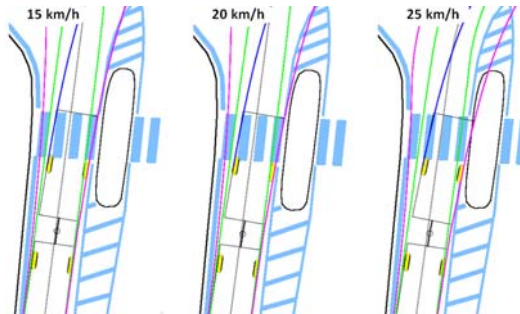
Fig. 15: The rupture curves (AutoTURN) for turning from leg B to leg C without use of the left turning lane (speeds 15, 20 and 25 km/h)

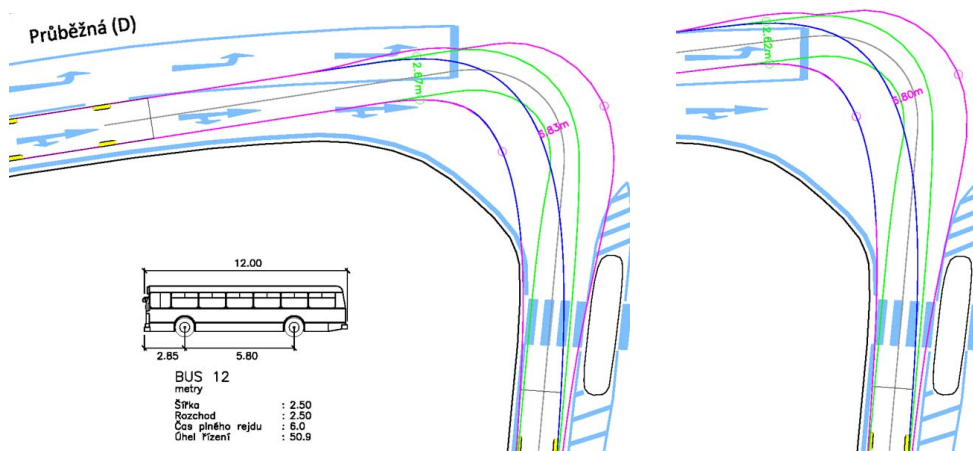
As next problem will be describe the *right* turning from Průběžná street (*leg D*) in the direction to bus stop on leg C, when the articulated bus used the left turning lane. The buses (here only 12-metre vehicles) have to drive by the next left turning lane for prevent driving onto curb or refuge island. Fig. 16 (left) shows situation, when the bus is driving only partly through this lane, Fig. 16 (right) shows situation, when the bus is driving through this lane by whole width. This maneuver is problematic already for speed 10 km/h.

Fig. 16: The rupture curves (AutoTURN) for turning from leg D to leg C with partial (left) and full use of the next turning lane (speed 10 km/h)
