**Vladislav KŘIVDA<sup>1</sup>, Ivana MAHDALOVÁ<sup>2</sup>****ORIGIN OF DANGEROUS CONFLICT SITUATIONS ON INTERSECTION  
WITH INAPPROPRIATELY DESIGNED BUILDING ELEMENTS****VZNIK NEBEZPEČNÝCH SITUACÍ NA KŘÍŽOVATCE  
S NEVHODNĚ NAVRŽENÝMI STAVEBNÍMI PRVKY****Abstract**

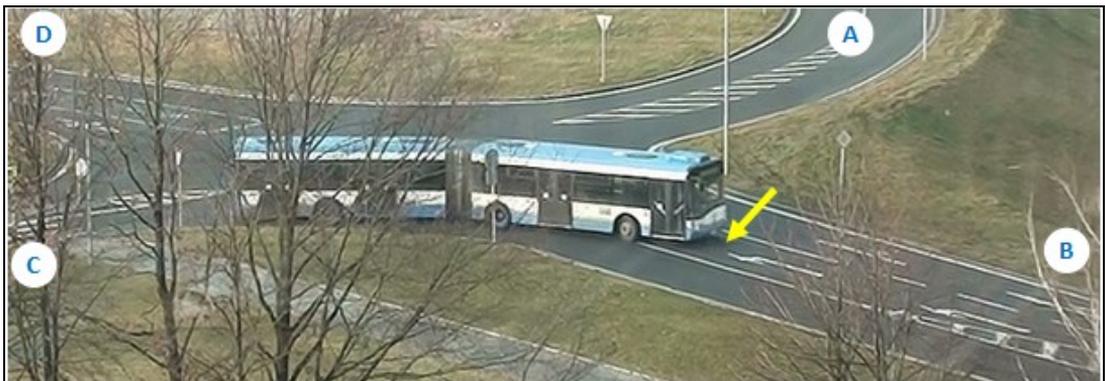
The problem with right turning into leg B will be described as first. For correct turning without mounting the curb of corner the driver has to go with use opposite lane (see Fig. 6). He also goes through visual island (see Fig. 7). The “down” record shows that drivers don’t go through curb but through guide line (see Fig. 8). In spite of it the curb of this corner is damaged (see Fig. 9) – due to that only the one piece of curb is damaged, we can conclude, that it was damaged by another reason than by mounting of vehicle (e.g. the wrong installation of this piece).

Fig. 6: The bus is going to opposite direction (exit B)

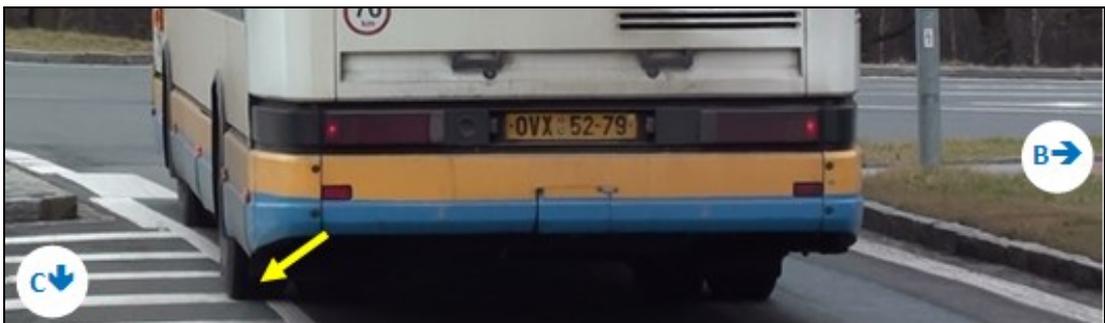
Fig. 7: The bus is going through visual island of refuge island

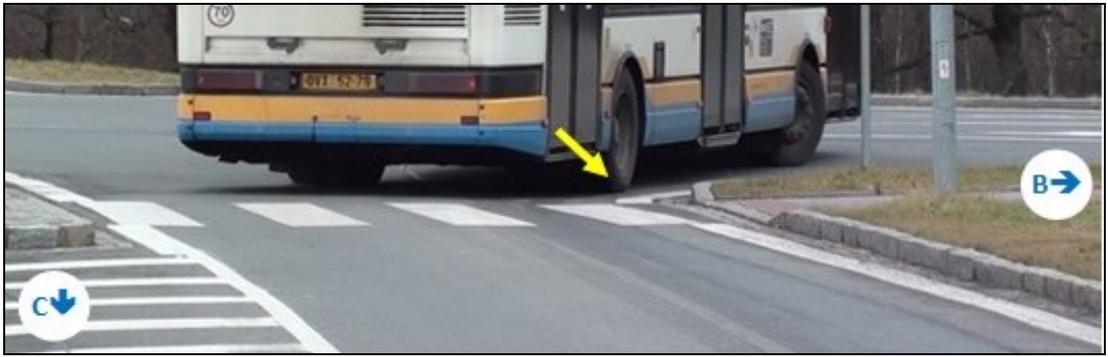
Fig. 8: The bus is going in needful space from curb

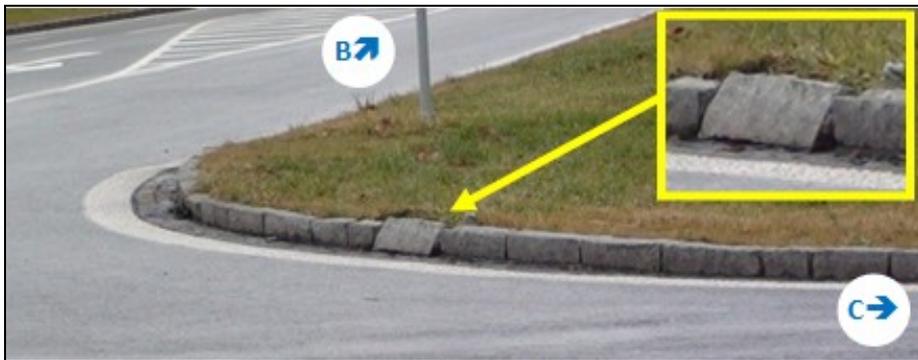
Fig. 9: The damaged curb of corner (from C to B)

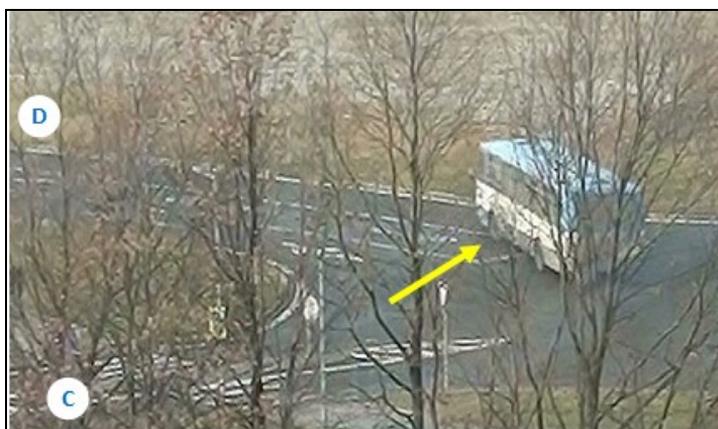
The second case, when the driver is going to opposite direction, is the case of left turning from leg C to leg D. Turning lane (its stop line) is located too near to center of intersection and drivers then goes through this lane (see Fig. 10). Drivers of combinations of vehicles have similar problems when they are going from leg A to D (buses don't go by this direction). It's caused by inadequate radius of this corner.

Fig. 10: The bus is going to opposite direction (exit D)

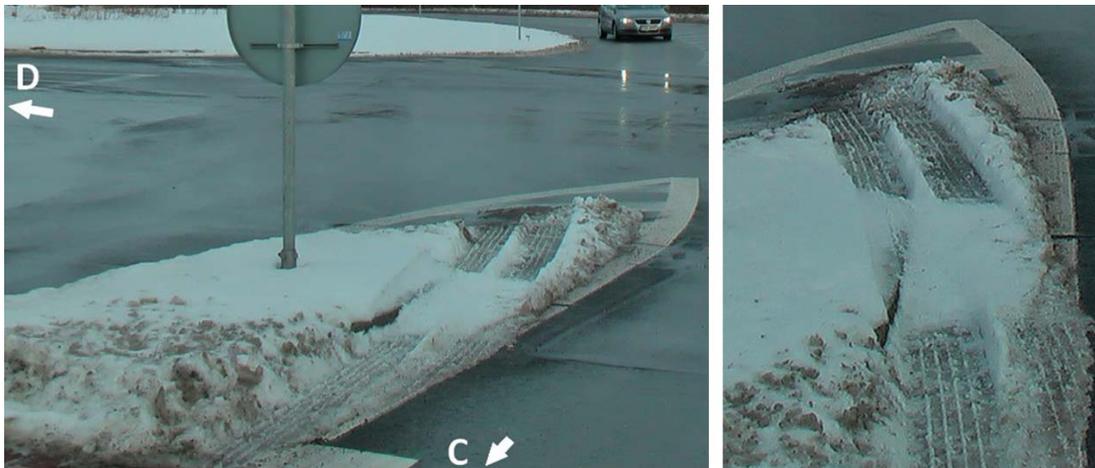
The drivers have also a partial problem with refuge island on leg C – it's showed on Fig. 11 (however, it can be caused only by snowy island).

Fig. 11: The tracks in snow caused by mounting the refuge island

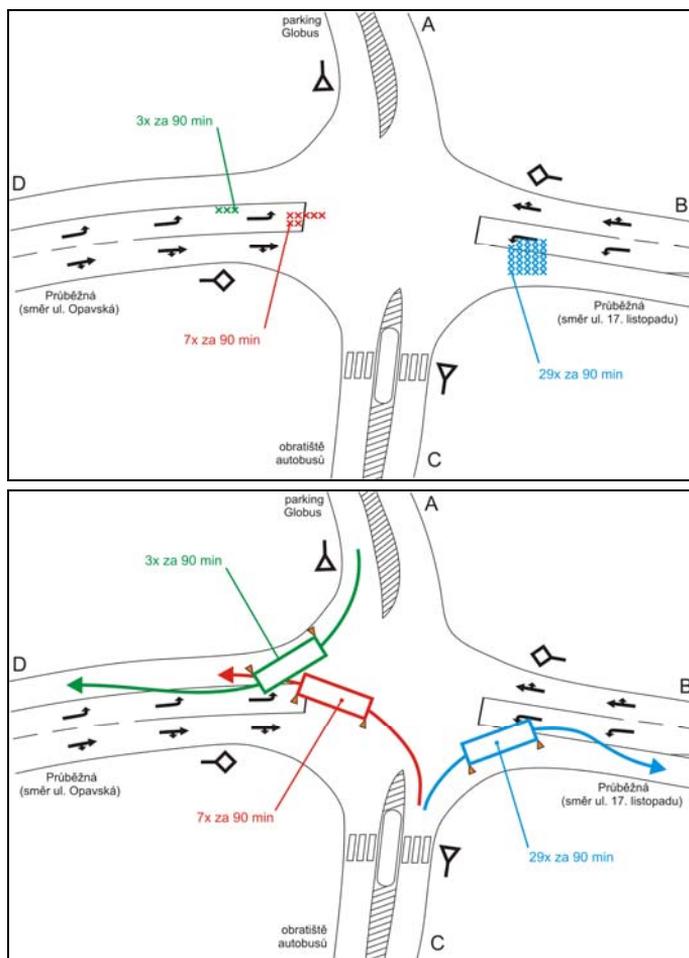
The Fig. 12 shows the scheme of locating and arising of conflict situations presented above. Their numbers are in Tab. 1.

Fig. 12: Scheme of locating (up) and arising (down) of described conflict situations

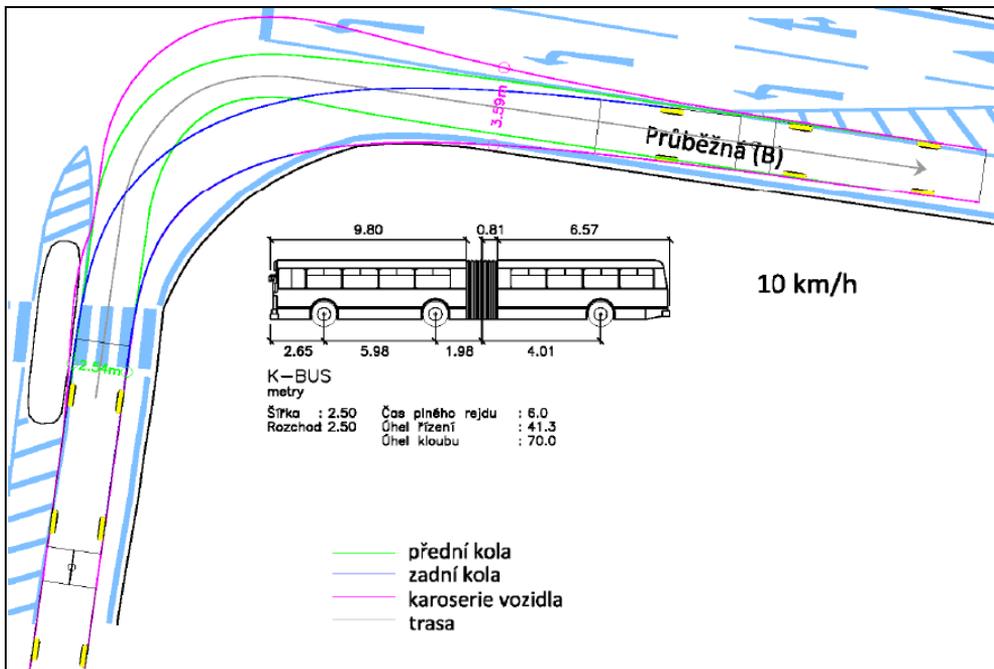
There will be described right turning of bus from bus stop Opavská (leg C) to street Průběžná (leg B) when articulated bus has to go into opposite direction (in spite of movement near refuge island) to averting of mounting the curb of corner. The situation for speed 10 km/h is showed on Fig. 13.

Fig. 13: Rupture curves during right turning of bus from leg C to B

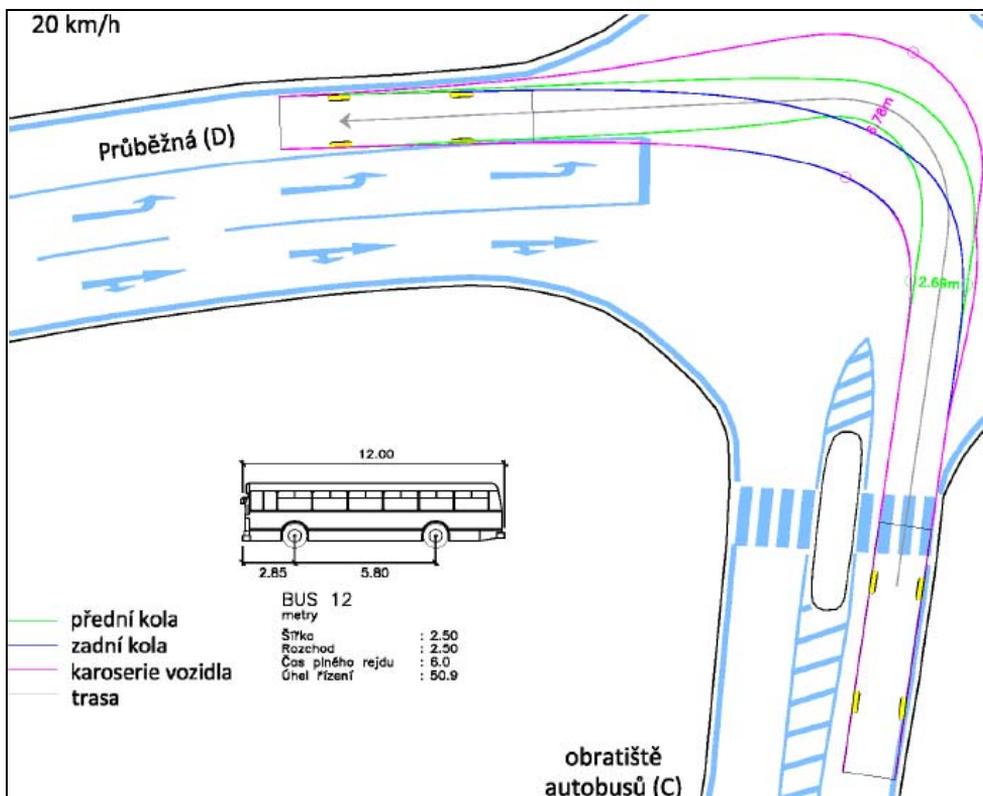
The similar situation also arises during left turning from bus stop Opavská (leg C) to street Průběžná (leg D), when vehicle is going into opposite turning lane (see Fig. 14). Driver has more options for selection of correct trajectory and not during higher speed the driving into opposite direction isn't considerable (e.g. 20 km/h, see Fig. 14).

Fig. 14: Rupture curves during left turning of bus from leg C to D

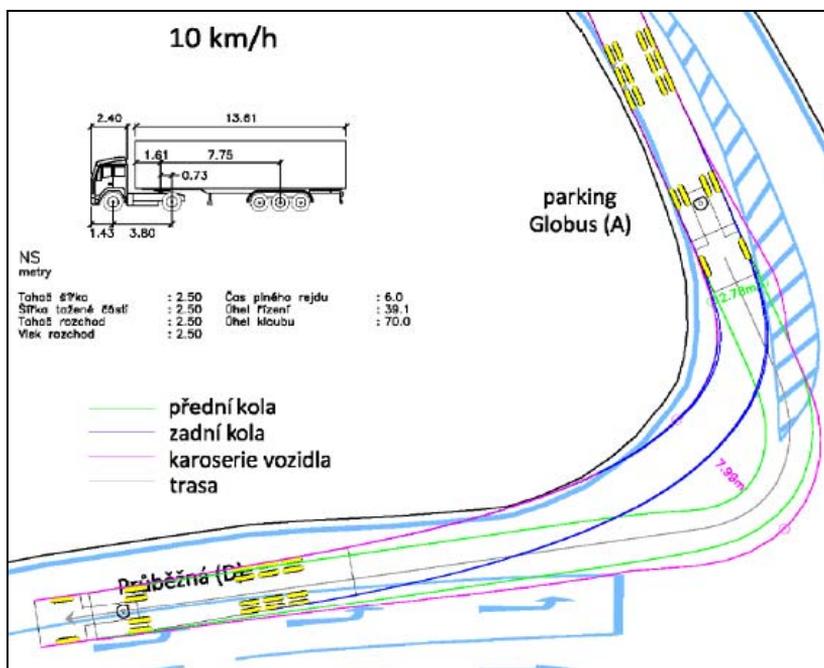
During right turning from parking Globus (leg A) to street Průběžná (leg D) the driver of larger vehicle has to go through visual island on the entry of intersection and also into opposite turning lane on leg D (see Fig. 15). This trajectory has to be chosen to avert of mounting the curb corner (also during speed 10 km/h).

Fig. 15: Rupture curves during right turning of combination of vehicles from leg A to D

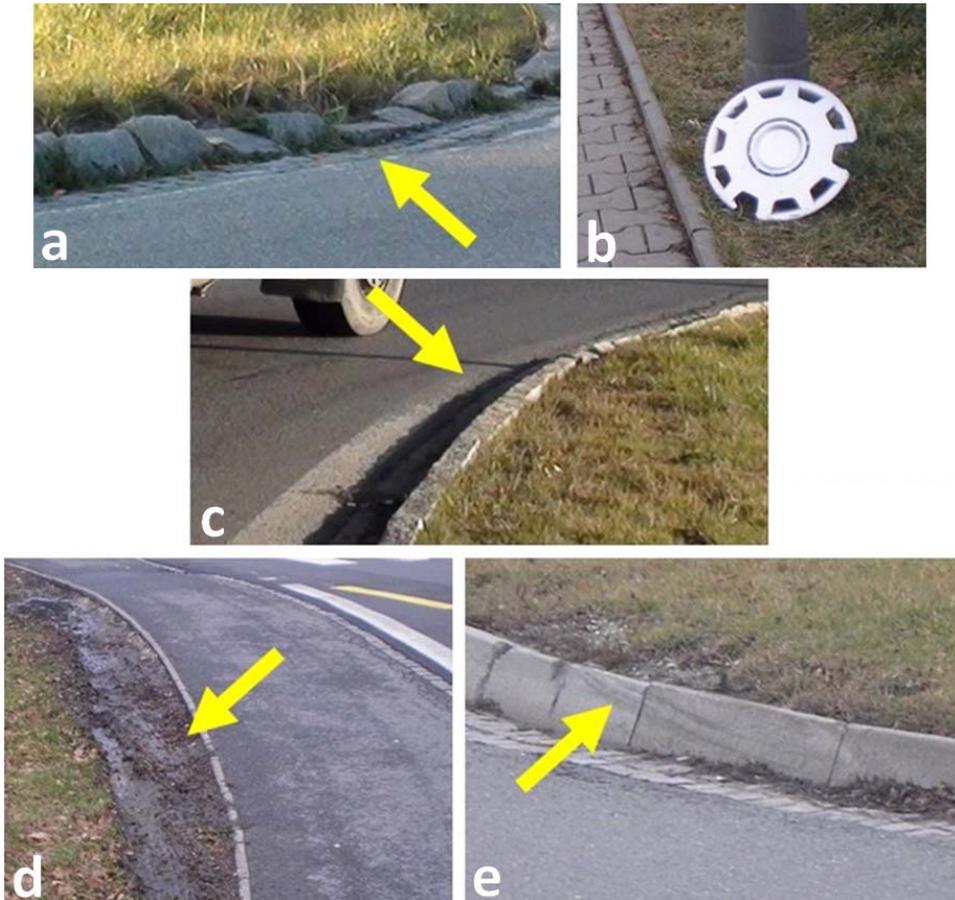
The presented text shows the example of monitoring of intersection with various identifying characteristics (see Fig. 16) which can point on inappropriate design building elements of intersection. Not always it's singular situation (accident, damage by winter maintenance etc.). The video analysis of conflict situations is excellent tool for detect of periodicity of incidence of these conflict situations (e.g. see also [8] and [9]).

Fig. 16: Selected identifying characteristics for identification of inappropriate designed building elements (a – damage curb; b – damage wheel disc cover; c – wrong noticeable guide line; d – wheel prints on grass; e – tire smudge on curb)
