**Renáta KORENKOVÁ<sup>1</sup>, Peter KRUŠINSKÝ<sup>2</sup>****DIAGNOSTICS OF THE TECHNICAL CONDITION OF TIMBER ROOF FRAMES  
USING FAKOPP 3D SONIC TOMOGRAPH****Abstract**

The Fakopp 3D Sonic Tomograph is used in practice for making the diagnosis of latent, i.e. internal, damage to living trees. We experimented with the possibility of using this device for decay detection in timber elements of a roof frame. It was tested in the laboratory (in labo) as well as in the roof space of a historical truss (in situ). We examined the timber elements of historical wooden trusses that had relatively a small diameter.

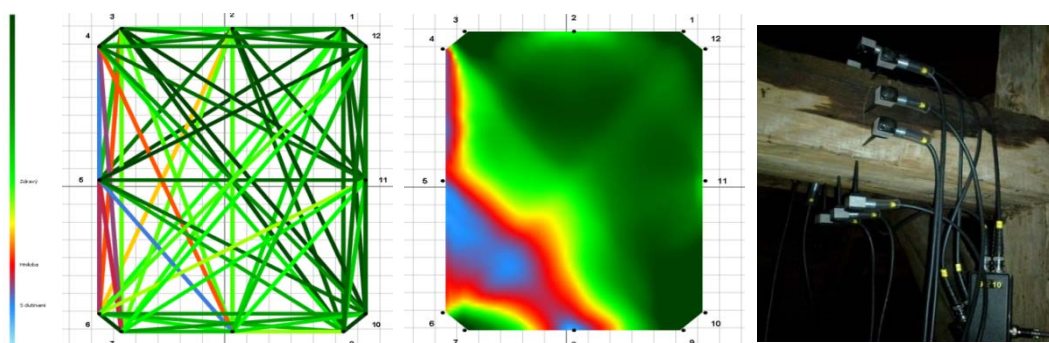
The church has an original timber roof frame over the nave dated from 1759 [8]. It is made of spruce with hewn elements. A part of the truss over the sanctuary is colonised by bats, there are obvious leavings of their excrements on timber. Measurements were made in a collar beam nearby the central trestle. The lower speed of sound indicated the higher moisture content in wood. It is because its capillaries that were filled up with the air are now filled up with water [6]. In consequence of this the environmental resistance to spreading ultrasonic waves rises. The collar beam is 190/140 mm horizontally. It is clearly broken-down by ligniperdous insects, but it is weak, non-active damage. There are visible cracks close to the surface on its bottom, maximally 5 mm wide.

Fig. 1: The collar beam - the roof frame of the Turzovka's church. The linear and 2D tomogram, right - the photo from measuring

The tomograms prove that there are cavities, or some larger crannies in the lower corner of its cross-section, which is not evident from the visual inspection. Measurements may be affected by bats' droppings.

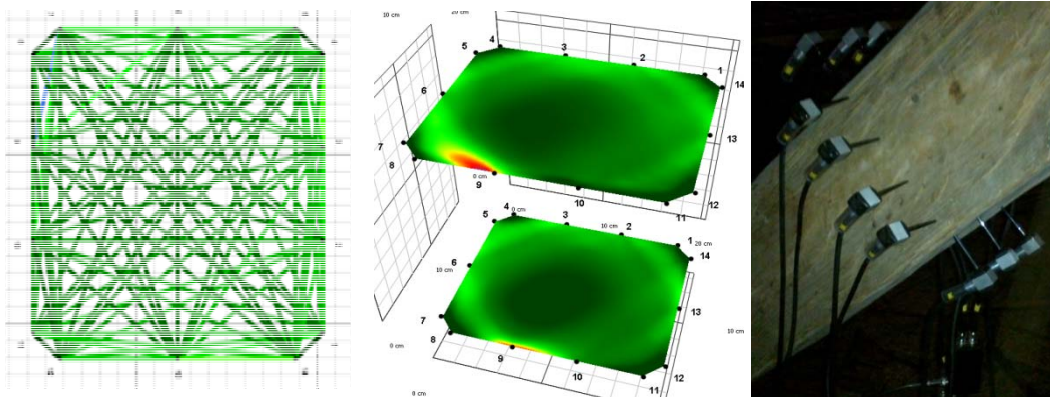
The church has an original timber roof frame over the sanctuary dated from 1759 [8]. This truss is quite well-preserved; there is some local significant damage, especially on its foot. A foot strut of a king post, with dimensions 180/215 mm, on the southern side was tested. The visual examination refers to perceptible surface damage. It is the consequence of ageing and an attack of ligniperdous insects - woodworm that is not active. There are also splits nearby the surface, their width is max. 5 mm, their depth is unequivocal. The tomogram demonstrates only surface damage of a timber element which is sound at its depth.

Fig. 2: The foot strut - the roof frame over the nave in the Turzovka's church. The two-level tomogram with 300 mm spacing, right - the photo from measuring

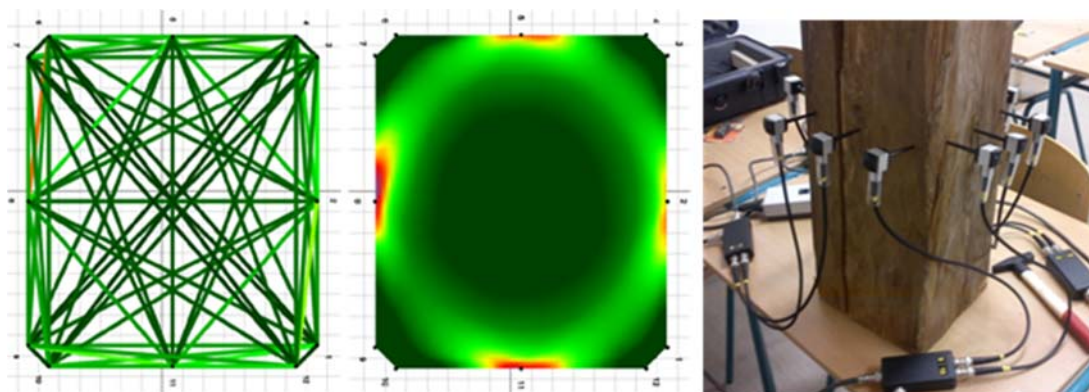
The roof frame of the church in Čierny Váh is of 1803 (d) [9]. Measured timber part is spruce, and has 190/170 mm. The moisture content of wood is 10 %. The ocular inspection confirms distinctive breaches, and surface degradation caused by ligniperdous insects and ageing.

Fig. 3: The part of a strut - the roof frame of the church in Čierny Váh. The 2D tomogram, right - photo from measuring

One evident crack is 70 mm deep, and reaches almost the diameter centre. Its width is 12 mm on the surface with gradual tapering towards the centre. It was not clearly caught by scanning. The linear tomogram indicates a defect between sensors 6 and 8, unlike the 2D one.

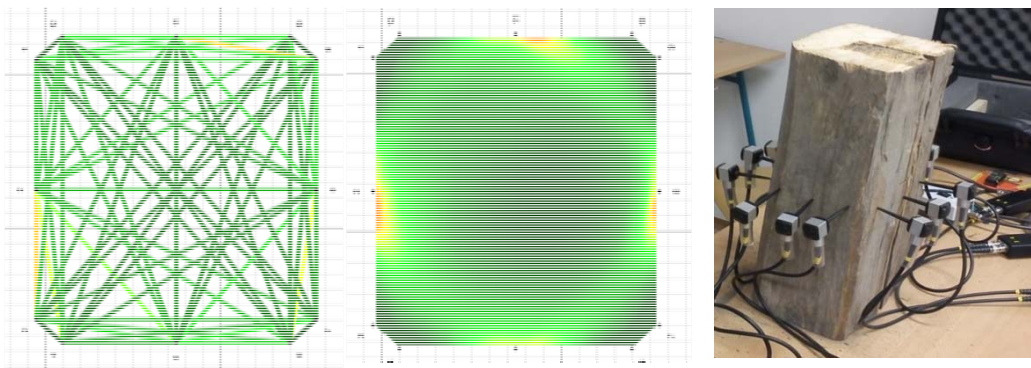
The truss construction, made of spruce, arose in 1870. The moisture content of wood is 10%. We studied a timber element with dimensions 230/190 mm. The visual examination reveals some damage on its surface as a result of an activity of ligniperdous insects. It has a fissure extending to 100 mm, running towards the centre where it has the width of around 1 mm. Despite it is rather deep, it is not visible neither in the 2D tomogram, nor in the linear one.

Fig. 4: The part of a post - the roof frame of the church in Kamenná Poruba.  
The 2D tomogram, right - photo from measuring.

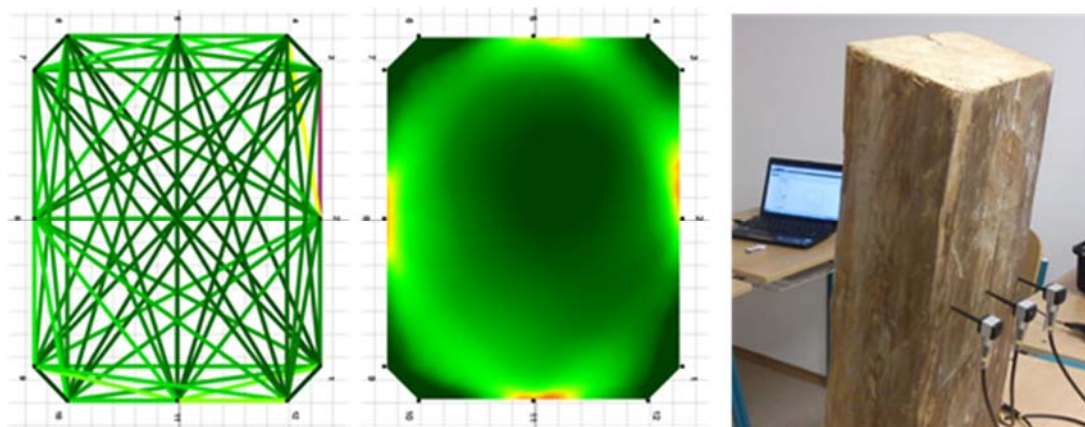
The roof frame of the church in Socovce is of 1775 (d) [10]. The timber strut is spruce with the cross-section of 190/150 mm. The moisture content of wood is 10%. There are discernible marks of damage from ligniperdous insects, and more surface cracks max. 3 mm wide. One of them is 10 mm wide and 50 mm deep, but it is not found in the 2D tomogram. The linear one shows a defect between sensors 2 and 3. There is obvious surface damage in the middle part of the cross-section.

Fig. 5: The strut - the roof frame of the Socovce's church. The linear and 2D tomogram,  
right - photo from measuring

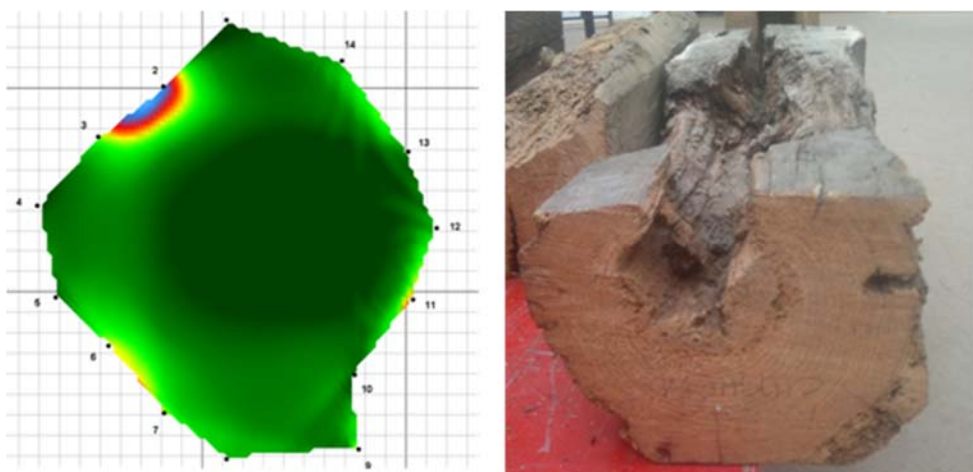
The roof frame of the church in Čimhová is of 1775 (d) [8]. This part of a wall plate in the church truss made of fir was chosen as an example of an irregular cross-section of a timber element. It is approximately 200/190 mm. The visual study unveils the higher age of an element as well as its decay in a large measure. The leaking water caused considerable damage

The tomogram refers to its surface damage with one rotted small channel, and points out the difficulty of achieving an exact scan of such a section. Therefore, the precision of this measurement is debatable.

Fig. 6: The involved part of a wall plate - the roof frame of the Čimhová's church.  
The tomogram, left - photo of measured element
