**Jaroslav SANDANUS<sup>1</sup>, Kristian SOGEL<sup>2</sup>****LOAD-BEARING STRUCTURE MODELLING OF HISTORIC BUILDINGS****Abstract**

In the contribution the analysis and subsequent reconstruction of two religious building's roof structure is presented. In the first case, the towers of the monastery church in Jasov are described. Second the Chapel in Bratislava is introduced. Through these structures the modelling problems and methods by historic buildings are presented. For each object the diagnostic inspection, structural analysis and recommendation for reconstruction is mentioned.

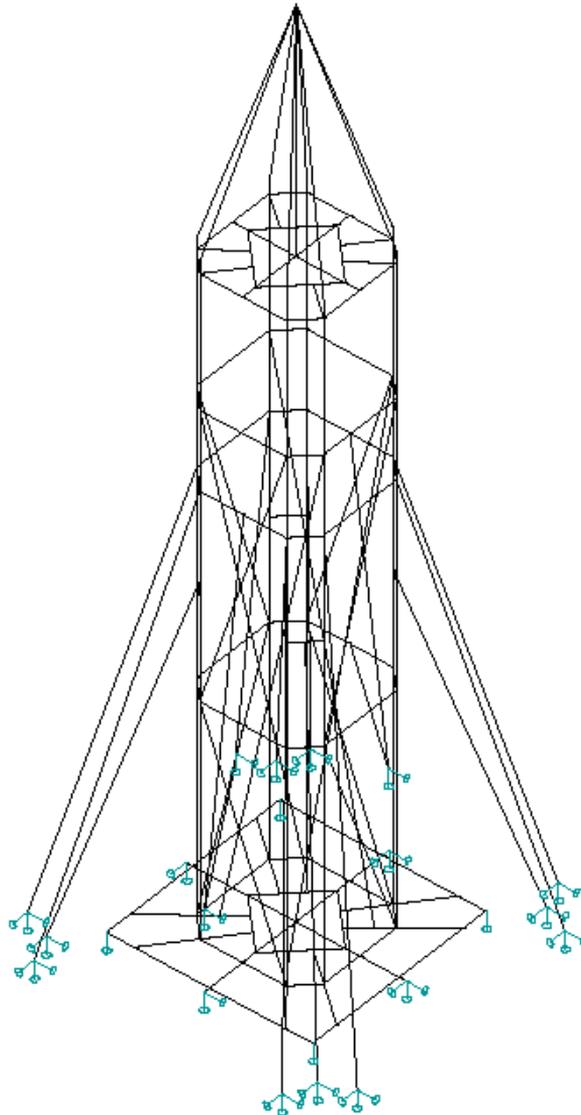
Fig. 2: 3D FEM model of the original structure

During the diagnostic survey it was found out that the structure of the towers are not reinforced sufficiently. In one of the towers the spatial reinforcement lacked, which prevents twisting the tower structure. This tower was slightly twisted around its vertical axis in the time of inspection.

Due to the shape of the towers, the wind load is the main load. By structural analysis three cases were verified. First: the state before the reconstruction, when the anchorage was not sufficient. Second: the state during the reconstruction, when the cover plates were removed and third the state after reconstruction, when all the deficiencies were removed.

The cross sections of elements and their joints predetermine the way of loading. Some elements can carry only tensile force, other only compressive. Most of carpentry joints are designed to compressive forces. They are not able to carry significant tensile forces.

On the base of the diagnostic inspection and structural analysis, the design of reconstruction has been carried out. First it was necessary to strengthen the tower base (fig. 3, 4), because of biotic damage by the supporting walls. Furthermore it was necessary to completely replace the elements of onion rings and decking. The new additional steel bracing system with a circle cross section was designed, located between the main supporting columns. The main columns were additionally supported by timber elements, providing better load distribution on the base of the tower. For the case of future inspections, the system of ladders and landings were proposed providing safe access to the highest positions of the towers. Besides the safe access, the landings are increasing the spatial rigidity of the structure.

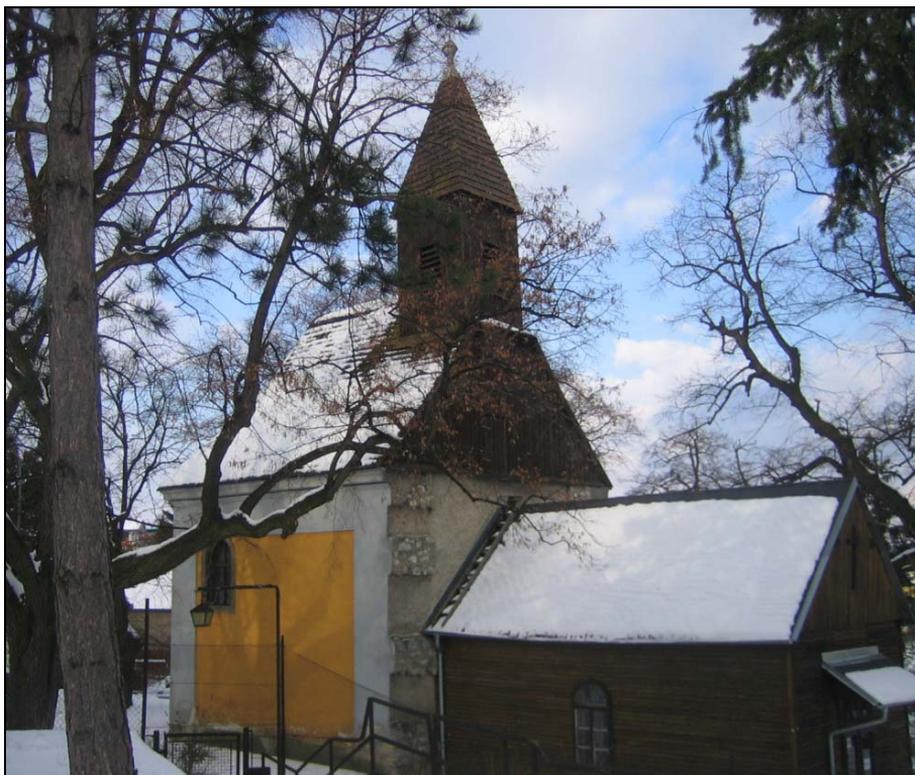
Fig. 5: The chapel of Madonna Mary

The reconstruction of the baroque chapel began to at the "last" moment. The serious condition of the chapel can also evaluate an observant passerby. The tower of chapel was inclined toward the altar. The geodetic survey obtained the horizontal deformation of the tower about 0,5m at its highest point. During the diagnostic inspection serious defects of principals and other beams was detected, causing the inclination of the tower. The moisture of wooden components was measured with a portable moisture-meter. By many elements an absolute moisture content above 35% was detected, which was not corresponding to the equilibrium moisture content of wood for the climatic conditions in the attic in the time of inspection. This state was measured also in places where the direct leakage of rainwater could not appear. According to the measured values of wood's moisture content it is likely that the covering of the church does not fulfil its function in terms of tightness and in terms of vapour impermeability [3].

The last renovation of the wooden structure was inexpert, because the original structure was repaired by amateur way by adding various additional elements, which had very little static efficiency. The structural elements were not protected against the progressive decay. The intervention to the load-bearing structure in such a degree was very insensitive and induced further rapidly degradation of the wooden components. As the supporting points the vault was used, what is unacceptable in terms of load bearing system and did not match to the original idea of the load-bearing system.

Based on the diagnostic inspection the emergency condition was announced. Consequently the project of reconstruction was worked out, with the aim to maintain the original structure. It was necessary to cooperate with the Regional Monuments Board during the design works, seeing that the most of the original elements could not be saved. That's why the new structure was worked out as a real copy of the original roof structure, using the material of the same plants and using the same covering. In terms of indoor climate of the attic space, it was necessary to create effective ventilation. The air supply was designed near the wall beams and air will be led away through the tower of the chapel.
