**ENGINEERING-GEOLOGICAL CONDITIONS OF LANDSLIDE IN THE OSTRAVA-KARVINÁ
COALFIELD**

The paper deals with a slope deformation Staříč (sequence number 2) in the Frýdek Místek district in the north-east of the Czech Republic. It makes part of a wider three-year study, which comprises 6 localities of slope movements in total (sequence numbers 1 to 6) in the Ostrava-Karviná District, in case of which there is a potential precondition for changes in stability due to undermining. In the first phase, archive materials, basic data, aerial photographs of slope deformation were studied and evaluated. Subsequently, engineering-geological mapping were performed, on the basis of which all landslide manifestations, such as starting scar, cracks, layer outcrops, hydrogeological structures etc. were recorded. After this phase, resistivity tomography measurements (geophysical method of multielectrode resistivity measurement) were taken. The mentioned methodology was applied in the interest area for the first time.

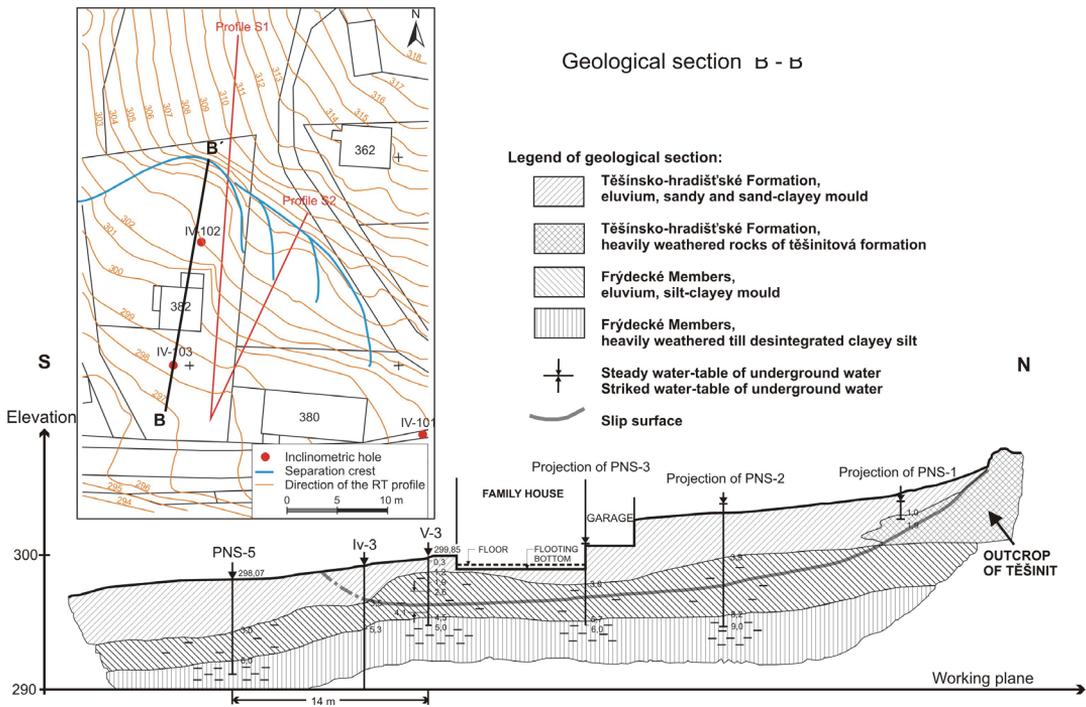
Fig. 3: Geological section and map of the interest area along with the sections placement

In the interest locality it is possible to interpret the following geological section on the basis of a *previous archive survey works* and *engineering-geological mapping* (Figure 3).

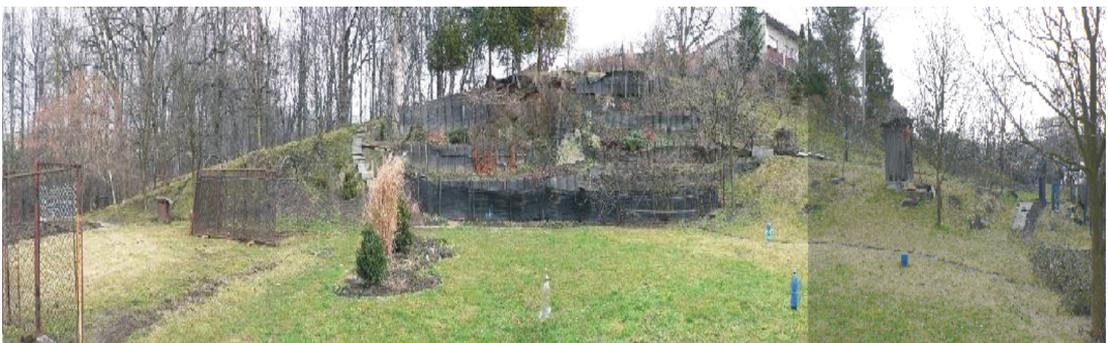
Fig. 4: Tear edge of the slide

The tear edge of the slide is pronounced, it reaches as high as 7 m (Figure 4) and spreads in the direction NW-SE.

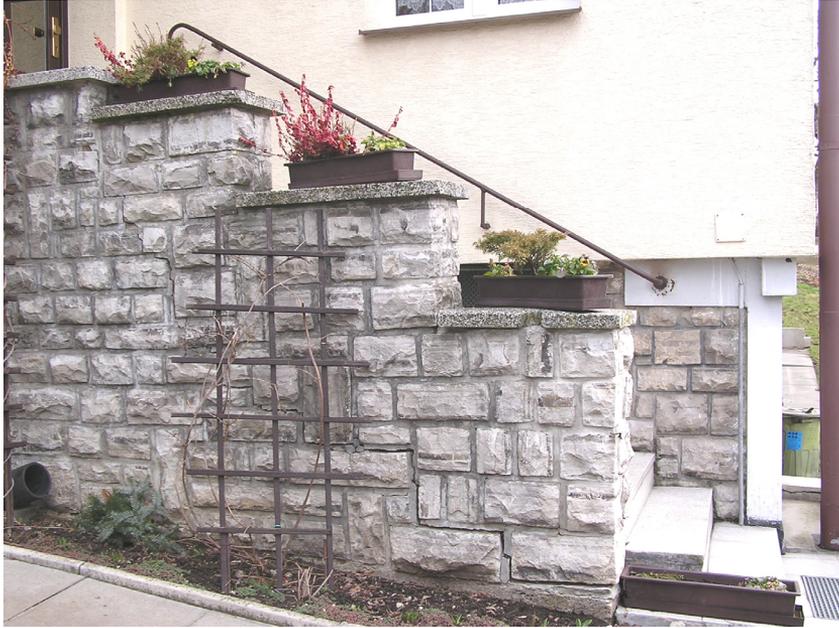
As for the circumstantial evidence of the slope deformation and its active manifestation, we identified damage to the construction of the house (Figure 5), to the workshop (Figure 6), bending of trees in its vicinity (Figure 7), sliding and displacement of the top soil near the workshop (Figure 8), bent fence in the top part of the slope deformation (Figure 9), and terrain deformation with the manifestation of floor bulging in the workshop up to 15 cm (Figure 10).

Fig. 5: Damage to the construction of the house

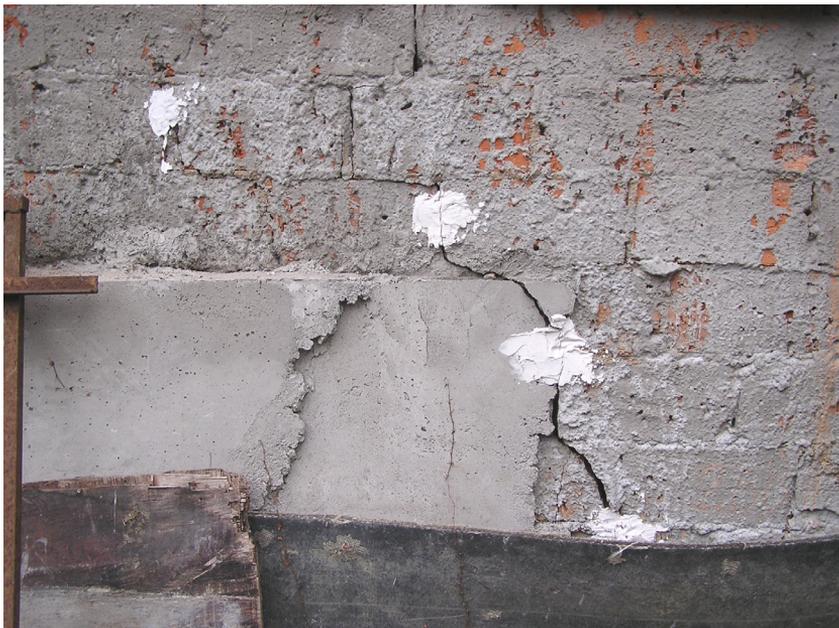
Fig. 6: Damage to the construction of the workshop

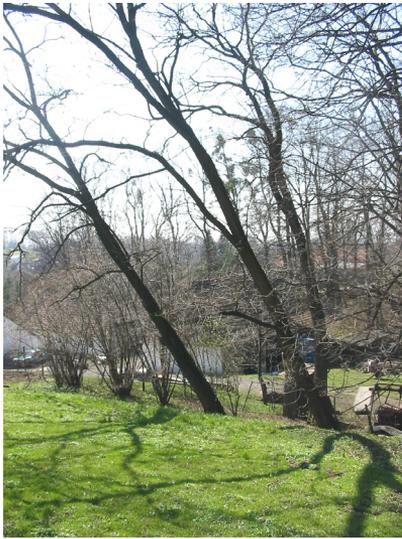
Fig. 7: Bending of trees

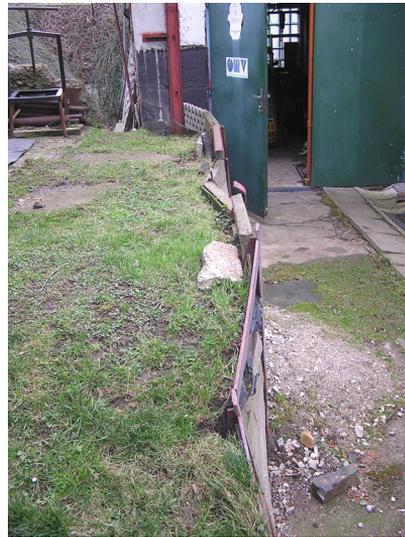
Fig. 8: Sliding and displacement of the top soil near the workshop

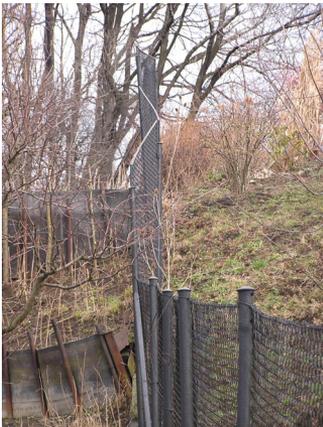
Fig. 9: Bent fence in the top part of the slope deformation (left) Figure 10 Terrain deformation with the manifestation of floor bulging in the workshop up to 15 cm (right)

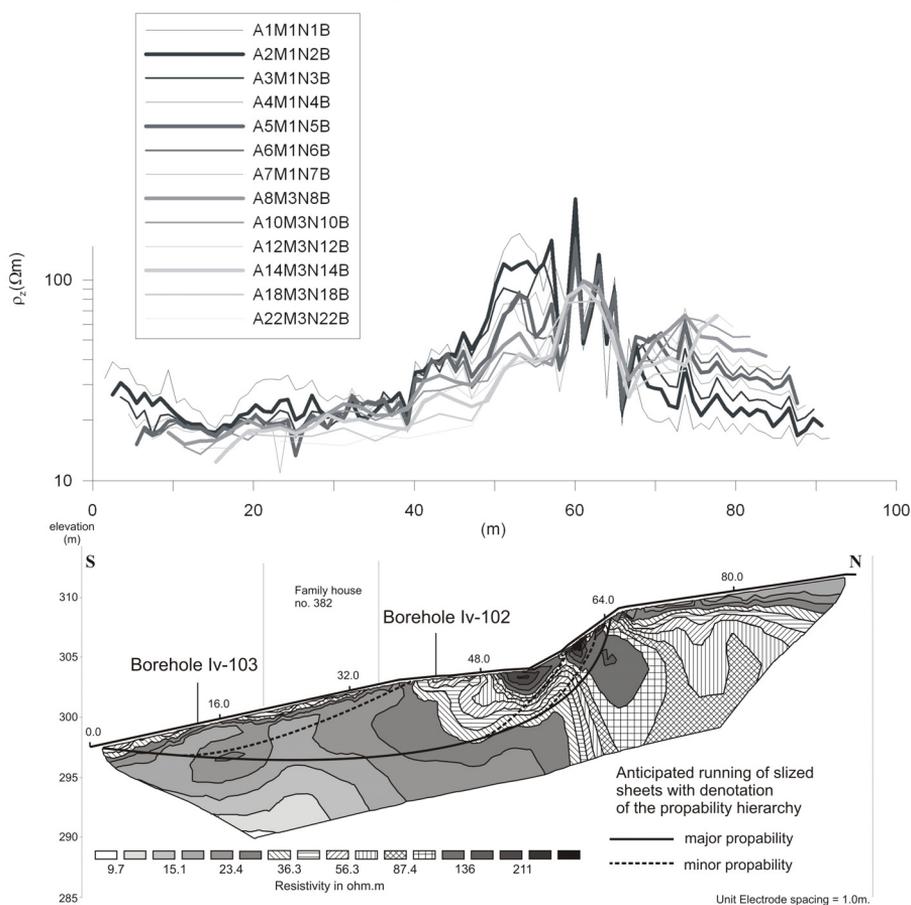
Fig. 11: Resistive model of S1 section

The interpretation of the slip surfaces of *S1 section* (Figure 11) was mainly conditioned by morphology, by means of top tear edge manifestation, and next by inclinometric measuring in the bores Iv-102 and Iv-103 (bore placement – Figure 3). According to the inclinometric measuring in the bore Iv-102 an occurrence of a slip surface was proved in the approximate depth of 6-7m under the collar of well and the slip surface depth identified in the bore Iv-103 was about 3 m p. t. (under the ground). Inclinometric measurements register both movements caused by undermining in the direction of the subsidence trough as well as movements related to a slide.

Resistively, the outcrop of teschenites is demonstrated by a considerable rise in resistance, 150 Ωm and more, and the course of the slip surface is situated between the maximum resistance values on the stationing 50 - 65 m and next, it runs in an inclinometrically identified depth in the bore Iv-102. Cracks were situated according to local resistive minimums both in the model as well as in the section curves.

As for lithology, the tear edge begins at the outcrop of teschenites on the stationing 65m and transits to silty claystone (it is identified in the place of bore Iv-102 2.5 m under its roof).

With the bore IV-103 in the slip surface depth there is a boundary between clayey-sandy loam and loamy-stony debris in the bedrock.

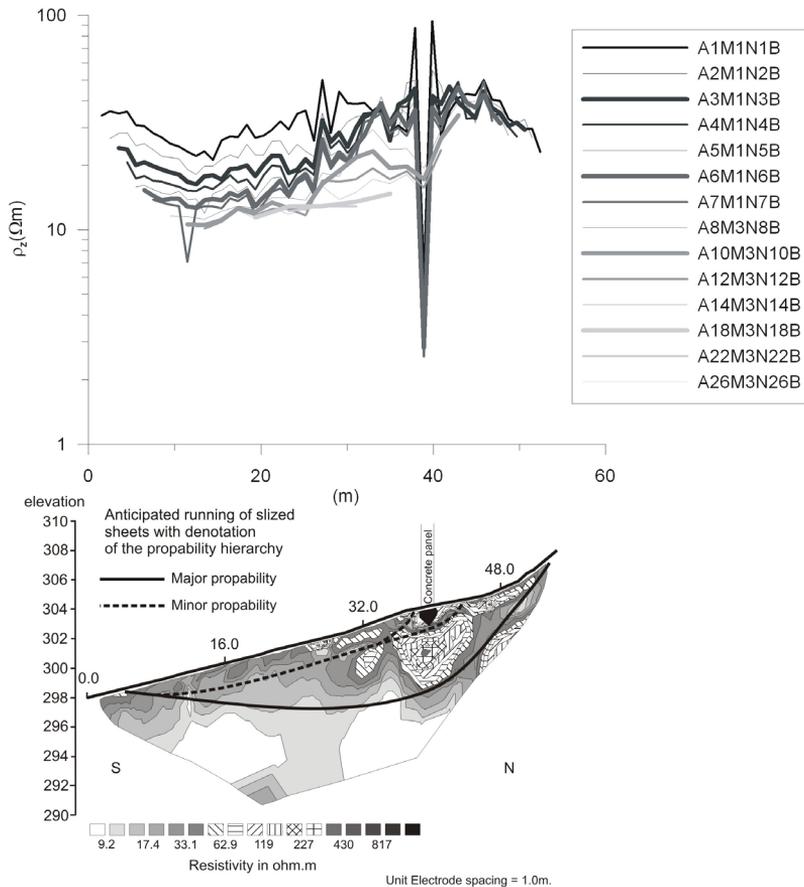
Fig. 12: Resistive model of S2 section

The determination of the course of the slip surface with *S2 section* (Figure 12) was only grounded in the areal continuity of the course of the slip surface as in the vicinity of the measured section there is no inclinometric bore. Similarly to the S1 section, this slip surface is affected by morphology and its course is situated between the local maximums of impedance. The maximum depth of the estimated slip surface 6 m p.t. is found on the stationing 37m.
