THE COLLECTION OF THE BRICKS AND THE FLOOR TILES FROM THE JAVORNÍK

The samples of the architectural details are the parts of depository in Ostrava from the year 2015. They are historical bricks and ceramic floor tiles from the buildings in the town Javorník (Czech Republic). The objects were dated and determined as a part of the buildings, which they are from. For these objects were prescribed the conditions to convenient placing.

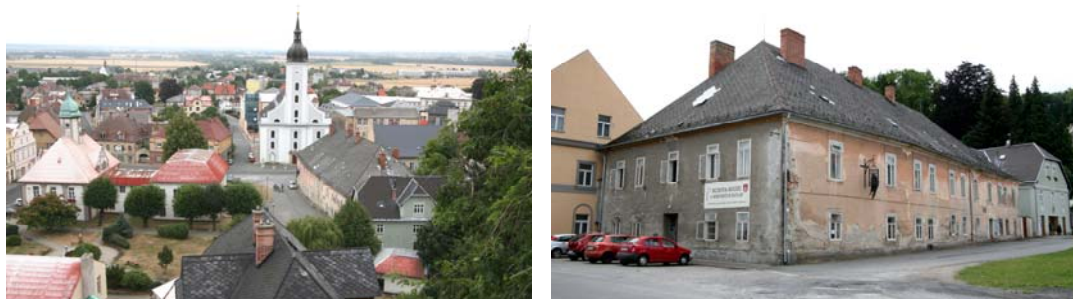
Obr. 1 a 2: Jihovýchodní fronta náměstí v Javorníku s budovou čp. 7, foto, 2015, Budova čp. 7 v Javorníku od severu, foto, 2015

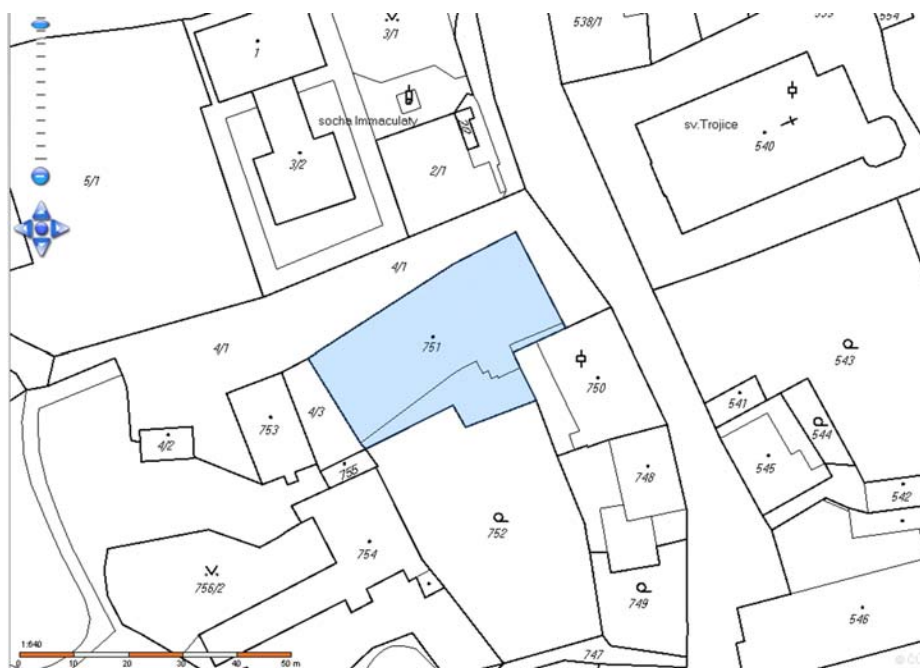
Fig. 4: House at No 7 on the cadastral map of Javorník, 2014. Taken from www.cuzk.cz

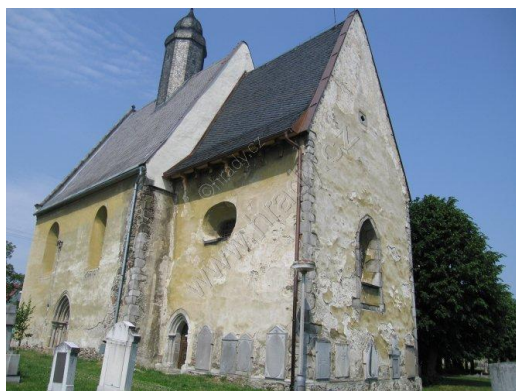
Fig. 4 and 5: St. Cross Church in Javorník-Ves, ground-plan taken from *Umělecké památky Moravy a Slezska II* (*Artistic Monuments of Moravia and Silesia II*), and photo, 2006.

The St. Cross Church probably dates back to the period around the half of the 13th century. In 1579, another St. Helena's patronium is mentioned. The building conversion of the church took place in 1582. Dendro-chronologically, the roof frame is dated to 1631. Several coats of paint of gothic and renaissance origins were preserved in the church interior. [6, 11]

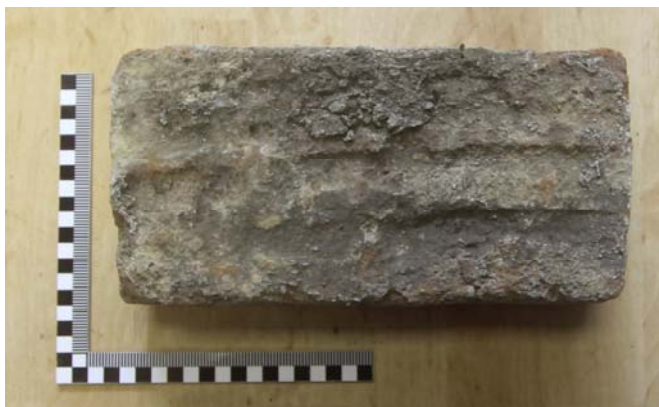
Fig. 6: The brick structured by drawing lines by fingers from the Building at No 7 in Javorník, photo, 2015 (Inv. No A220)

3.1 The brick from the attic of the former land court in Javorník (Inv. No A220)

A raw burnt brick has been found in the attic of the building of the former land court in Javorník. Its dimensions are 29 x 14.5 x 7.4 cm and, on one of the longer sides, it is structured with deep grooves formed by commonly drawing lines by fingers in the shape of a slow arch. Other similar bricks are parts of the attic floor.

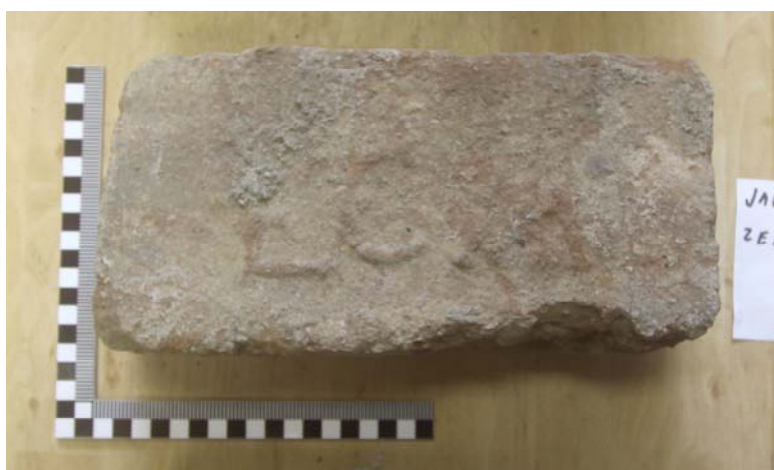
Fig. 7: The brick marked with a duty stamp from the Building at No 7 in Javorník, photo, 2015. (Inv. No A221)

3.2 The brick from the attic of the former land court in Javorník (Inv. No A221)

Apart from the bricks structured by drawing lines by fingers in the attic of the building of the former land court, also standalone bricks marked with duty stamps were found in the floor. A raw burnt brick with dimensions 28.5 x 14 x 8.5 cm was included in FAST's (*Faculty of Civil Engineering*) collections under Inv. No A221. On its longer side, the brick is marked with an embossed duty stamp comprised of three letters. The relief is considerably outworn and the letters are not clearly legible. They may be letters E C (G? D?) and W (M?).

The dating of the stamped bricks from the Building at No 7 in Javorník is much more problematic, because the letters are not clearly legible. Letter E may mean bishop's goods. The last letter W? could probably refer to Vidnava, where the brickworks is documented by written sources.

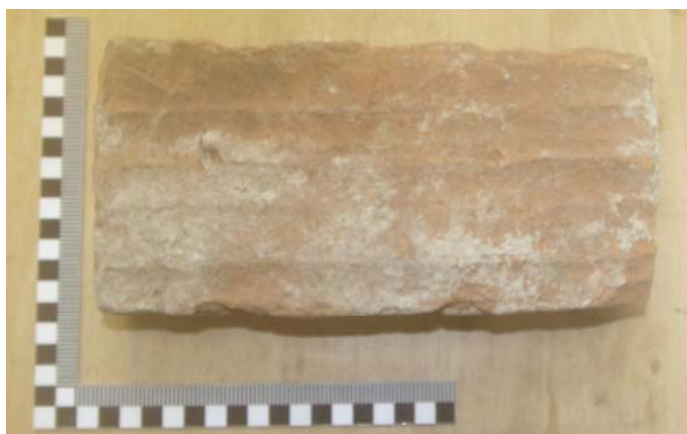
Fig. 10: The brick structured by drawing lines by fingers from the cemetery church in Javorník, photo, 2015 (Inv. No. A224)

3.4 The brick from St. Cross Church in Javorník (Inv. No A224)

The raw burnt brick with dimensions 24.2 x 11.8 x 6 cm comes from St. Cross Church in Javorník. On one of its longer sides it is structured by low-relief grooves which were crated by drawing lines by fingers led with a slight irregularity.

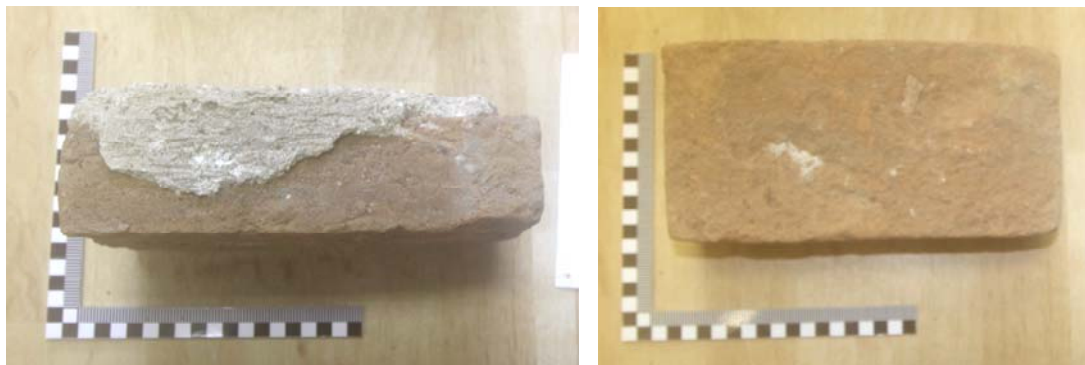
Fig. 10: The brick structured by drawing lines by fingers from the cemetery church in Javorník, photo, 2015 (Inv. No. A224)

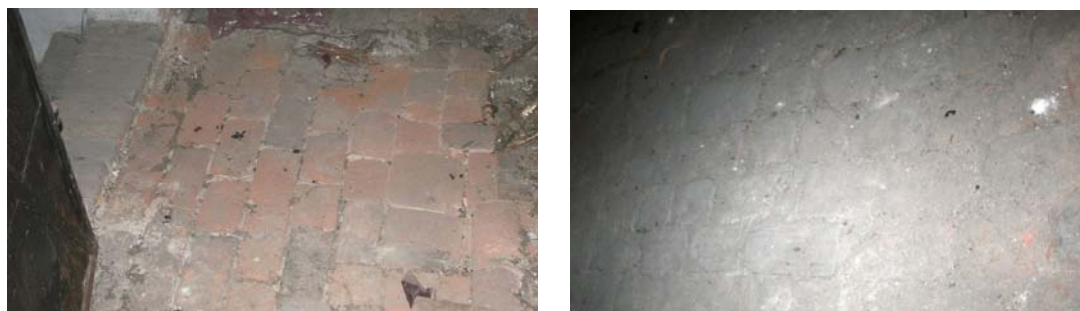
Fig. 13 and 14: The tile paving in the attic of the Building at No 7 in Javorník comprised of bricks and ceramic squares, photo, 2015. The brick paving in the attic; some of the bricks are structured by drawing lines by fingers, photo, 2015.
