ORIENTATION OF BLIND AND VISUALLY IMPAIRED PEOPLE - CASE STUDY

3. Solutions to accessibility and orientation of the blind and visually impaired people – Ostrava-Svinov transfer junction

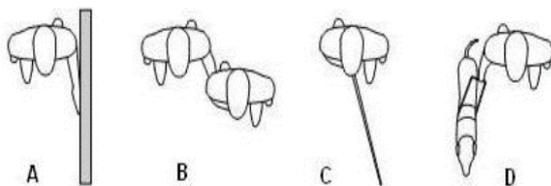
Postures are divided into low and high holding. Low holding is used for securing before obstacles found at the height of waist. High holding is used for protection of the face and head [5]. Walking with a seeing guide (Fig. 1) consists in a continuous verbal contact (giving information o the surroundings) and giving the blind one's arm who holds the seeing person in the position under the elbow or forearm. The guide does not draw the blind, (s)he walks half a step before the blind, always on the less safe side [2]. When moving in buildings or rooms that are familiar to the visually impaired, they use trailing (Fig. 1). The blind gets about in a parallel way with the wall, holding his/her hand waist-high slightly forward and his/her slightly bent fingers are sliding across the wall. Walking with a guide dog (Fig. 1), in terms of ensuring the safety of mobility for the visually impaired, it is comparable to walking with a seeing guide. The so-called guide dogs are trained specially for this purpose; they cope with noise, traffic, escalators, indication of a dangerous obstacle in the way (possibly getting out of the way) and safe delivery of its master to the place needed [2].

Fig. 1: Basic mobility techniques used by the blind: A – trailing, B – walking with a seeing guide, C – walking with a white cane, D – walking with a guiding dog.

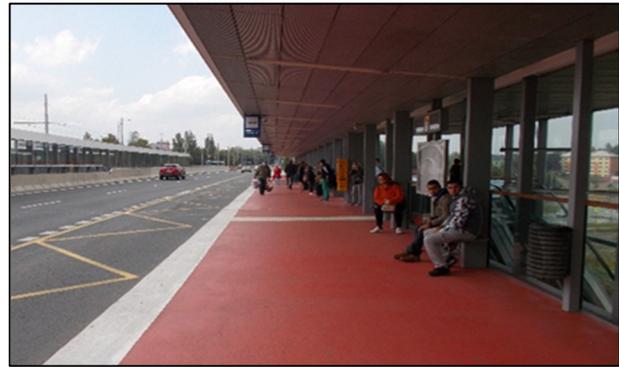
Boarding points of tram and bus stops are designed in an identical way. The surface of boarding points is elevated above the carriage way (rails) by 200 mm. The surface is made of concrete, the walking area of which is painted red. The boarding edge is distinguished in a contrastive way with 400 mm wide white paint. Individual boarding points are provided with adhesive tactile signal strips in white colour. The natural guiding line here is made up of the glazed facade in the structure of which there are columns carrying the roof. These columns are protruding in the space (200-400 mm) and there are provided with seats and waste bins making problems to the blind during their movement as they are not always able to identify these elements and collision with them or with sitting people may happen (Fig. 3).

Fig. 3: Design of the boarding point surface.

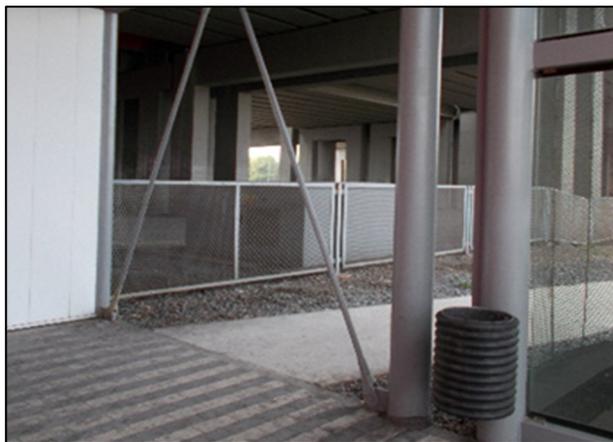
The central part of the communication area between individual boarding points is provided with a 300 mm wide artificial guiding leading through the centre of the communication with branching to individual staircases. However, this design does not provide the blind people with sufficient tactile contrast and it becomes unreadable for them. Utilization of the natural guiding line in the form of walls of the passage is unsatisfactory in this place due to access to individual boarding points. The route of the blind would cross these directions and a collision with another passenger could happen. Another questionable element of the new areas of the transfer junction is the actual aesthetic interpretation composed of glass, concrete, and metallic (predominantly columnal) structures. The aesthetic appearance of the entire area is perfectly unified (the combination of white, red, black, and grey colours is repeated in it) which may cause considerable difficulties to the visually impaired people in recognition of individual areas and their functions, not speaking of glass areas where there are contrast marking in their central part (represented here by handrail). Two lifts found behind the staircases and escalators are accessible from the ground. They are accessible using a natural guiding line formed by the red facade. The lifts are in compliance with applicable regulations in terms of space and equipment (the controls are at a height of 1000-1200 mm, they are provided with Braille fonts, they contain a tilting seat, etc.). In vicinity of the lift there are draw-bars on the structure interfering with the communication area and the blind and visually impaired people have no chance to register them with the mobility techniques they use. Thus this structure becomes very dangerous (Fig. 4).

Fig. 4: Draw-bars in the communication area.

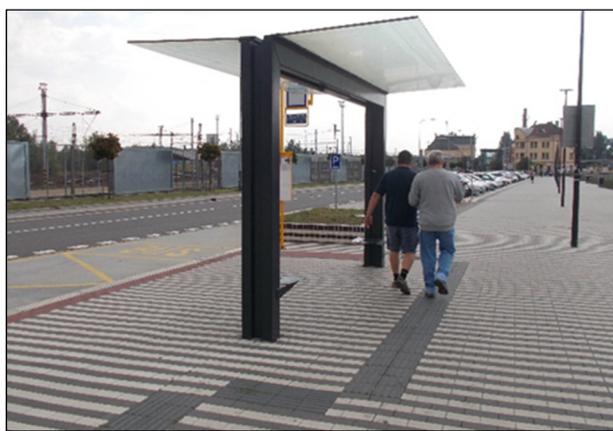
The entire area of the Svinov Bridges low stop is found on the ground level. Analogous to the other areas, it is made up of a uniform surface made of smooth concrete pavement in grey-white colour combination. Tactile warning elements (signal and warning strips) are made of red pavement and so they create a sufficient contrast both for the visually impaired and the blind. The artificial guiding lines here are constructed in two ways – the elevated kerb and the pavement in black colour with tactile 400 mm wide grooves which is primarily found in the area of the stops and on the footpath towards the railway station. The wrong placement of the bus stop roof is questionable as it affects unsuitably and unnecessarily the smoothness of the artificial guiding line and makes the mobility of the blind people difficult (Fig. 5).

Fig. 5: Unsuitable location of the stop roof.

to keep the original premises of this building. A great nuisance is the incomplete implementation itself and misunderstanding of structuring and continuity of individual elements of the barrier-free route that create obstacles paradoxically and complicate the smooth motion of the visually impaired people (refer to unsuitable placement of the stop roof or artificial guiding lines).
