NUMERICAL ANALYSIS OF JABLUNKOV TUNNEL COLLAPSE

Abstract

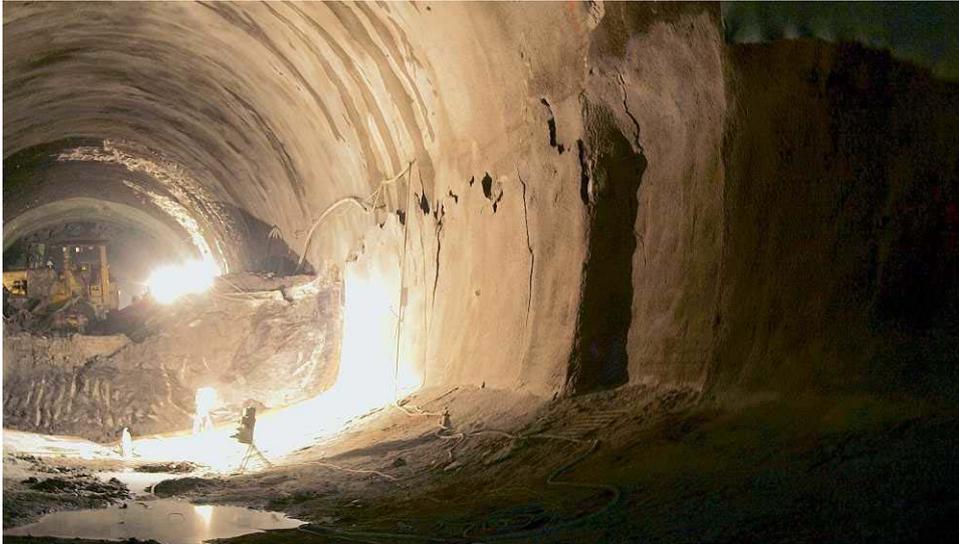
The collapse itself occurred by obvious exceeding of the bearing capacity of lining of shotcrete in the left part of the support whereas the image of the failure was, according to the photograph taken several minutes before the collapse (photo 1), the same as at the end of the collapse on a Jablunkov side, i.e. it indicated obvious exceeding of the bearing capacity of lining by the formation of a shear crack owing to a high vertical load.

Photo 1: Photo from the point of origin of the collapse - shear failure in the right side of the lining

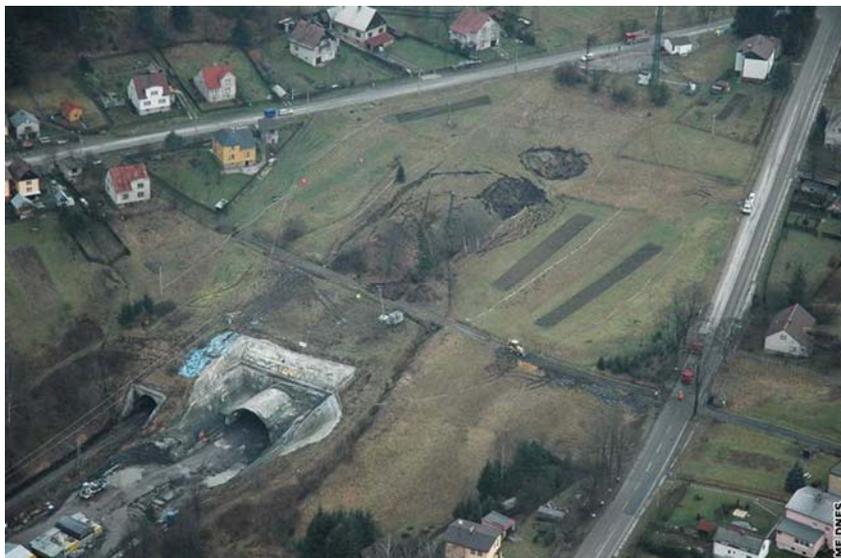
Photo 2: Photo from the point of the origin collapse - formation of the surface crater (author MF Dnes)
