Vladislav KŘIVDA¹**ANALYSIS OF CONFLICT SITUATIONS ON ROUNDABOUTS
IN VALAŠSKÉ MEZIŘÍČÍ****ANALÝZA KONFLIKTNÍCH SITUACÍ NA OKRUŽNÍCH KŘÍŽOVATKÁCH
VE VALAŠSKÉM MEZIŘÍČÍ****Abstract**

The article describes briefly the methodology of video analysis of conflict situations and presents the results of the video analysis performed on roundabouts in Valašské Meziříčí. This paper was prepared with financial support for research and development project No. CG911-008-910 "The influence of construction components on the safety and continuity of transport in roundabouts and possible prediction of traffic accident occurrences"

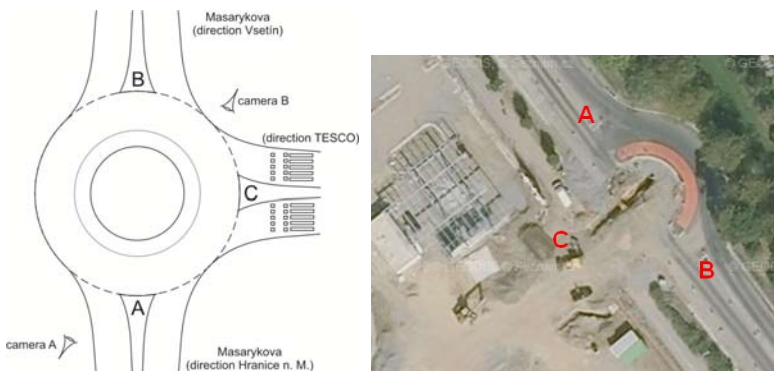
Fig. 3. Roundabout at the Masarykova street, next to TESCO hypermarket

The most frequent conflict situation in that roundabout was 2j_o1 when a vehicle moving from the B leg straight on into the A leg was close to the kerb in the A exit on the right-hand guide line. The kerb was damaged there probably by vehicles which failed to keep the track in the circulation belt and move out of the road. This situation occurred 23 times during an hour (1.78 KS per 100 vehicles). In 14 cases (61 %), the vehicles were trailer trains, in 2 cases (9%) - semi-trailer trains, in 6 cases (26%) - trucks and in one case (4%) - a bus.

Another frequently-occurring conflict situation was (6)_{f_k}2 when a queue of vehicles in the next roundabout (in a distance of 145 m) stopped the traffic at the B exit (5 times per hour; 0.39 KS per 100 vehicles). The C entrance, C exit and A entrance were restricted as well (5, 2, 2, respectively). The queue caused the vehicle to delay for 32 seconds approximately (minimum: 15 s, maximum: 40 s). Such a situation occurred only five times during one hour. But in higher traffic intensity (such as on Friday afternoon when more people leave the town for weekend or go shopping to the TESCO hypermarket), such situations would be, in all probability, more frequent and more subsequent situations would have to be dealt with.

The reason for such conflict situation seems to be a relatively high speed of the vehicles who enter Valašské Meziříčí and see quiet a wide road in front of them (and this induces over-speeding). It is believed that the exit has been designed correctly (the capacity for the vehicles above can be verified simply by drag curves). This means, the drivers appeared to fail to drive the roundabout correctly. In order not to damage the kerb and in order to prevent road accidents, a solution would be to build a reinforced crescent-shape roadside at the A exit. Big vehicles could drive then safely on the roadside.

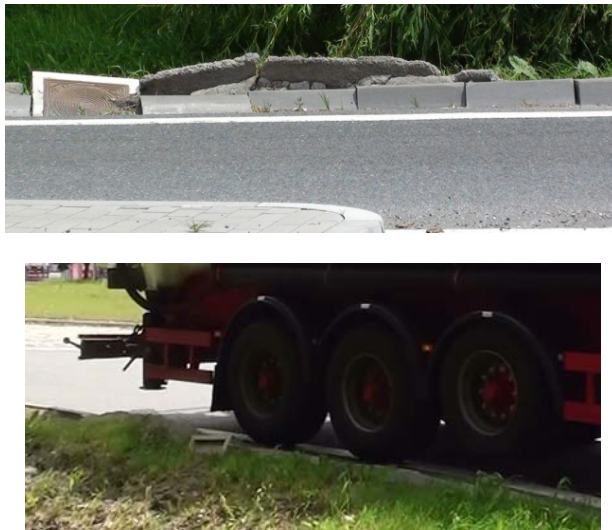
Fig. 4 Details of the damaged kerb at the A exit and a trailer train driving too close to the kerb
