**Antonín LOKAJ<sup>1</sup>, Kristýna KLAJMONOVÁ<sup>2</sup>****CARRYING CAPACITY OF ROUND TIMBER BOLTED JOINTS  
WITH STEEL PLATES UNDER STATIC LOADING****ÚNOSNOST SVORNÍKOVÝCH SPOJŮ KULATINY S VLOŽENÝMI OCELOVÝMI  
PLECHY PŘI JEDNORÁZOVÉM STATICKÉM NAMÁHÁNÍ****Abstract**

Aim of this article is in presentation of results of static tests of round timber bolted connections with steel plates. Round timber connections tests in tension were made on pressure machine EU100 in laboratory of the Faculty of Civil Engineering VSB-TU Ostrava. Results of laboratory tests have been statistically evaluated and completed by graphical records of deformation response on loading.

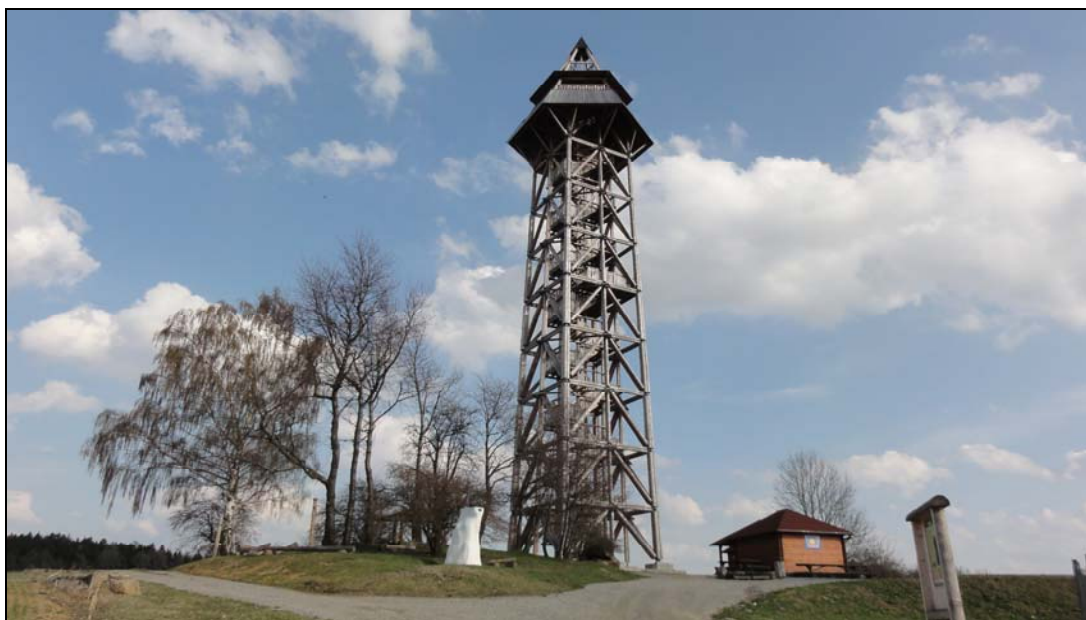
Fig. 1: Watchtower near Lázně Bohdaneč made of round timber

Timber constructions made of round timber become increasingly popular nowadays. It concerns footbridges, bridges, watchtowers ( the tallest round timber watchtower in central Europe was built at Lázně Bohdaneč in 2011, tower height is almost 53 m – Fig. 1 and [2]) or playground equipment. If these constructions are designed with truss supporting system, element connections are often made of bolts with embedded steel plates.

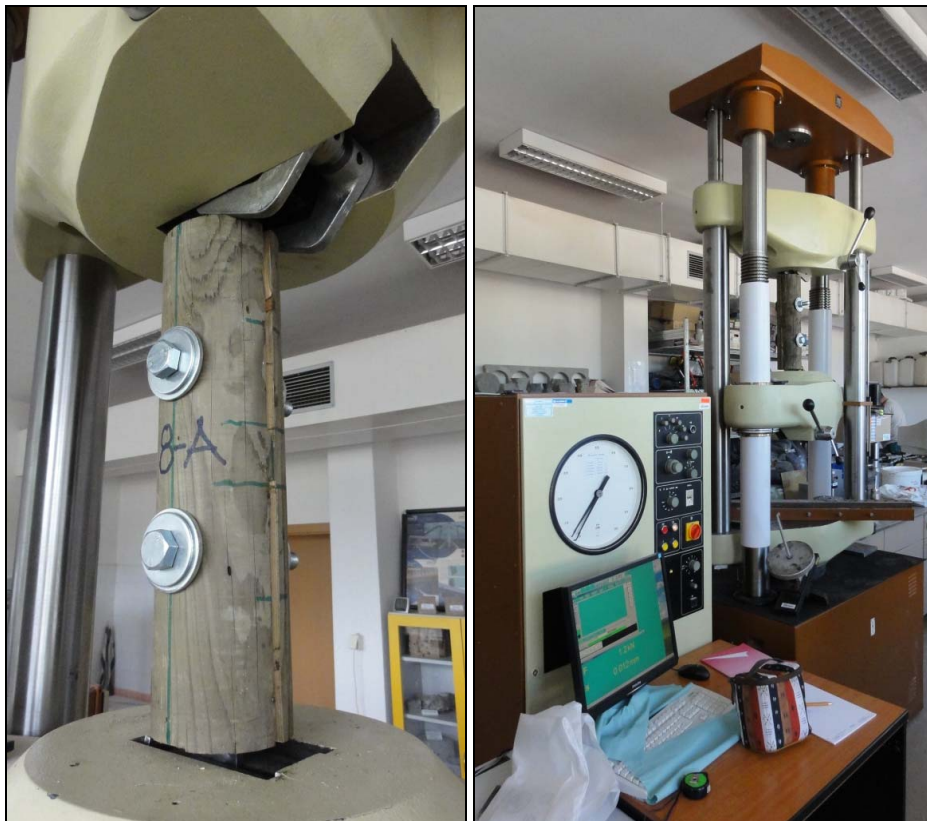
Fig. 2-A/B: Tested sample in the press (A - left), the press EU 100 with sample (B - right)

It was necessary to adapt dimensions of the test samples by possibilities of machinery in laboratory of the Faculty of Civil Engineering at VŠB - Technical University of Ostrava. Spruce round timber with diameter 120 mm and sample length 450 mm was used. We used the bolts that were made from HS (High Strength) steel category 8.8 ( $f_y = 640 \text{ MPa}$ ,  $f_u = 800 \text{ MPa}$ ) with diameter 20 mm. Joint plates were from steel category S235 with thickness 8 mm and width 70 mm, holes for bolts had diameter 22 mm. Holes for bolts with diameter 20 mm were made in the round timber. Nine test samples were produced reasonably (Figure 2-A). Tensile tests were conducted on the press EU100 with a recording system (Figure 2-B).

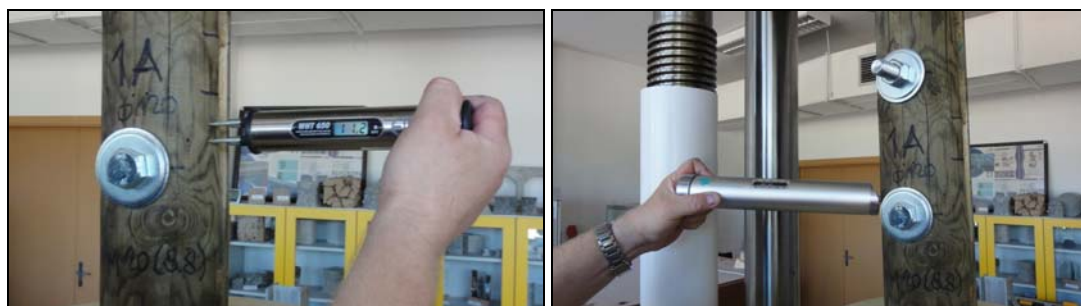
Fig. 3-A/B: Humidity measuring of sample (A – left), testing with PILODYN 6J (B –right)

A few nondestructive tests were carried out before start of tests in the press. Aim was to determine the quality of the round timber material, particularly its moisture and density. Test samples were weighed on a laboratory scale, their moisture and dimensions were measured (Figure 3-A). Apparent density and mass density was determined from measured values. The average moisture

was 11,3%. Average value of apparent density reached  $542 \text{ kg/m}^3$ . Average thickness of annual rings was 12,4 mm, it confirms the relatively high measured density values and the quality of the tested round timber. Average penetration depth measured with penetration device PILODYN 6J was 10,9 mm, this corresponds to mass density of round timber  $430 \text{ kg/m}^3$  (according to the relations in [5]).

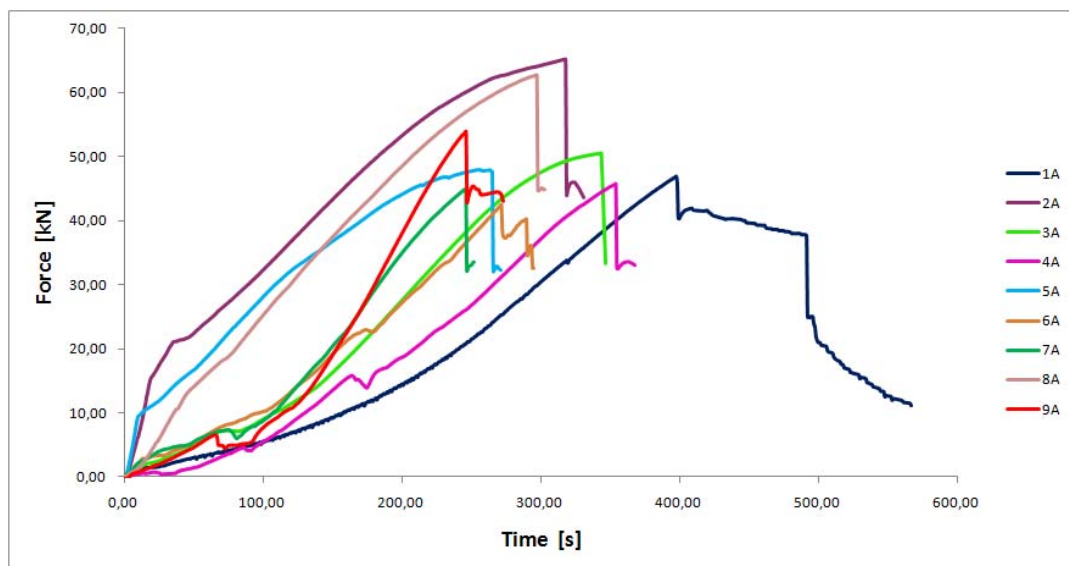
Fig. 4: Tension force increase in the joint during time

Testing was proceeded in the press EU100, while tension force was increasing gradually. The choosen rate of displacement of jaws of the press seems to be optimal, because destruction of all tested samples appeared in time-boundary  $300 \pm 120 \text{ sec}$ , which corresponds to interval of laboratory tests for short-time strength according current European standards for timber structures.

Diagram of increasing of tension force during time is in Fig. 4. Fig. 5. shows relation between displacement (eg. elongation) of the joint and tension force working in the joint.

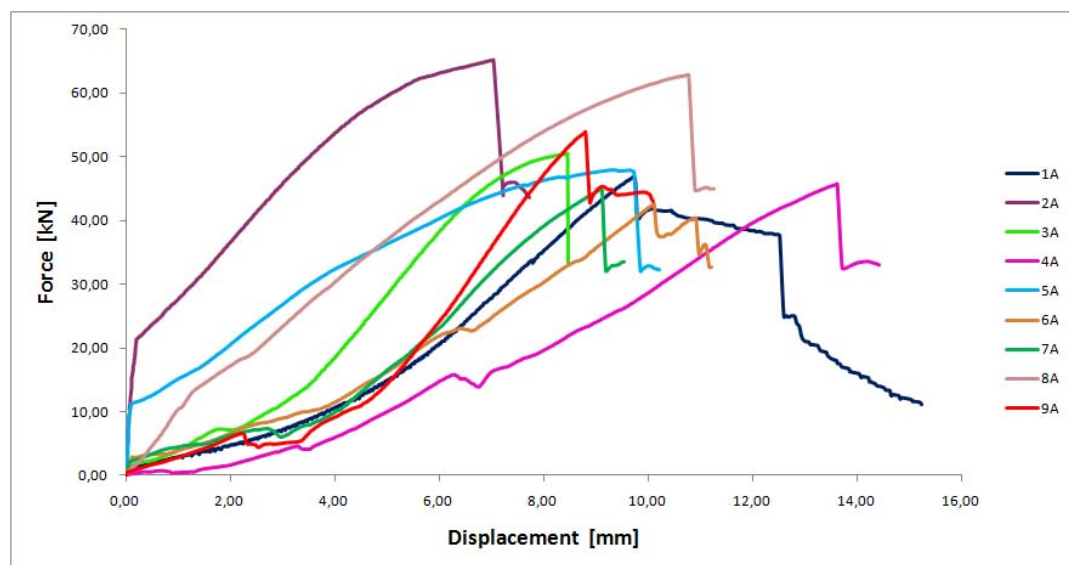
Fig. 5: Relation between tension force in the joint and displacement of the the joint

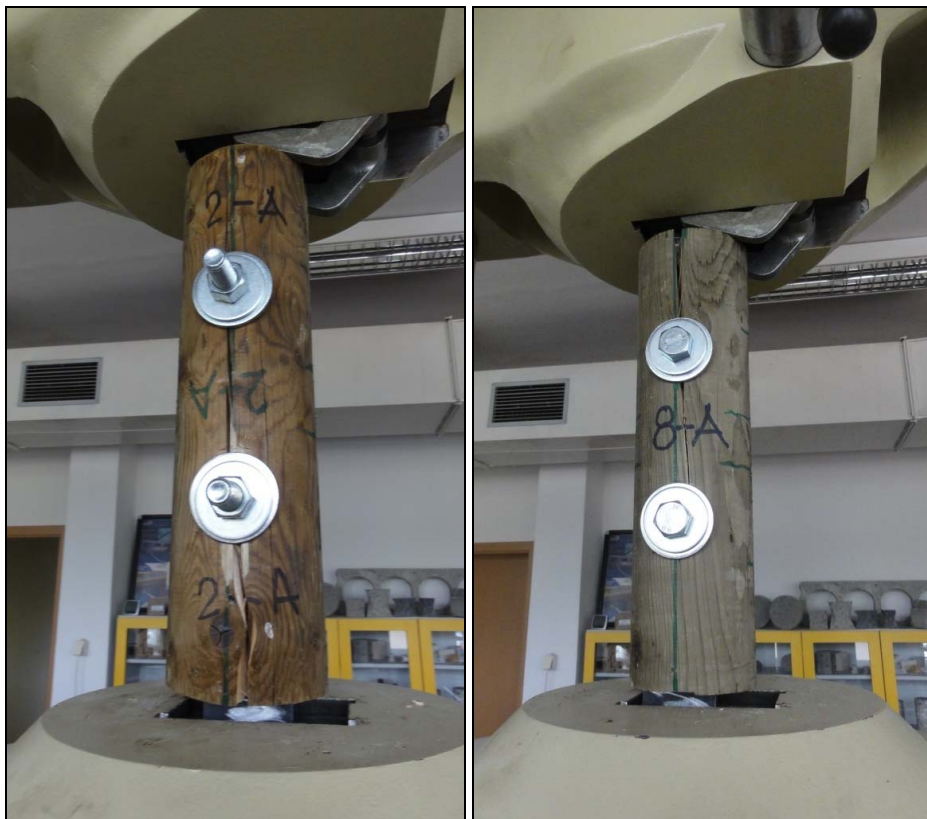
Fig. 6: Collapse of testing samples in the press EU100

The weakest part of the joint should be steel bolt, according to relations for double shear joints steel to timber type with steel plate inside, even if this bolt is designed from high strength steel. Destruction of the joint should have been caused by achievement of plastic carrying capacity of bolt in bending and by setting of plastic hinge. Deceleration of increase of the force during testing time can be observed on Fig. 4 and a similar clearly deceleration of increase of force in relation to increase of displacement can be observed on Fig. 5. It indicates plastic reshaping of the bolt. All testing samples collapsed by disruption of the sample (Fig. 6). Disruption of the sample was caused by exceeding of timber strength in tension perpendicular to the grains, but a block shear collapse was not observed. Fracture of the bolt was not observed in any test.
