Miroslav PINKA¹, Martin STOLÁRIK²**SEISMIC RESPONSE HYDRAULIC HAMMER
ON THE SECONDARY LINING TUNNEL****SEIZMICKÁ ODEZVA HYDRAULICKÉHO BOURACÍHO KLADIVA
NA DEFINITIVNÍ OSTĚNÍ TUNELU****Abstract**

Hydraulic Hammers, seismic measurement, secondary lining.

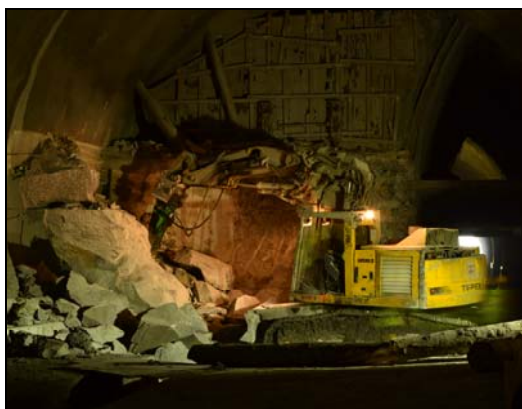
The measurement was carried out when removing the concrete plug. To remove the concrete, the TEREX TC 240 heavy caterpillar shovel excavator equipped with the TEREX THX4400S hydraulic demolition hammer was used (Fig. 1).

Fig. 1: Heavy crawler excavator TEREX TC 240

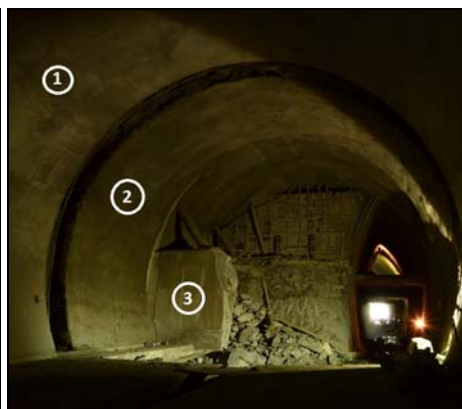
Fig. 2: Situation measurement

The measurement took its course during the removal of the concrete plug (in Fig. 2, numbered 3). The objective was to find out the influence on the final lining of poured concrete (numbered 1) between the place of work executed and the final lining there was a 13 m long portion of primary lining of shotcrete (numbered 2). The distance between the primary lining and the place of work was

3 m. The minimum distance beyond which the demolition hammer can get during its operation to the final lining is 16 m. Therefore, the first sensor was put at a distance of 16.5 m, while the others were put at distances of 21 and 27 m respectively.
