**Martin MAGURA<sup>1</sup>****ANALYSIS OF THE EXHAUST TRACT OF THE TURBOCOMPRESSOR  
LOADED BY HIGH TEMPERATURE****Abstract**

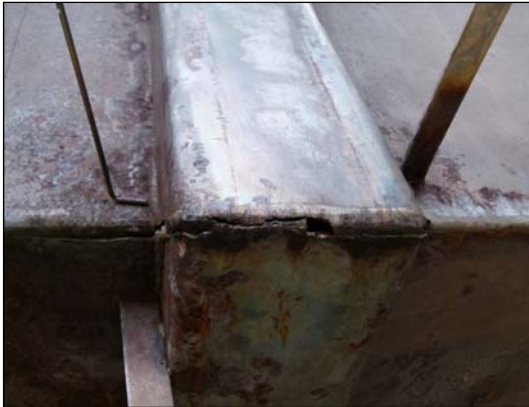
Fig. 3: Cracks in stiffeners at the corner

Cracks are concentrated in the corners and in the junctions of stiffeners with silencers and elbow. In Figure 3 we can see the crack in the corner stiffeners, and in Figure 4, in the junction of stiffeners. Most of dashed welds are cracked too.

- Welding, all welds connecting stiffeners to the walls from dashed to continuous with a minimum height of 3 mm.
- Strengthening the stiffeners in the corners by welding reinforcing plate with thickness 10 mm. The weld must be designed as blunt. Weld reinforcing plate will be using fillet welds height 4 mm. (Fig. 8)

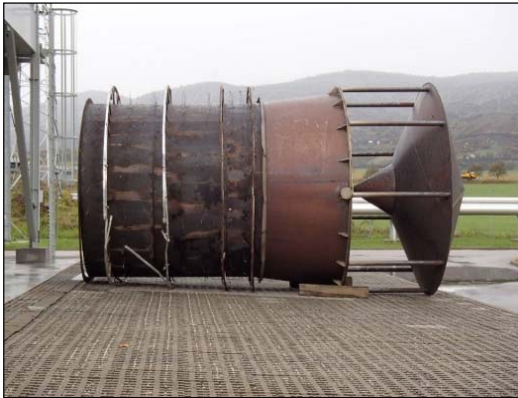
Fig. 11: Segment of the vertical chimney

This chapter analyses the last part of the exhaust tract, the circular chimney located above the elbow (Fig. 11). The height of the chimney is about 16.9 m, with the chimney consisting of three segments with a diameter of 3200 mm, the wall thickness being 4 mm. At the joint of segments there is a mounting flange plate with the thickness of 16 mm and the width of 100 mm. The flanges are connected with 36 screws M20 to move away from each other 10 °. The middle segment is in the middle intermediate horizontal reinforcement with the same size as the mounting flange. Last upper segment cone extends and is finished with a roof with baffles of flowing gas.

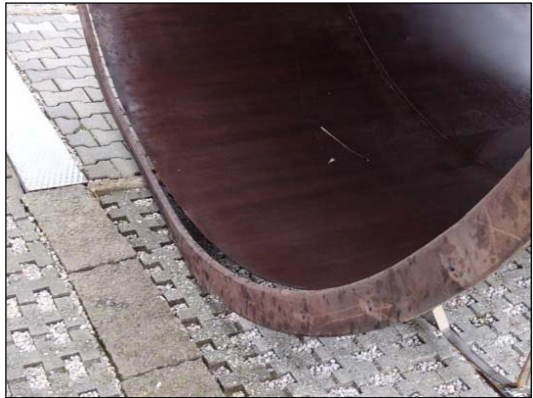
Fig. 12: Detached mount flange

Disorders occur especially in the lower mounting flanges of all segments (fig. 12) and place of the intermediate stiffeners.

Cracks arose during last three years (since the last diagnostic examinations) with the increased frequency of starts. These start-ups heat the constructions unevenly, causing uneven thermal expansion. This phenomenon gives rise to significant voltage spikes and low-cycle fatigue.

Detached mounting flanges were welded the original location using butt, respectively fillet welds. It was necessary to shape them to their original circular shape so to allow the segments to re-connect with each other. After the flange was welded to the pipe, the pads from sheet of thickness 4 mm and size 150/400 were welded to. Pads have shift away from each other and 10° total there were all around 36 pc. After that to the flange and pad was welded reinforcement from sheet thickness of 12 mm and size of 96/350 mm.
