**Dimitra ACHILLOPOULOU<sup>1</sup>, Theodoros PARDALAKIS<sup>2</sup>, Athanasios KARABINIS<sup>3</sup>****INTERFACE CAPACITY OF REPAIRED CONCRETE COLUMNS  
STRENGTHENED WITH RC JACKETS****Abstract**

Concrete jacket, construction damage, repair and strengthening, dowels, welded bend down bars.

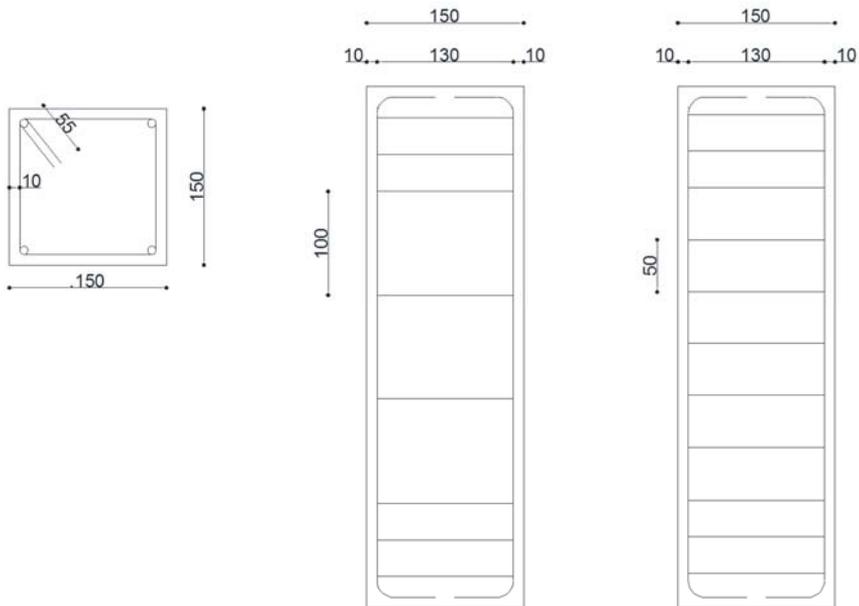
Fig. 1: Cores' reinforcement details (mm)

The material used were concrete of approximately 24 MPa nominal strength measured cylinder specimens at 28 days, 566 MPa yield stress for longitudinal reinforcement and 250.76 MPa for stirrups. Specimens were symmetrically reinforced with two bars of 8 mm diameter at each face (Fig. 1). Transverse reinforcement consisted of 5.5 mm diameter spaced at 100 mm or 50 mm. All steel bars were adequately anchored.

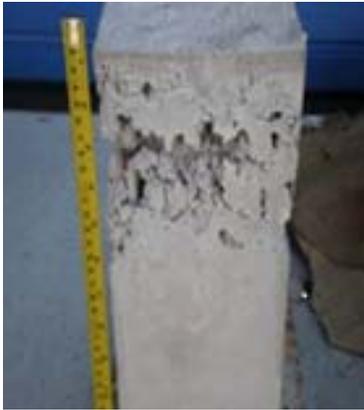
Fig. 2: Construction Damages\_  $D_m R_c$ -5

During casting consolidation of concrete was incomplete in order to create initial construction damages in 9 columns (Fig. 2). Casting was not performed according to the provisions set by EN 206-1 [22] and ACI 309R-06 [23] as in real construction sites where it is common to ignore the standards set. According to international standards of concrete consolidation through internal vibration for application of plastic concrete in thin members and confined areas the use of a 20-40 mm head diameter vibrator is suggested. In this way, the radius of action is 80-150 mm. What is more, the rate of concrete placement is assumed to be within 920-4600 mm in the current study, a 20 mm head diameter vibrator was used and concrete was being placed in higher frequency than predicted. Five specimens were constructed healthy and considered as reference models. Damaged specimens were repaired using high strength thixotropic concrete and were subjected to axial compression repeatedly with cycles of 1‰ axial strain up to 10‰. This pre-loading procedure created cracks as found in real structure members before retrofitting. The axial deformation was measured from the relative displacements between two loading platens with the use of Displacement Transducers (D.T.). The axial load is applied in a compression machine with a capacity of 3000 kN maximum load (Fig. 3).

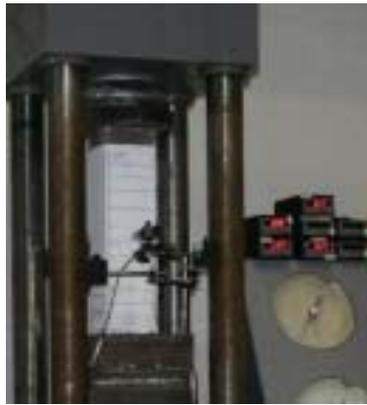
Fig. 3: Experimental Setup

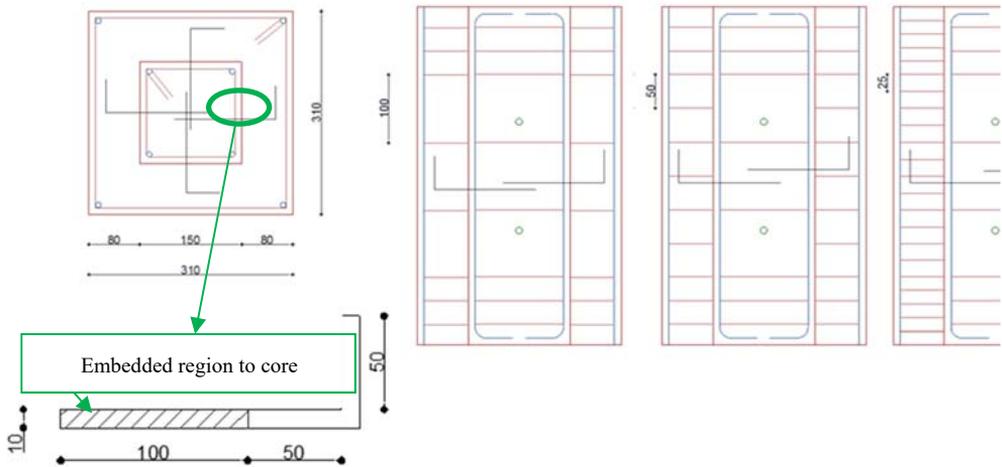
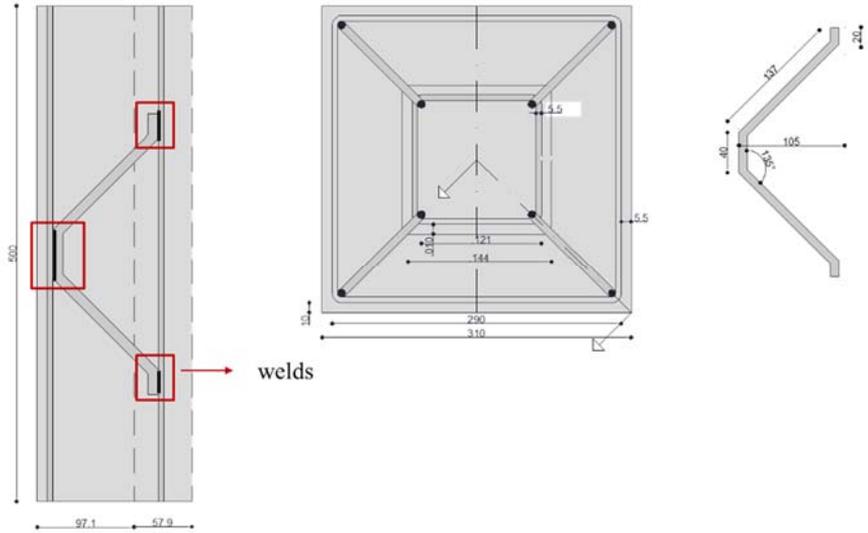
Fig. 4a: Jacketed specimens containing dowels (mm)

Fig. 4b: Jacketed specimens containing welded-bend down bars (mm)

Fig. 4: Reinforcement details of jacketed specimens

Jackets of 80 mm (3.15 in) were placed at all four faces made of 31MPa nominal stress. Again the cross section was symmetrically reinforced with two 8 mm longitudinal bars and stirrups

spaced at 100 mm and 25 mm (Fig. 4). All steel bars were of the same quality class with the steel of the cores. The size of jacket was decided in order to create enough anchorage length for the steel connectors placed.

Steel connectors of different kind were selected in order to investigate their efficiency in transferring loads. Eight specimens were selected for retrofitting. In two repaired and retrofitted ones six dowels of 10 mm (0.394 in) were placed, symmetrically at the two opposite faces (Fig. 4a). Three healthy identical ones also contained dowels. In three healthy specimens, before the jacket was casted the longitudinal bars were welded together with bend down bars of 8 mm diameter (Fig. 4b). Steel connectors were designed according to the minimum percentages indicated by EN-1998/3 [17], [18] ( $\rho_{\delta_{min}} \geq 1.2 \%$ ). ACI-318R-08 [19] provides only the shear resistance of the interface but not the minimum percentage of steel crossing it [ $V_n = A_{vf} f_y (\mu \sin \alpha + \cos \alpha)$ ]. An epoxy resin (EN 1504 [24] [(Bond strength 14 days: 15.1 MPa (2200 psi), compressive strength 28 days, 23°C: 84.1 MPa, Shear strength ASTM D732 24.8 MPa)] was applied as a bonding agent at the interface of old and new concrete since no other preparation was adopted. In fact, in previous study [21], epoxy resin was proven to act effectively and favourably to the transferring load capacity (Table 1–Specimens’ characteristics Table 1).

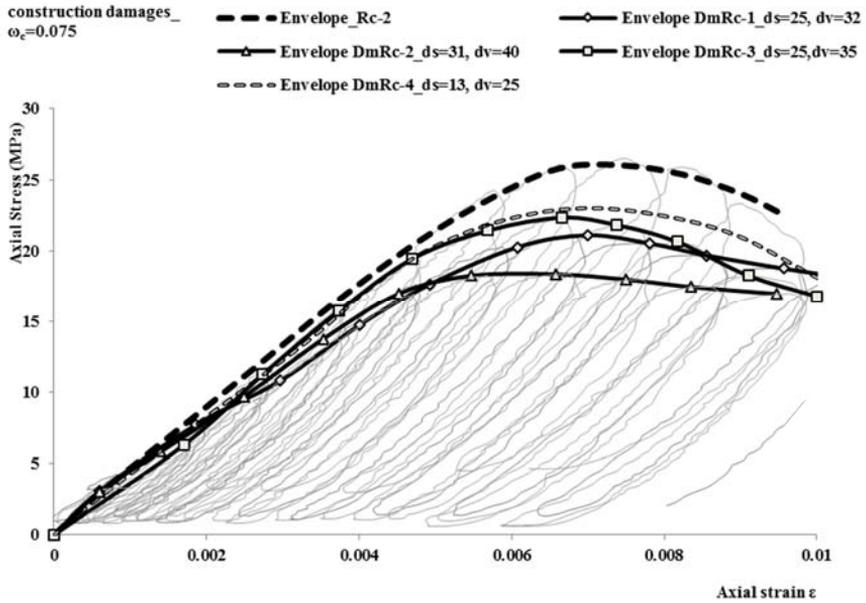
Fig. 5: Construction damage effect on repaired columns with low ductility requirements

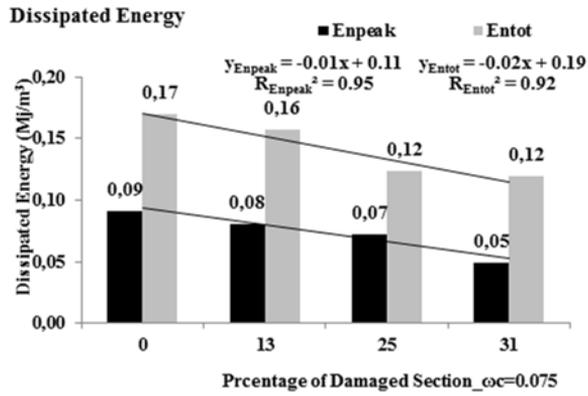
Fig. 6: Dissipated energy of low ductility columns: peak stress-totally

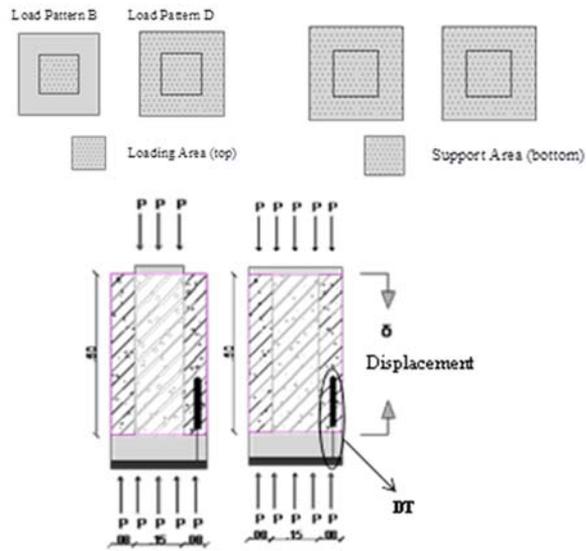
Fig. 7: Load Patterns' Shape

Two different Load Patterns were selected (Fig. 7):

- Load Pattern B (B): Direct loading of core with the entire retrofitted element supported. That case simulates the function of a retrofitted column of a real structure where the growth of the axial load happens through the old column (core).

- Load Pattern D (D): Direct loading of both core and jacket in order to investigate the mechanical behavior of the jacketed column considered as monolithic.

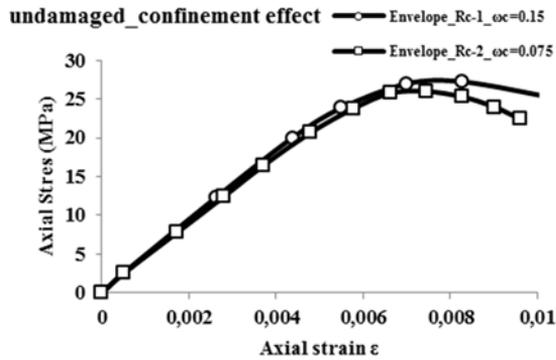
Fig. 8: Confinement Effect

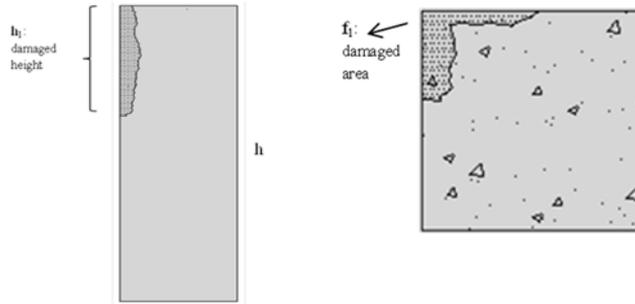
Fig. 9: Damage Indexes definition

In order to quantify the construction damages a simple model was developed by authors. The penetration of damage in the section and its expansion along the height of specimens was measured (Fig. 9). The percentages of those damages to the designed dimensions are extracted through three different indexes:

I) Section index  $d_s$  is the damage ratio of the section (Eq. 1)

II) Axial index  $d_h$  which quantifies the expansion axially (Eq.2) and,

III) Volumetric index  $d_v$  (Eq.3) which combines the above-mentioned indexes resulting to the volumetric ratio of damage.

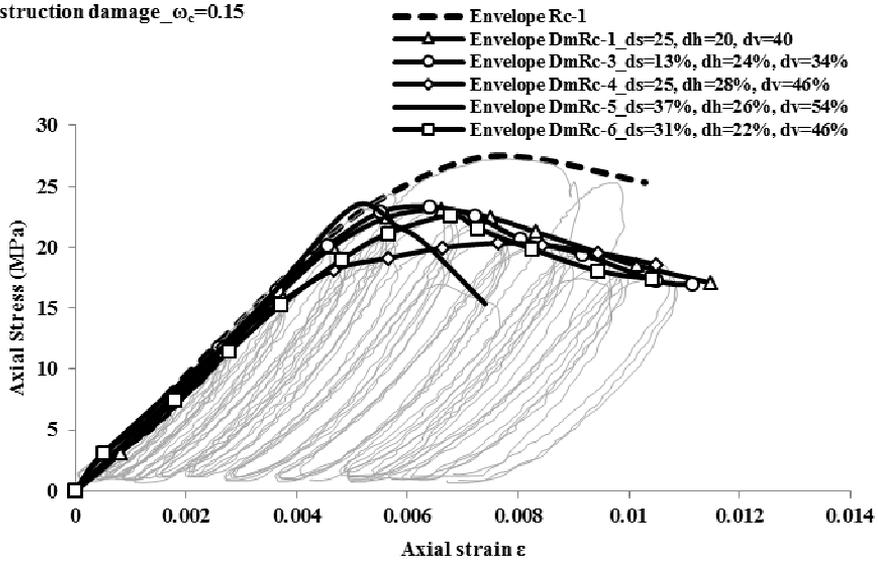
Fig. 10: Construction damage effect on repaired columns designed with ductility requirements

The effect of construction damages in repeated loading of low ductility specimens is shown in Fig. 10. Again, up to 3‰ axial strain all coincide. At strain greater than 3‰ specimens highly damaged ( $d_s$  index, Table 1:  $D_mR_c-1$ ,  $D_mR_c-2$ ,  $D_mR_c-3$ ) present lower values of maximum stress than the healthy one ( $R_c-2$ ). All stress-strain curves have peak stress at 7‰ strain. After peak, the damaged specimens present a steady plastic branch. The healthy specimen after 8‰ strain loses its capacity and the curve declines abruptly. It is noticed that for the same levels of repaired section ( $d_s=25\%$ ) specimens present minimal differences in terms of stress. After 8‰ strain, though, the total damage seems to affect the behavior. Specimen with higher combined damage index ( $d_v$ ) present descending branch ( $D_mR_c-3$ ). The dissipated energy up to peak stress and on the whole is shown in Fig. 12. It is remarkable that in highly damaged sections ( $D_mR_c-2$ ), the dissipated energy is lower both up to the peak stress and up to the total strain (25% and 30% respectively) comparing to the non-repaired specimen ( $R_c-2$ ).

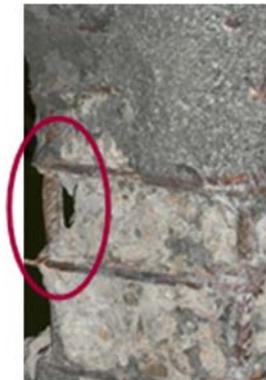
Fig. 11: Buckling of longitudinal bar of  $D_mRc-5_{\omega_c=0.15}$  after loading

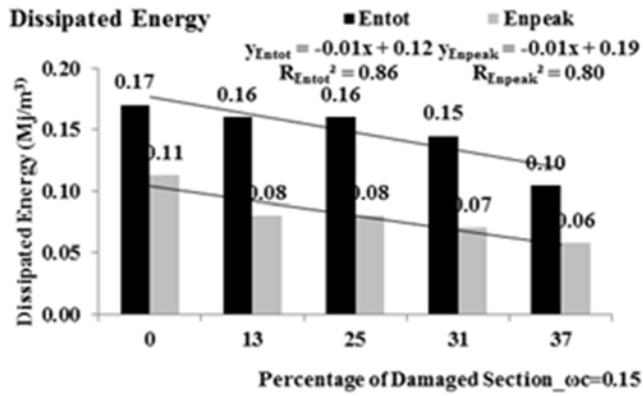
Fig. 12: Dissipated energy of columns with ductility requirements: peak stress-totally

The repaired construction damages seem to affect similarly specimens designed with ductility requirements (Fig. 13). The maximum stress is obtained at 5 up to 6‰ strain. It is evident in higher levels of damage ( $D_mR_c-5$ ) the peak stress is more reduced (22%). It should be noted that when the impairment of the section exceeds 25% ( $D_mR_c-5$ ) the failure happens after 5‰ axial strain with abrupt reduction due to early buckling of the longitudinal reinforcement (Fig. 11). The dissipation of energy, again, both up to peak and totally of the repeated loading, is lower than the non-damaged one. Speaking of the same levels of section impairment, specimens with stirrups of minimum levels of modern design ( $D_mR_c-1$ ,  $D_mR_c-4$ ) dissipate slightly higher ratio of energy up to peak load than the ones with older codes ( $D_mR_c-1$ ,  $D_mR_c-3$ ), but 25% and 8% respectively higher energy on the whole. In both classifications ( $\omega_{wc}=0.075$ ,  $\omega_{wc}=0.15$ ) all specimens, damaged or not, exceed the 50% of their capacity in dissipating energy up to the peak point of the stress-strain curve (Fig. 12).

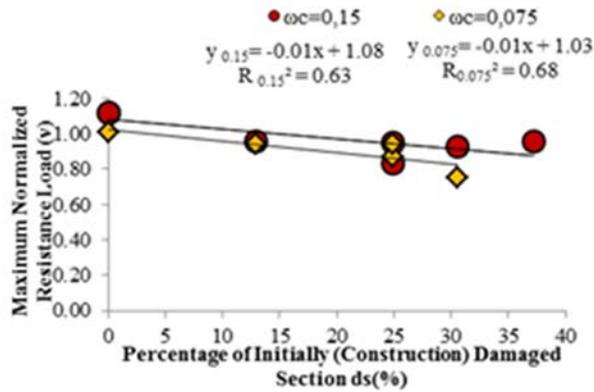
Fig. 13: Association of maximum normalized resistance load ( $\nu$ ) with the level of the (construction) damaged section  $d_s$  (%)

The tendency of highly damaged specimens ( $d_s$  index) to present resistance in lower stress than designed is illustrated graphically (Fig. 13) in order to examine the dispersion in both classifications. It’s sure enough that the declination is in tolerable limits, the dispersion factor ( $R_2$ ) for both levels of ductility, low and high, is quite satisfactory (0.68 & 0.63 respectively).

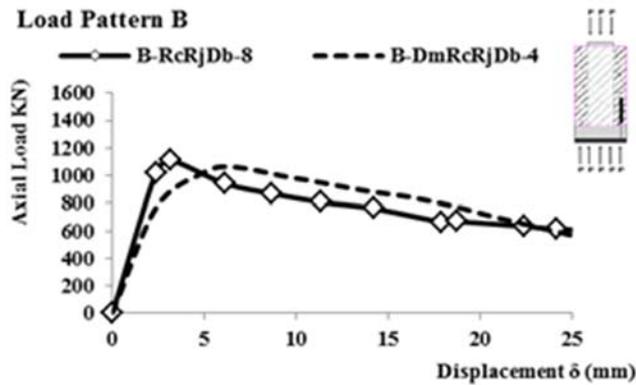
Fig. 14: Axial Load (kN) vs Deformation  $\delta$  (mm) chart for Load Pattern B

On the other hand, on higher percentages of repaired section and on the presence of dowels (Fig. 14,  $B-D_mR_cR_jD_b-4$ ), the behavior seems to be slightly different. The maximum resistance load (5 % lower) is found in almost twice the axial strain of a healthy column ( $B-R_cR_jD_b-8$ ). However, the rate of reduction ( $r_p$ ), of peak load in every next strain ( $dP_{peak}/d\varepsilon$ ) is blunter in the damaged specimen (Fig. 16, Fig. 17). The secant stiffness of the damaged specimen is lower.

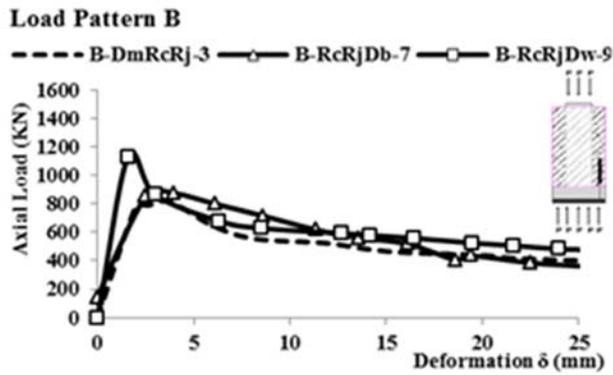
Fig. 15: Axial Load (kN) vs Deformation  $\delta$  (mm) chart for Load Pattern B

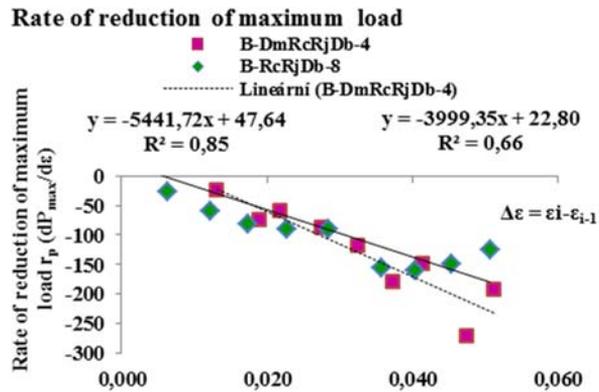
Fig. 16: Rate of reduction of maximum load in plastic strain - Load Pattern B

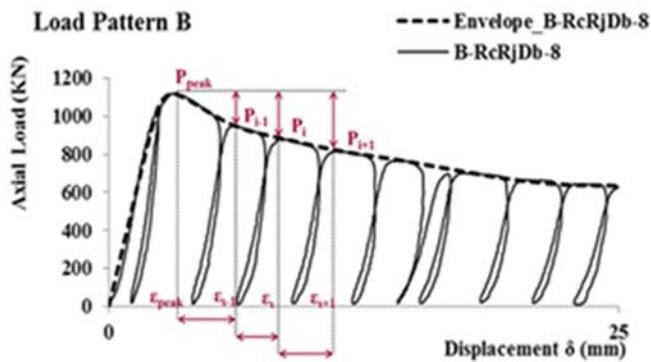
Fig. 17: Definition of  $r_p$  rate of reduction

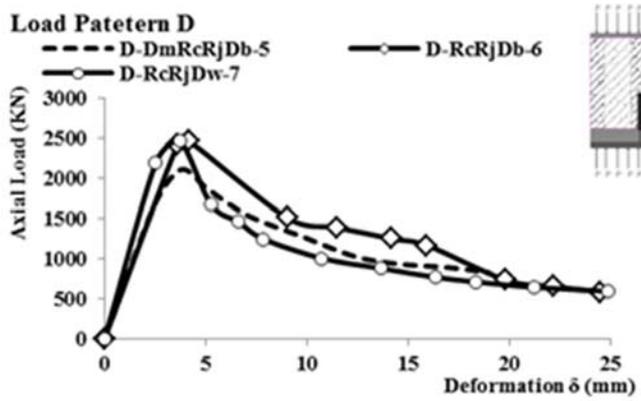
Fig. 18: Axial Load (kN) vs Deformation  $\delta$  (mm) chart for Load Pattern *D*

In addition to, there is strong difference between these specimens and the one with welded longitudinal bars of core and jacket (Fig. 18). The last one presents almost 3 times higher initial stiffness. The maximum capacity load is achieved in 53% lower axial strain (3.2 ‰ or 1.6 mm-0.063 in) and then up to 25 ‰ axial strain (12.5 mm- 0.492 in) the load remains 18 % lower than the one with dowels. Still, it is 6 % higher in all deformations than the damaged column. After 30 ‰ (15 mm- 0.555 in), the welded jacketed column presents up to 25 % higher load than the one with dowels or the damaged one. The repaired columns without reinforcement on the interface and small percentages of repaired section seem to have small influence in the final behavior ( $B-D_mR_cR_j-3$ ) (Fig. 12).

In Load Pattern  $D$  (Fig. 18), simulating the monolithic behavior of the retrofitted element, the first branch of the damaged column coincides with the undamaged one ( $D-R_cR_jD_b-6$ ) up to 7 ‰ axial strain (3.5 mm). Now, the damaged column ( $D-D_mR_cR_jD_b-5$ ) contains dowels crossing the interface and presents 17 % lower maximum load achieved in the same values of axial strain (7.5 ‰-3.5 mm-0.138 in). Then, the resistance load is lower from 13 % up to 19 %. Specimen with welded bars crossing the interface ( $D-R_cR_jD_w-7$ ) presents 30 % higher initial stiffness comparing to the other two specimens.

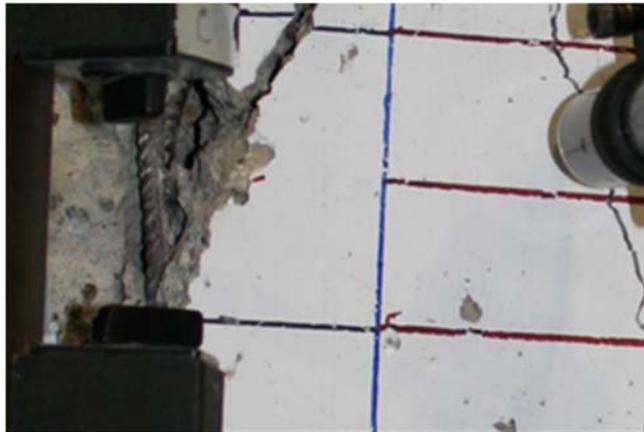
Fig. 19: Buckling of the longitudinal bar welds 4Ø8

In both Load Patterns  $B$  and  $D$ , due to the bars crossing the interface that are welded to the longitudinal ones, there are no plastic regions throughout the loading procedure. It is remarkable though, that the load is reduced in smaller values of deformation comparing to the one containing dowels. The reduction of about 270 kN takes place in Load Pattern  $B$  owing to the buckling of the longitudinal bars of both core and jacket that lead to the descending branch (Fig. 19). In contrary, the presence of dowels creates damaged areas around the bar (plastic regions) decreasing the capacity of the element to carry loads (Fig. 20).

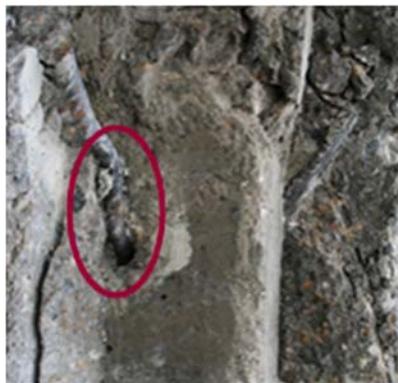
Fig. 20: Plastic region around the dowel bar - cut of specimen

In Load Pattern  $D$ , the reduction is higher due to the plastic regions around the steel bar created throughout loading. The direct loading of both core and jacket lead to the activations of all kind of strength mechanisms (confinement of both core and jacket, shear mechanisms along the interface) and to higher values of load. In both Load Patterns, after 20 mm (40 ‰) displacement dowels and welds result to the same values of resistance load. Hence, thereupon, all mechanisms capacities are depleted and specimens present a remaining resistance. Table 2 resumes all measured results.
