THE ANALYSIS OF SLOPE STABILITY OF THE STREAM VÝŠINA IN ORLOVÁ

This paper analyzes the stability of the slope near a stream in Orlova district. The instability of the slope has a negative impact on a hot water pipeline located in the crown of the slope. The assessment is based on a survey of the current state of the slope, and mathematical models in two cross sections. Mathematical models were developed in software Plaxis 2D based on finite element method (FEM). The results of mathematical models allow locating the critical slip surface in the slope, to predict the unstable areas and possible negative effects of a potential landslide in the hot water pipeline.

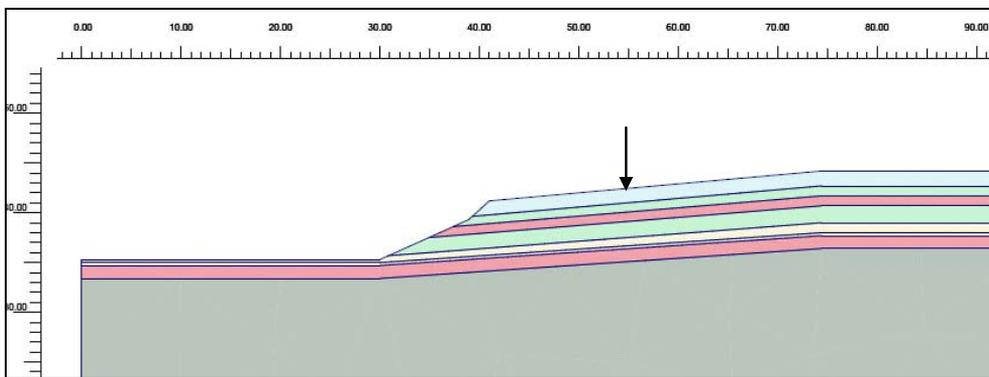
Fig. 4: Modelling geological structure – Model 1

Geological structure in the profiles was assessed in terms of test bore holes with respect to The Czech Geological Survey standpoint and a report by G-Consult Ltd. Soil material parameters, needed for the calculation itself, were accepted on the basis of geological survey and reported reference by G-Consult Ltd. In case there were residual strength parameters available, they were selected with respect to the current unstable visual signs. Listing of accepted soils with assumed parameters see below the table 1 [1], [2], geological structure model in profiles see the figures 4 and 5, hot water pipeline location is marked by an arrow.

The total degree of stability of the model calculation was 1,04. This value is on a boundary line of maximum limit of the shear strength. Therefore, the degree of stability does not reach required rate 1,5 for permanent slopes and indicates the instability of analysed slope structure despite the fact that the model did not take into account any other negative effects. Moreover, groundwater level was quite deep below the surface in the model (resulting from borehole survey and is supposed to vary depending on the climate conditions). For those reasons, we can consider the profiled slope as very unstable and it is likely to have other landslides in this area.
