Vladislav KŘIVDA¹, Ivana MAHDALOVÁ²**PROBLEMATIC TURNING OF BUSES ON WRONGLY DESIGNED INTERSECTION****PROBLEMATICKÉ ODBOČOVÁNÍ AUTOBUSŮ NA CHYBNĚ NAVRŽENÉ KŘÍŽOVATCE****Abstract**

The paper deals with problematic turning of buses on selected intersection with use of video analysis of conflict situations. This paper also describes a new attitude to division and marking of conflict situations and also one of the methods during video analysis of conflict situations by the evaluation of inappropriately designed building elements on intersections.

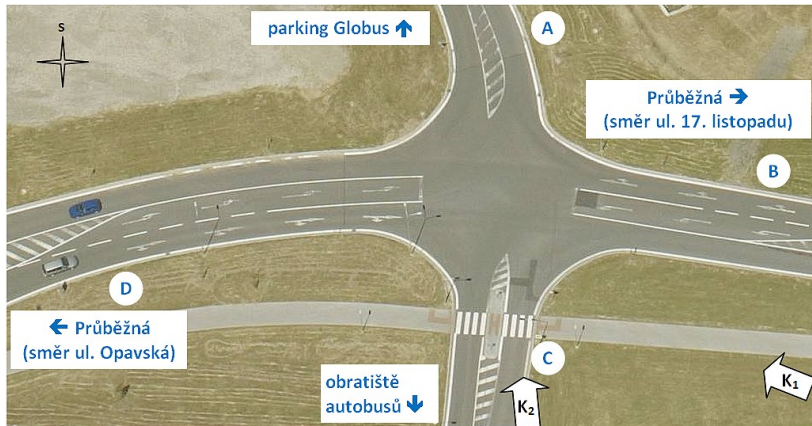
For our needs the intersection *Průběžná – obratiště autobusů – parking Globus* in Ostrava-Poruba was chosen (near Faculty of Civil Engineering, VSB – Technical University of Ostrava – see Fig. 2). The major streets have the turning lanes and the minor street which (leg C) has pedestrian crossing with refuge island.

Fig. 2: Monitored intersection *Průběžná – obratiště autobusů – parking Globus* in Ostrava-Poruba

The reason of this behavior is following: the bus drivers have problem to go into space between refuge island and right curb (see exit C on Fig. 2). In case of drive from leg B to C (the left turning) the buses usually drive over visual island (i.e. conflict situation 2j_{so}1-O1K) and then near the curb (i.e. conflict situation 2j_o1-O1K) – see Fig. 8. The vehicles going from leg D to C (the right turning) then drive near the curb (i.e. conflict situation 2j_o1-O1K) – see Fig. 9. This way of drive can moreover endanger pedestrians which are near pedestrian crossing.
