Leopold HUDEČEK¹, Jan KRAMNÝ², Eva OŽANOVÁ³**IMPACT OF THE TRACK CONSTRUCTION ON THE FLAT WHEEL DETECTION****VLIV KONSTRUKCE KOLEJE NA DETEKCI PLOCHÝCH KOL****Abstract**

The article deals with the impact of wheel service condition and type of the running rail on vibrations in immediate surroundings of the tram track. The entire measuring was based on the presumption of higher noise and vibration values during passage of a tram vehicle with the so-called “flat wheel” and the possible difference of values of vertical vibrations in individual types of the running rails.

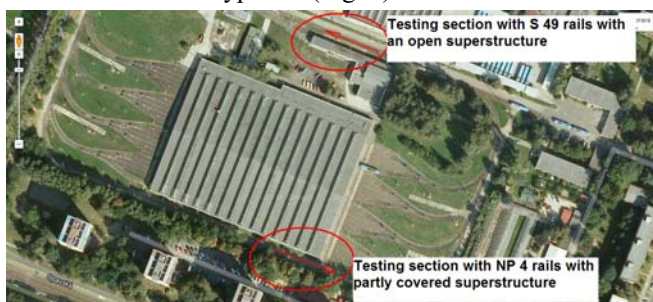
Fig. 3: Layout of placement of measured sections. The arrow points at the direction of the reference vehicle drive.

The measuring itself was done on July 26, 2001 in cooperation with the colleagues from the Department of Machine Parts and Mechanisms, Faculty of Mechanical Engineering, VŠB – TU Ostrava. There were selected two testing sections within the premises of Vozovna Poruba DPO, a.s. depot. Both of them have comparable conditions of vibration propagation. One of them with an open superstructure and the 49E1 (S49) rail and the other one with a superstructure covered with medium polluted crushed-run rock and the NP 4 type rail (Fig. 3).
